# Rapid geomorphic recovery of the Erskine River wave-dominated estuary after flash flooding

Sandra Brizga<sup>1</sup>

## Abstract

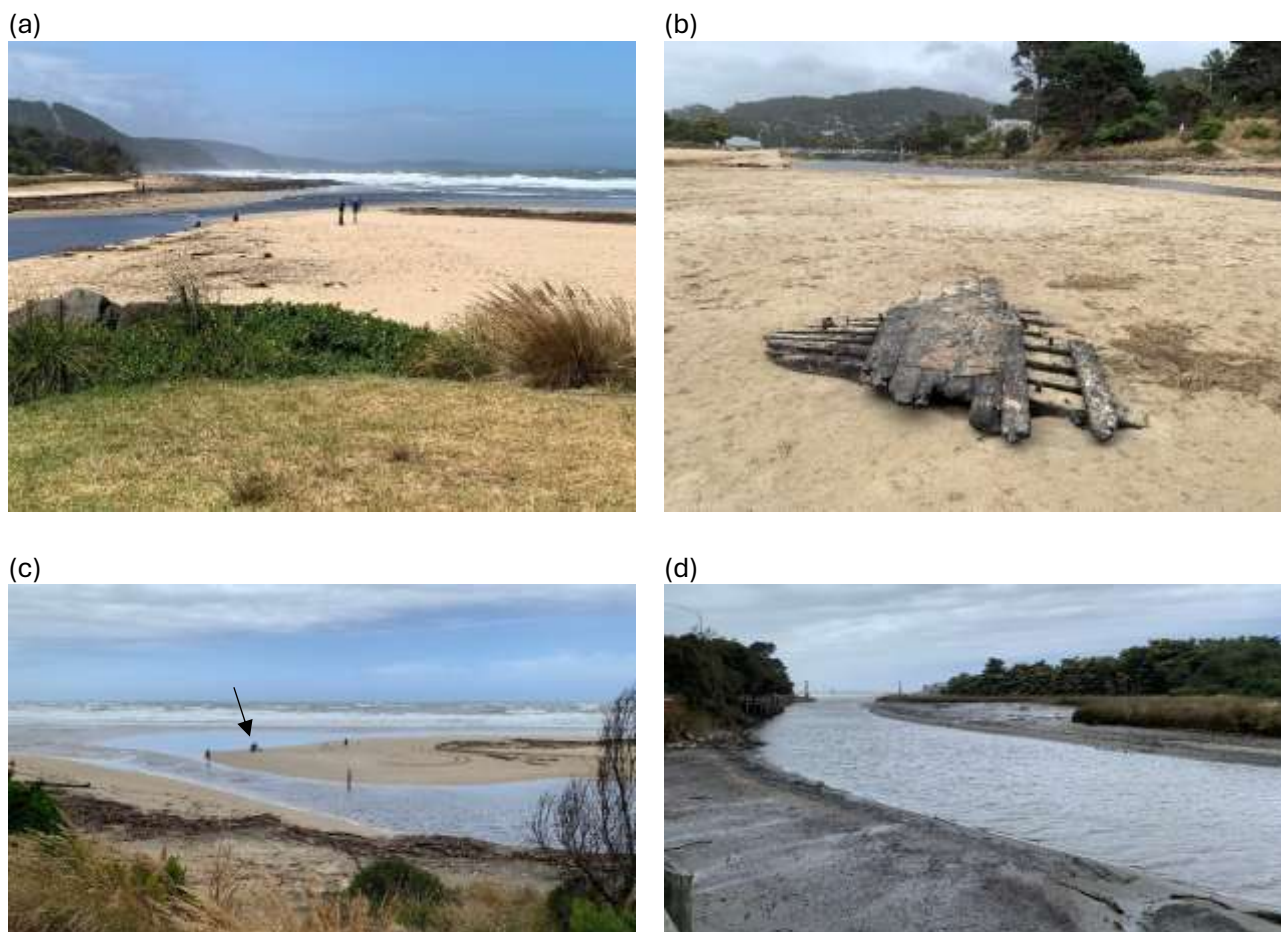
The flood eroded a channel through the entrance bar (Figures 3a, 3b and 3c) and flushed sand deposits out of the lower estuary into Loutit Bay. The flood cut exposed Eumerella Formation bedrock in the lower estuary and an old shipwreck usually buried under sand at the entrance bar (Lorne Historical Society 2026; Figures 3b and 4a).

The scour of the entrance bar lowered the base level for the estuary, draining the estuarine lagoon. Sand and mud banks were exposed in areas usually under water (Figure 3d, 4b). In the upper estuary, areas of river bed that are usually submerged by backwater from the estuarine lagoon were exposed by the fall in water level, including cobble and rock bars downstream of the Great Ocean Road (Figure 4c).

**Figure 3 Photographs showing the effects of the flood on the Erskine River estuary (all photographs around low tide): a) entrance bar and flood cut from south bank, 16 January 2026, b) exposed shipwreck, 17 January 2026, c) flood cut from north bank, exposed shipwreck arrowed, 17 January 2026, d) sand and mud banks exposed by fall in control level, 17 January 2026**

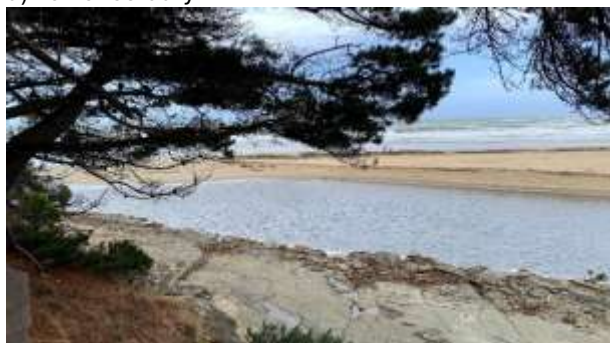
a) Lower estuary

Flood cut – January 2026

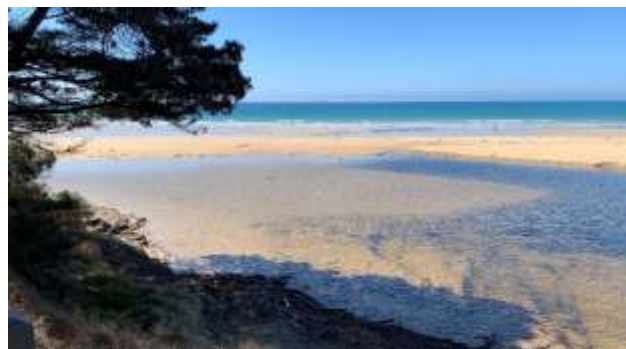
Geomorphic recovery was rapid. Wave action quickly deposited sand onto the entrance bar (Figure 4c), re-burying the shipwreck and re-establishing the control that maintains the estuarine lagoon (Figure 5). Within a few weeks, the river bed in the upper estuary (Figure 4c) and sand and mud banks in the middle estuary (Figure 4b) were again submerged by backwater from the entrance bar, which modifies tidal exchange including the effects of tides on water levels in the estuary. Measurements over several tidal cycles between 30 April and 4 May 2026 showed the tidal range in the middle estuary at the Swing Bridge was less than 1 m, compared to 2 m in Loutit Bay. A flood tide delta is developing in the estuarine lagoon immediately upstream of the entrance bar (Figure 4a).

Flood tide delta – March 2026

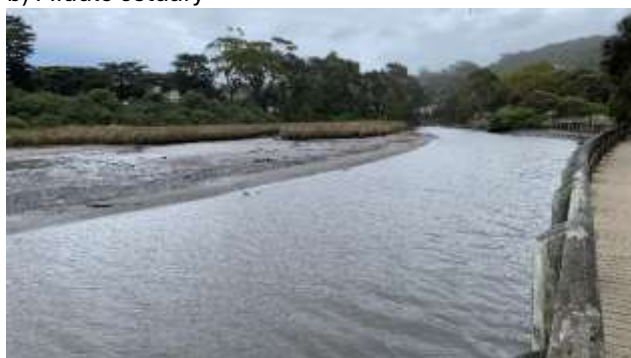
b) Middle estuary

Exposed sand and mud banks – January 2026

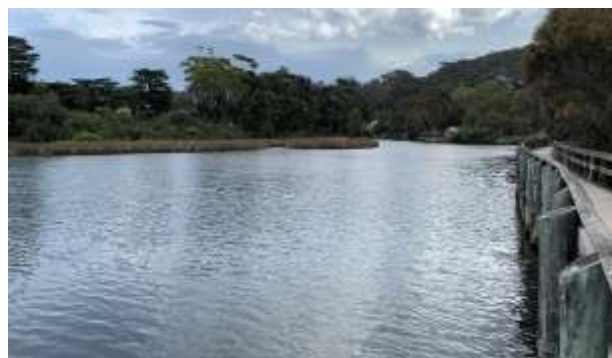
Resubmerged sand and mud banks – May 2026

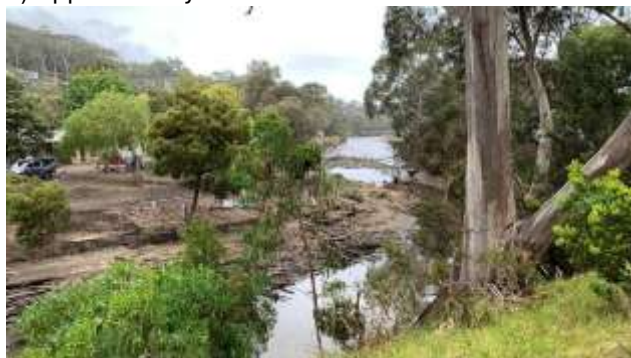
c) Upper estuary

Exposed river bed – January 2026

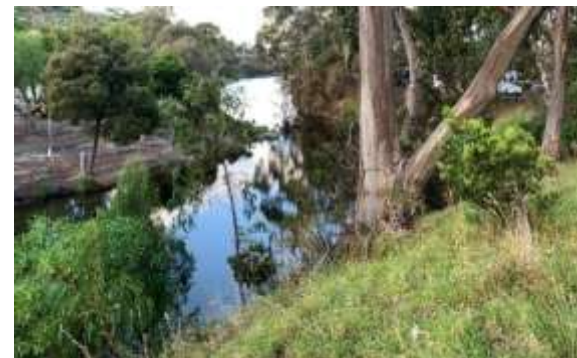
Resubmerged river bed – May 2026

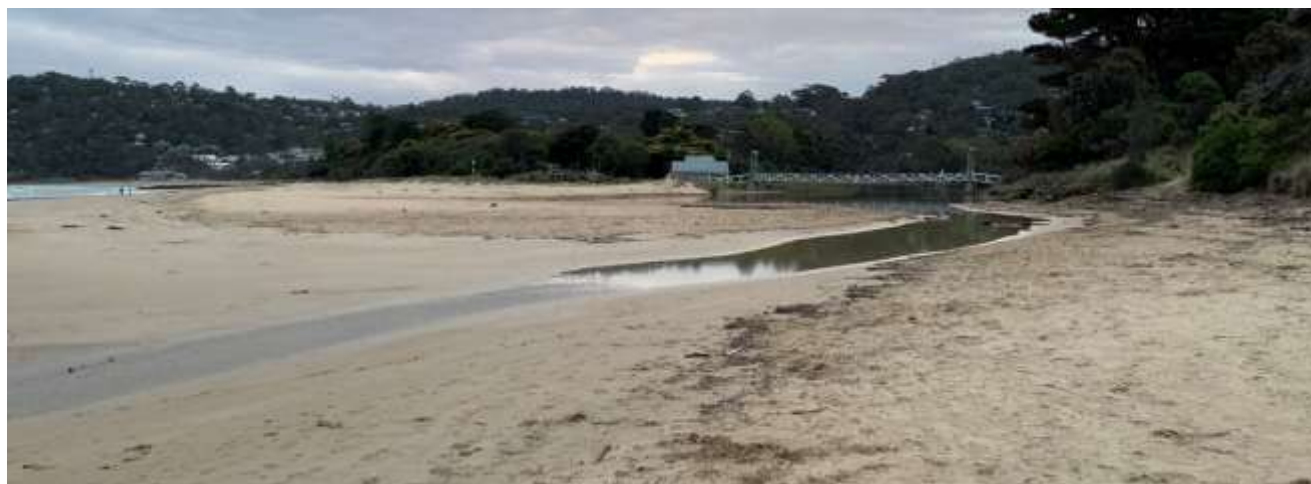
Figure 5 The entrance bar control for the estuarine lagoon (May 2026)
