## Between bedrock and a hard place: Managing bank erosion in a constrained urban environment

Adam Buller<sup>1</sup>

The City of Parramatta commissioned an Erosion Management Plan (EMP) for an 8km reach of Toongabbie Creek, upstream from its confluence with the Parramatta River. This paper summarises the key findings of that investigation and discusses their implications for urban waterway management.

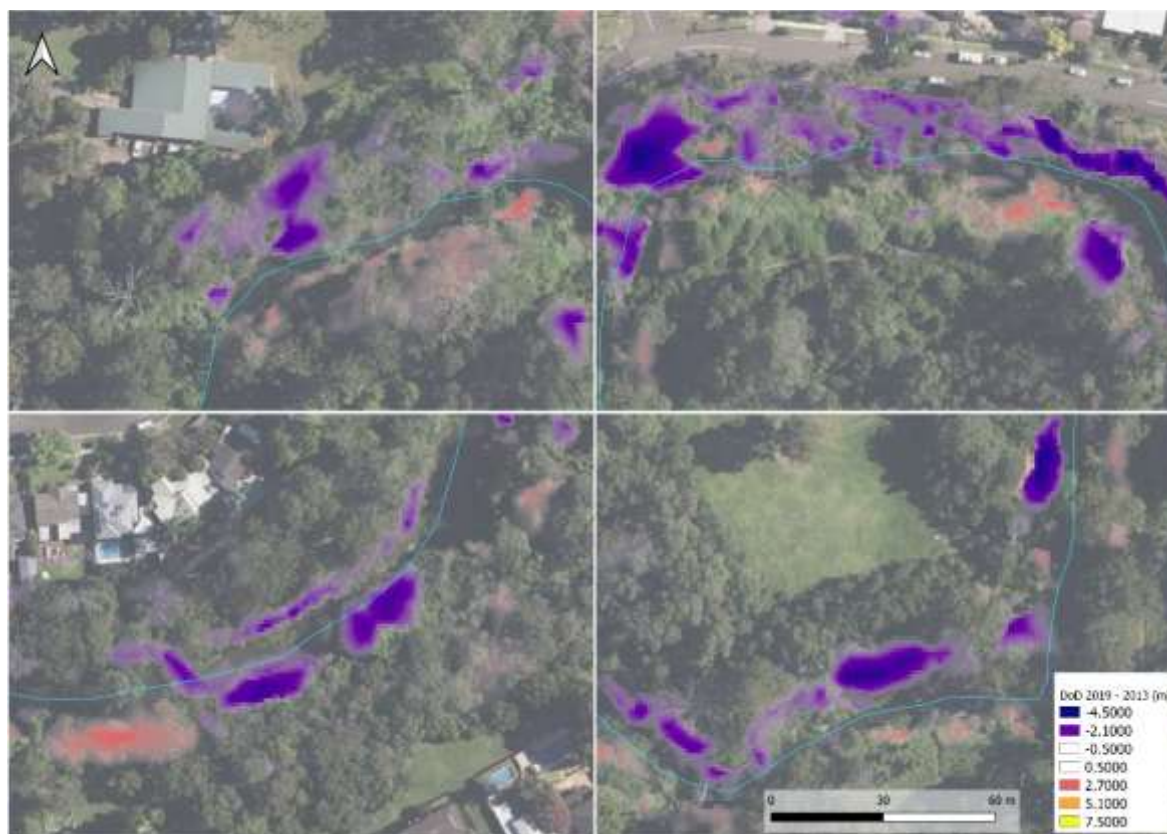
A desktop analysis was initially undertaken to characterise the study area and identify points of interest for further investigation during the on-ground assessment. Multi-temporal LiDAR was used to identify topographic changes that had occurred, including erosion and deposition of material (Figure 1).

**Figure 1 Multi-temporal LiDAR analysis of a sub-reach of the study area**

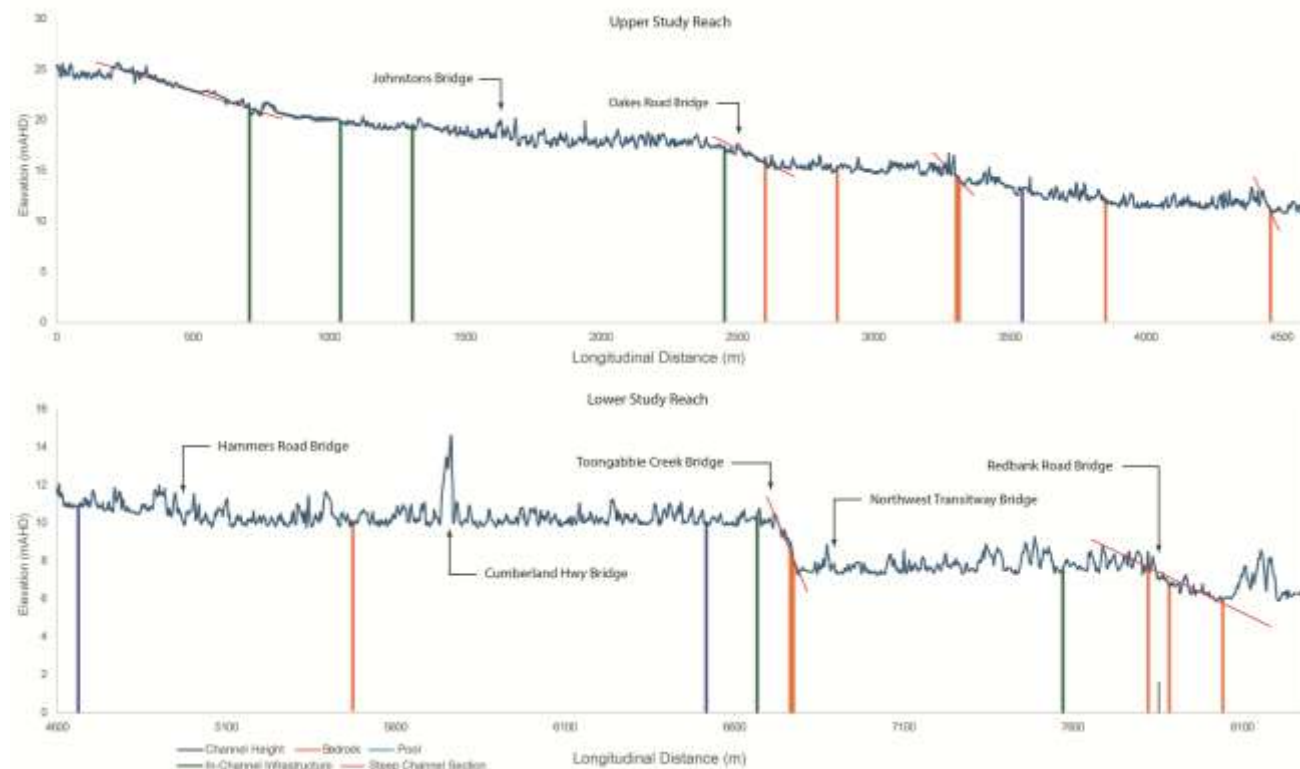
Bed slope analysis is a useful tool to identify historic or active bed deepening (incision) within the waterway, however, where water is present in the channel during LiDAR capture can be problematic as the level of the water surface rather than the underlying channel bed is captured, making it difficult to identify pools and bedrock controls without field observation. Figure 2 shows the bed slope analysis for the 8km study reach.

**Figure 2 Bed slope analysis (based on LiDAR derived water surface height)**

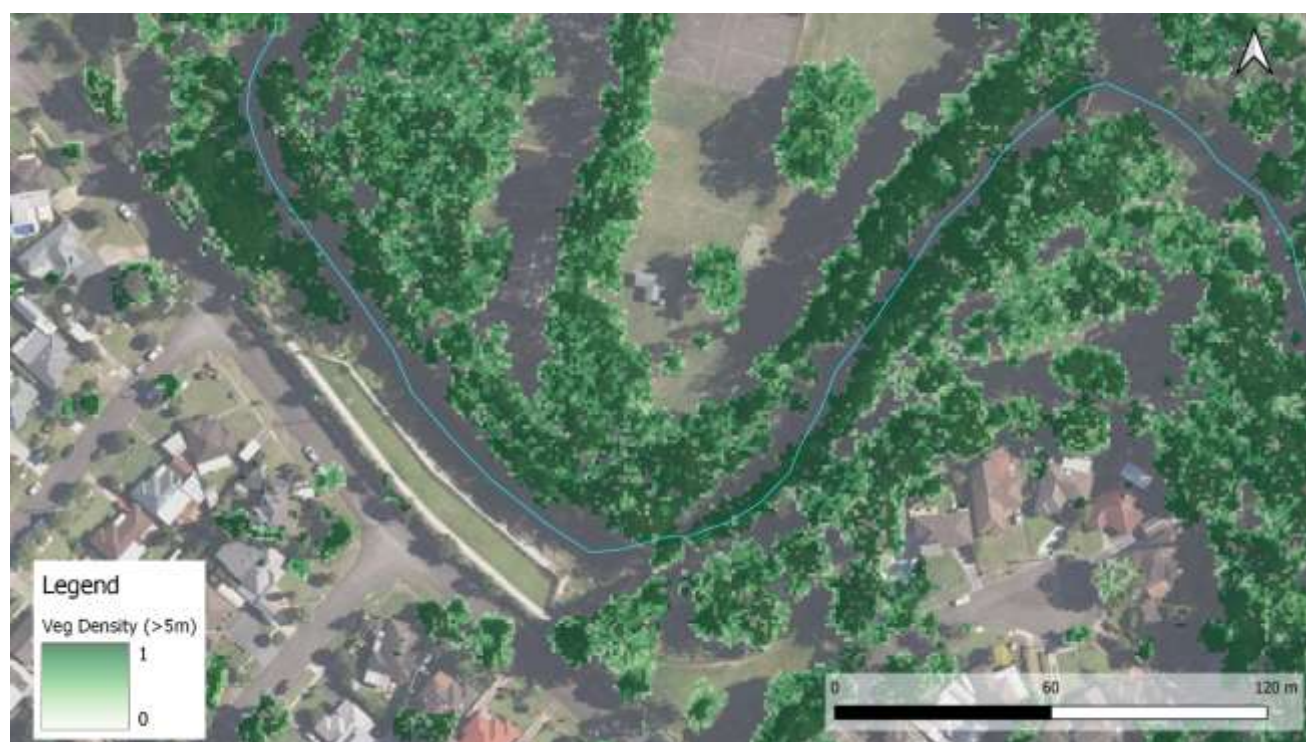
Vegetation within the waterway corridor serves an important function to the health and resilience of the waterway. An ecological vegetation assessment was carried out, focusing on classifying Plant Community Types (PCT's), identifying the presence, continuity and density of native species, and identifying invasive species and their proliferation and impact on native vegetation. In addition, vegetation density mapping (Figure 3) was prepared and filtered for specific canopy heights, to indicate the presence of significant, woody tree species that are important for soil stability cohesiveness.

**Figure 3 Vegetation density for species over 5m within a section of the project area (Source: 2022 1m LiDAR)**

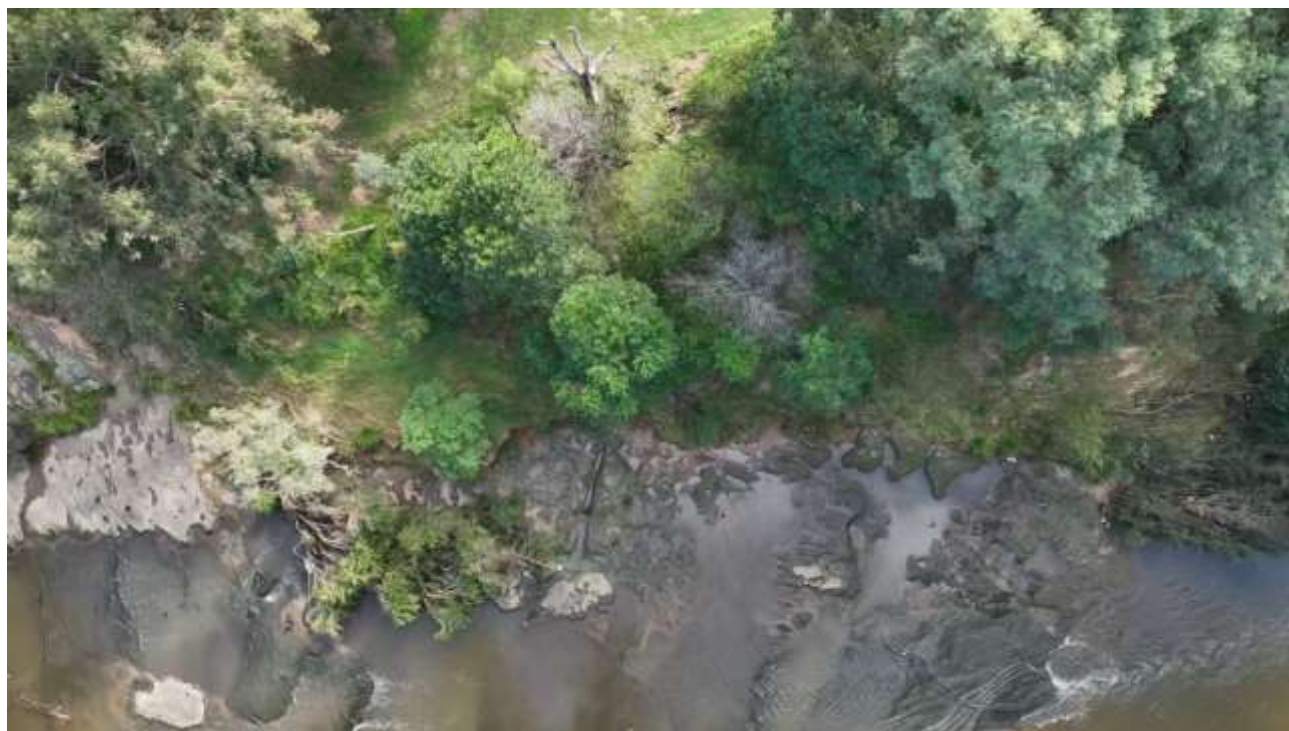
Capturing a detailed drone survey of the study area provided an unparalleled perspective of the waterway condition, providing a means to revisit specific locations, or view areas that were unable to be accessed on foot and allowed us to compare sub-reaches using side-by-side video footage to better inform the condition assessment. This proved to be an invaluable tool in prioritising the locations for intervention.

**Figure 4 Drone capture of bedrock within the study reach**
