## **Sands through the hourglass: a 30-year journey towards rehabilitation of the Genoa River, East Gippsland Victoria**

Sean Phillipson<sup>1</sup> and Rex Candy<sup>2</sup>

This paper describes the rehabilitation of the Genoa River over 30 years and lessons learned in protecting the river and Mallacoota Inlet from the impacts of extensive erosion and sedimentation.

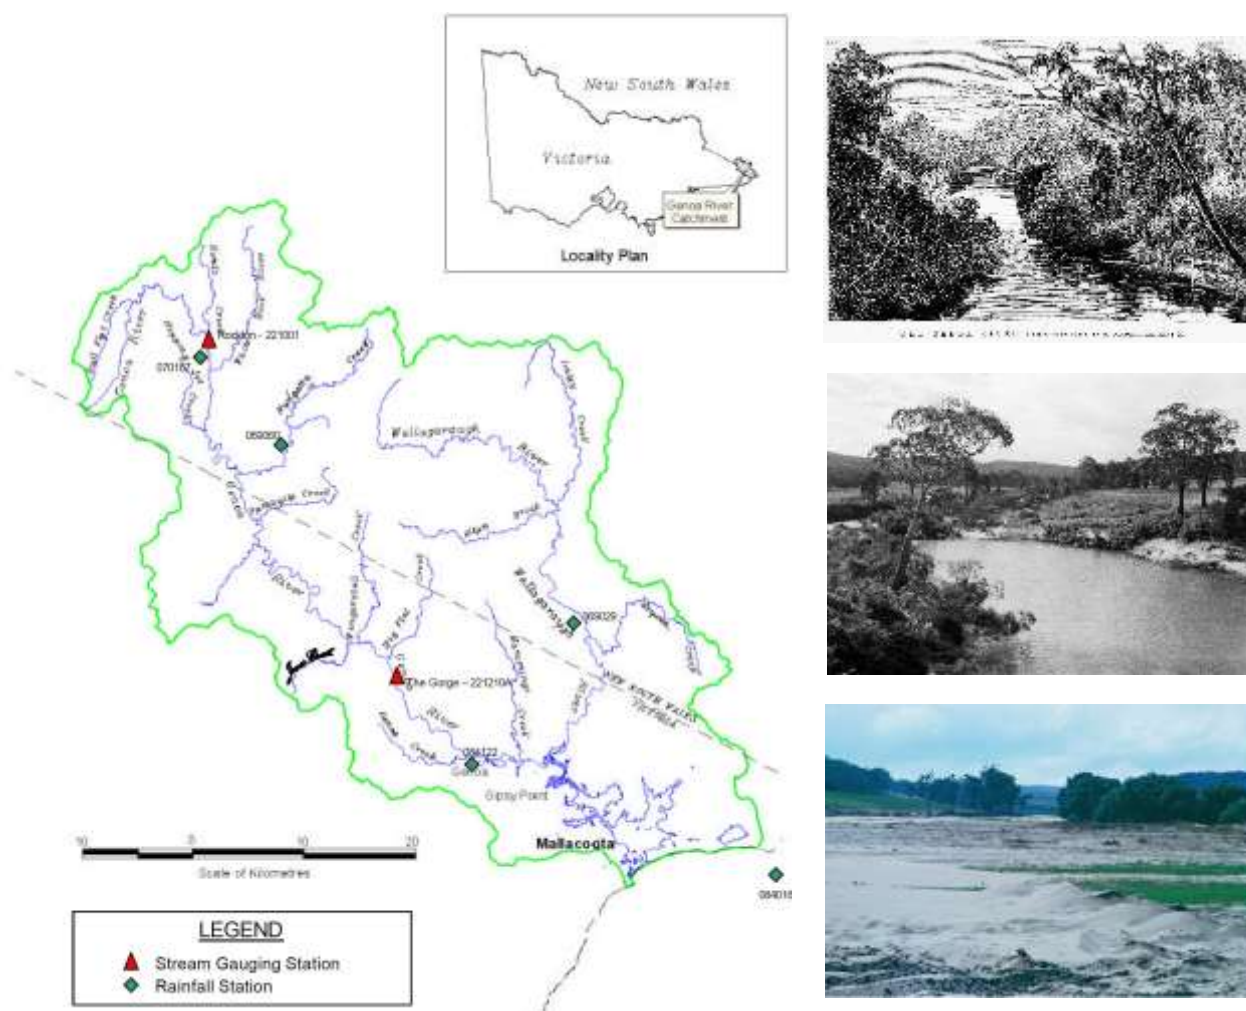
The condition of the river reflected the combined effects of historical land use and extreme flood events. In particular, the 1971 flood represented a major disturbance event that triggered widespread channel erosion and redistribution of sand throughout the system. Landscape scale fires in the catchment in January 1979 and the early months of 1983 also likely increased sediment supply to the river. The legacy of these events was evident for decades, with large volumes of sand persisting within the channel and floodplain.

**Figure 1 Genoa River catchment and locality map and images – a typical river channel circa. 1871 (top) and 1952 (middle); 1971 sand deposition on the floodplain following flooding (bottom) (reproduced from Brooks et al, 2001)**

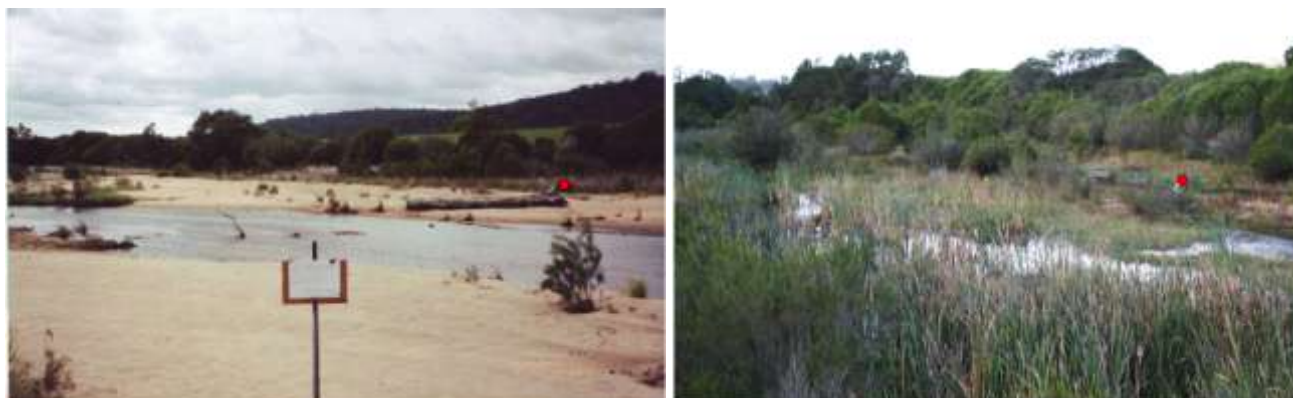
**Figure 3 Site of large wood installation in the Genoa River floodplain reach in 2002 (left) and 2009 (right). Note the establishment of in-stream vegetation and development of a narrow low flow channel**

Implemented by the newly formed East Gippsland Catchment Management Authority in the early 2000's, a key innovation was the introduction of **large woody debris (LWD)** to increase bed roughness and improve channel function. Anchored logs reduced flow velocity, trapped sand, and created diverse hydraulic conditions, enabling localised scour and deposition. These features provided stable sites for vegetation establishment, helping overcome the barrier of high sediment mobility that had previously limited recovery. Over time, LWD-driven changes promoted broader channel stabilisation and reduced sand movement.

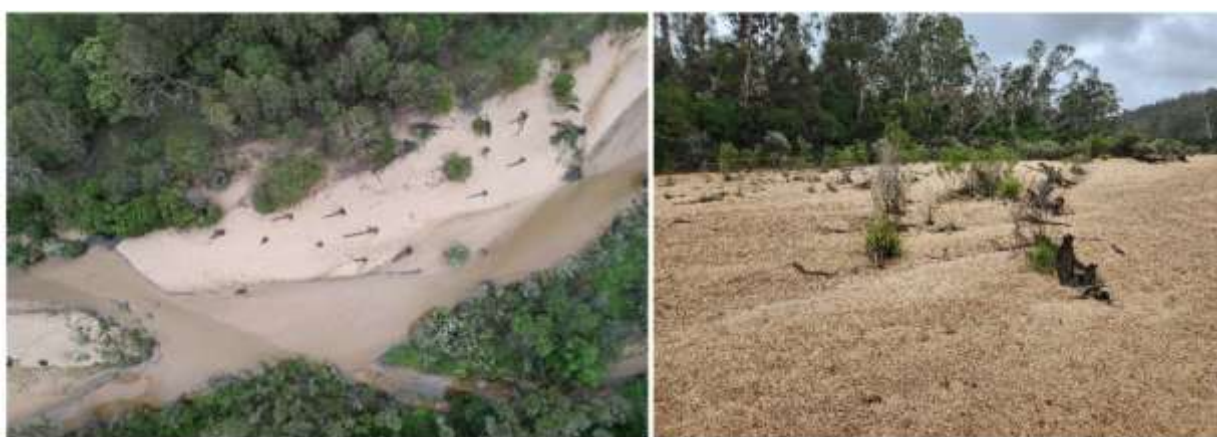
The effectiveness of on-ground works varied strongly with local sediment dynamics and amount of vegetation establishment. In upstream reaches, high and ongoing sand supply has limited the performance of interventions such as LWD. Many logs have been buried, stranded on unvegetated bars, or failed to generate meaningful scour, indicating that bed mobility remains too high for these structures to consistently function as intended. While there is some evidence of localised benefit, such as the formation of small shadow dunes and limited vegetation establishment associated with individual logs, these outcomes are patchy and suggest that, in highly dynamic sand-dominated environments, structural works alone may have limited influence without sufficient stabilisation through vegetation.

**Figure 4 Sites of LWD installation in the Genoa River in the upstream reach**

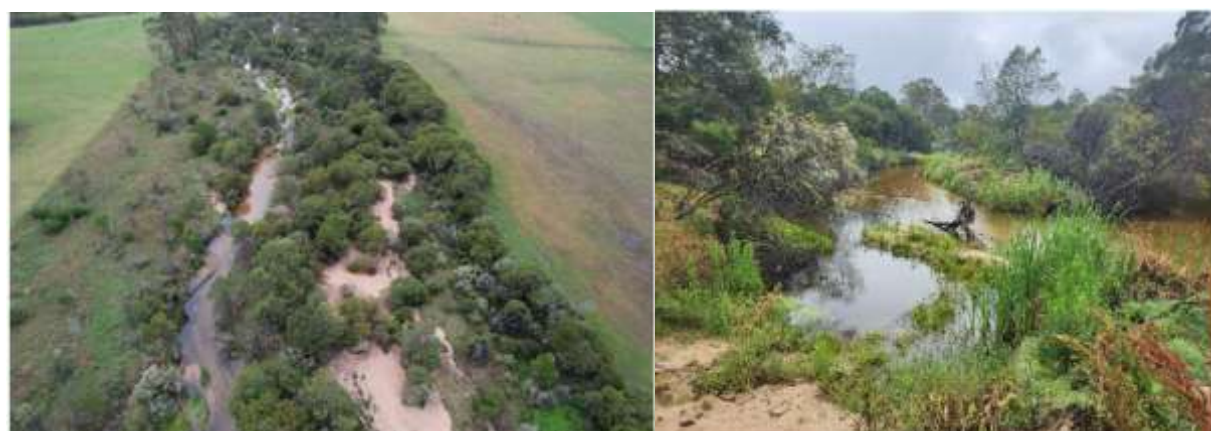
In contrast, downstream reaches demonstrated more effective outcomes where vegetation establishment is stronger, and channel conditions are more stable. Here, LWD appears to have contributed to increased bed complexity, including deeper pools and more defined channels, while supporting the development of vegetated islands and inset floodplains. However, some engineered structures, such as groynes, pile fields, and rock chutes, show limited evidence of promoting sediment deposition or sustained vegetation growth, although they have helped maintain overall channel position and reduce the risk of major channel change.

**Figure 5 Vegetation establishment in the Genoa River downstream reach**

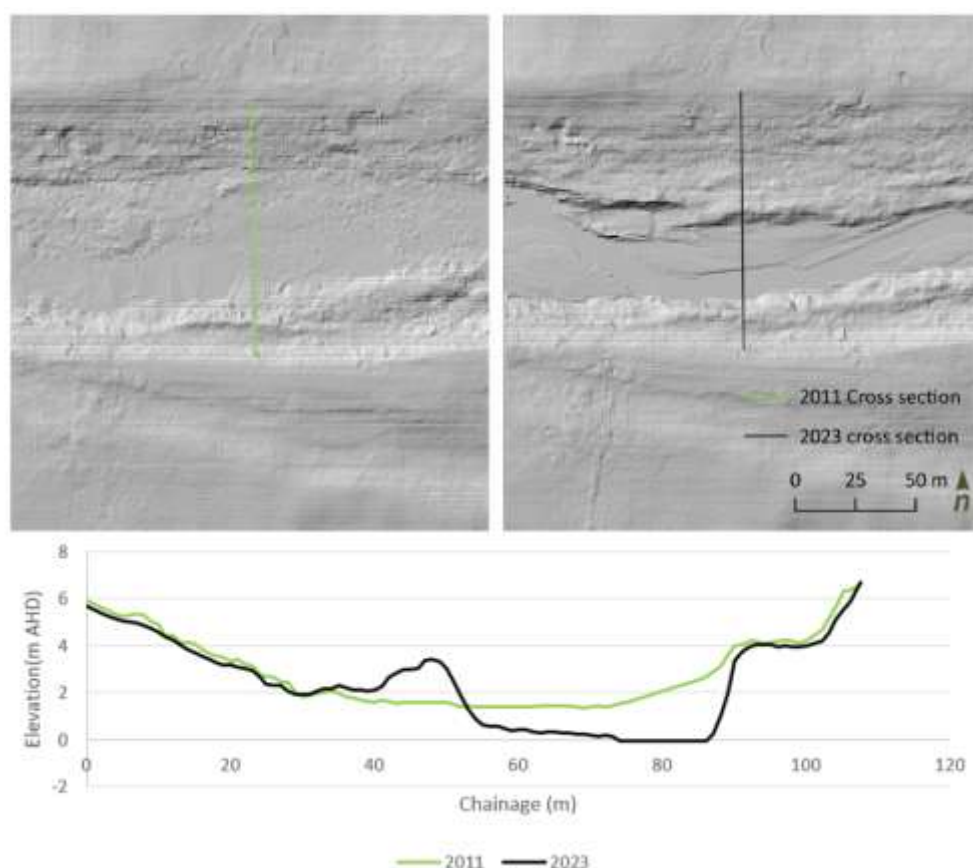
As a result, the channel has undergone measurable contraction in many reaches, with a reduction in the extent of exposed sand and a more defined channel form. The volume of actively mobilised sediment has decreased, and many previously unstable sections are now relatively stable under moderate flow conditions.

**Figure 6 Cross section of the Genoa River downstream of the Princes Highway (in the reach shown in Figure 7). Showing 2011 and 2023 surface elevation (Alluvium, 2024). Note the change in channel form**

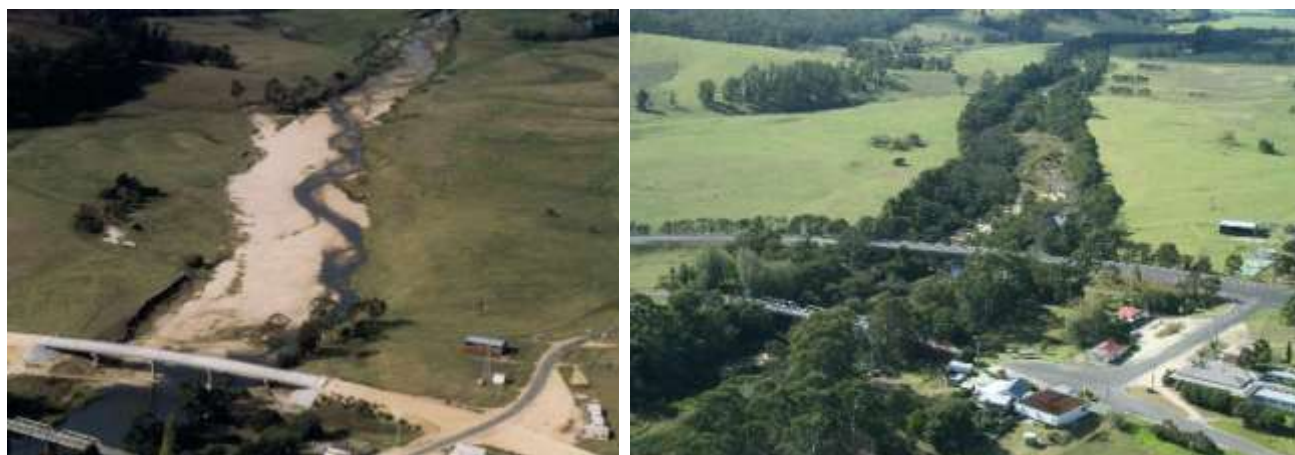
**Figure 7 The Lower Genoa River before (1986) (left) and after (2010) (right) an extensive rehabilitation project downstream of the Princes Highway in Genoa**
