## Living with change: Working with geomorphic-groundwater processes to inform river rehabilitation in Seqwater's Source Protection Program, North Pine River, QLD

This paper presents the outcomes of the Erosion Control at Dayboro Project, delivered as part of Seqwater's Source Protection Program. The project explored how geomorphic and groundwater process understanding can inform rehabilitation strategies that work with river adjustment processes rather than attempting to prevent change entirely.

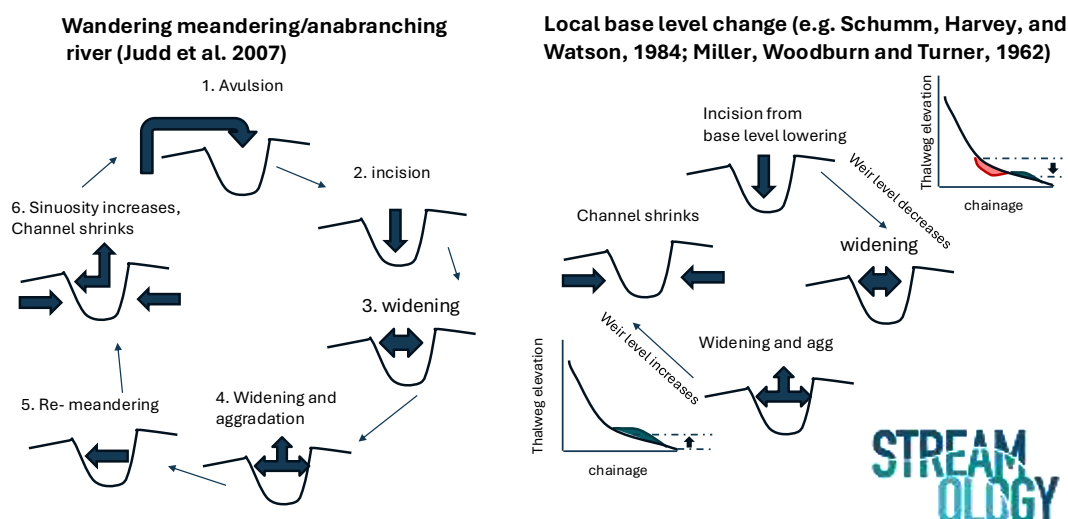
The geomorphic interpretation is not a simple case of channel incision. The observed channel evolution is controlled by the interaction of two primary geomorphic processes (Figure 2):

1. Wandering gravel-bed river dynamics involving lateral migration, bar reworking and avulsion; and
2. Local base-level adjustment associated with downstream meander cut-offs and lower operating water levels in North Pine Dam.

Figure 2 Two channel evolution models meet at Dayboro

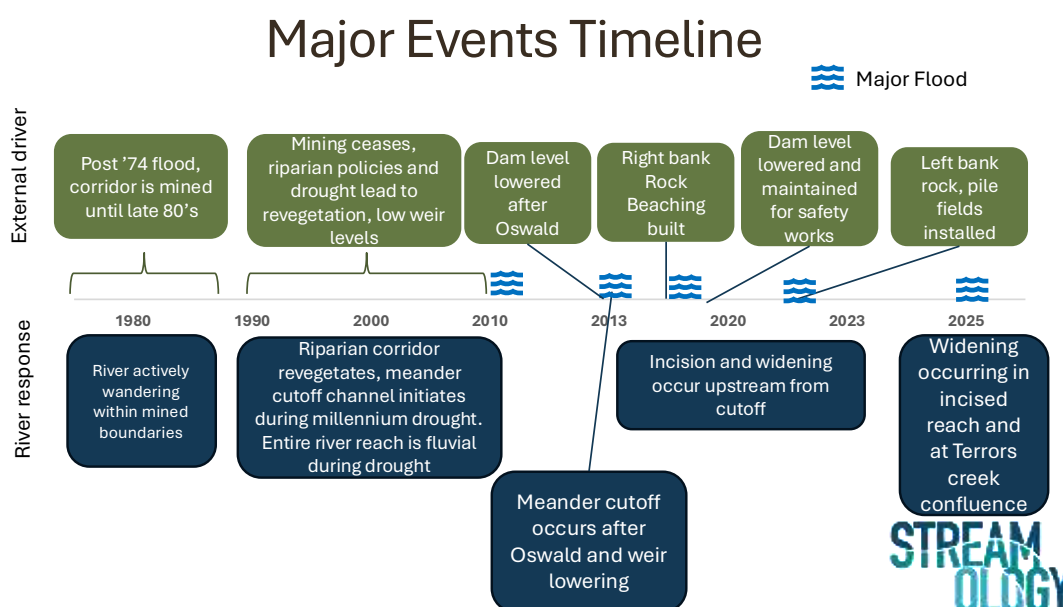
Together, these processes from a series of events (Figure 3) have initiated a wave of channel incision and widening that continues to propagate upstream through the reach.

Figure 3 Summary of major events timeline at Dayboro

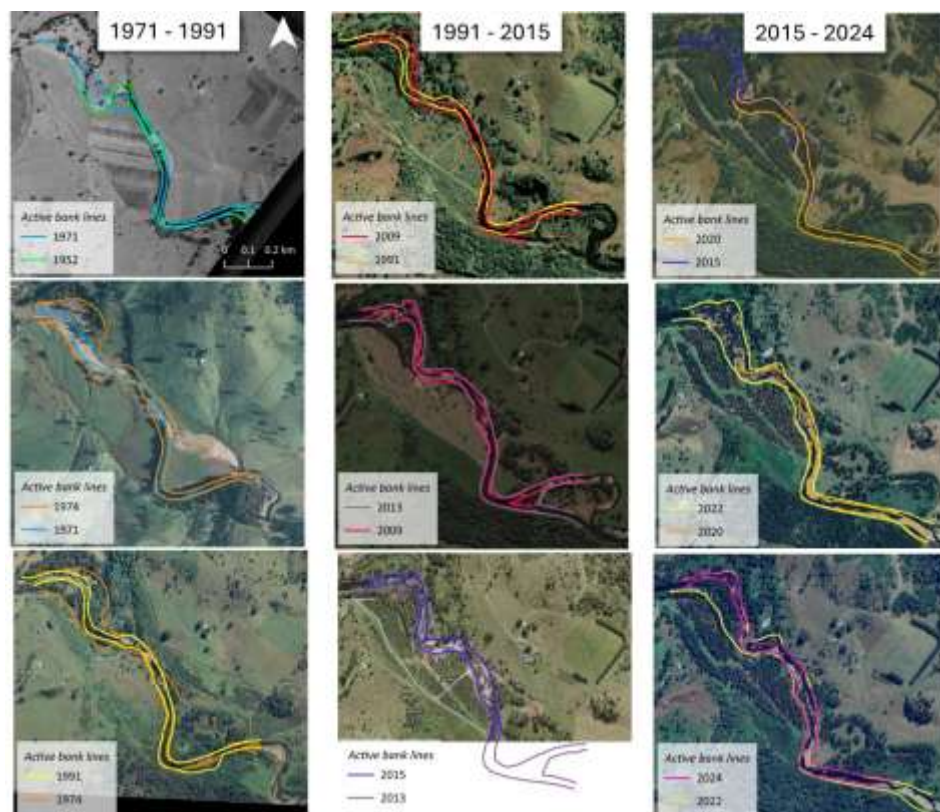
**Figure 4 Aerial imagery showing active bank line changes between 1952 and 2024**

The study found that erosion at Dayboro is not simply a localised bank stability issue, but rather part of a broader reach-scale geomorphic adjustment process. Historical analysis showed that downstream meander cut-offs combined with lowering of downstream water levels-initiated incision through portions of the reach following the 2011–2013 flood sequence. This incision subsequently propagated upstream, triggering widening and lateral instability.

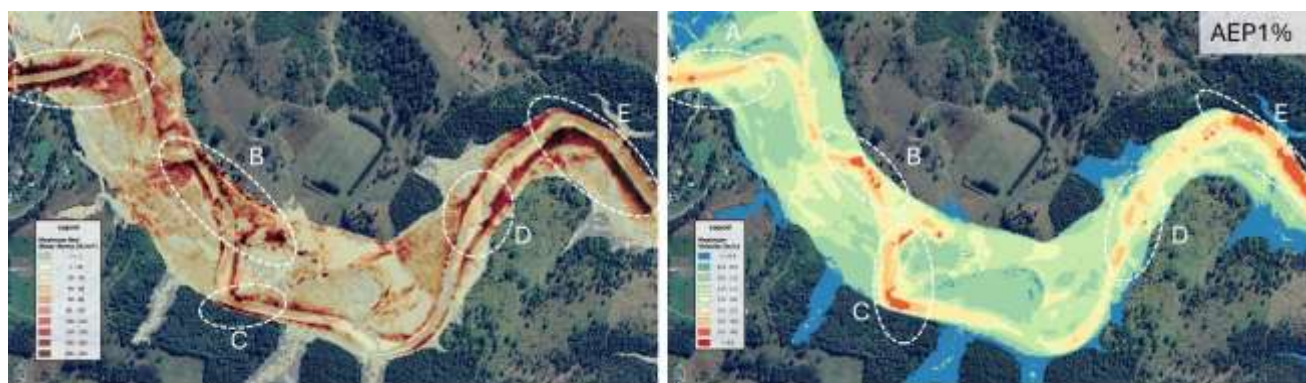
**Figure 5 Hydraulic modelling of existing conditions showing high bed shear stress concentrated on banks driving widening processes, and localised high velocities focused on the bed**

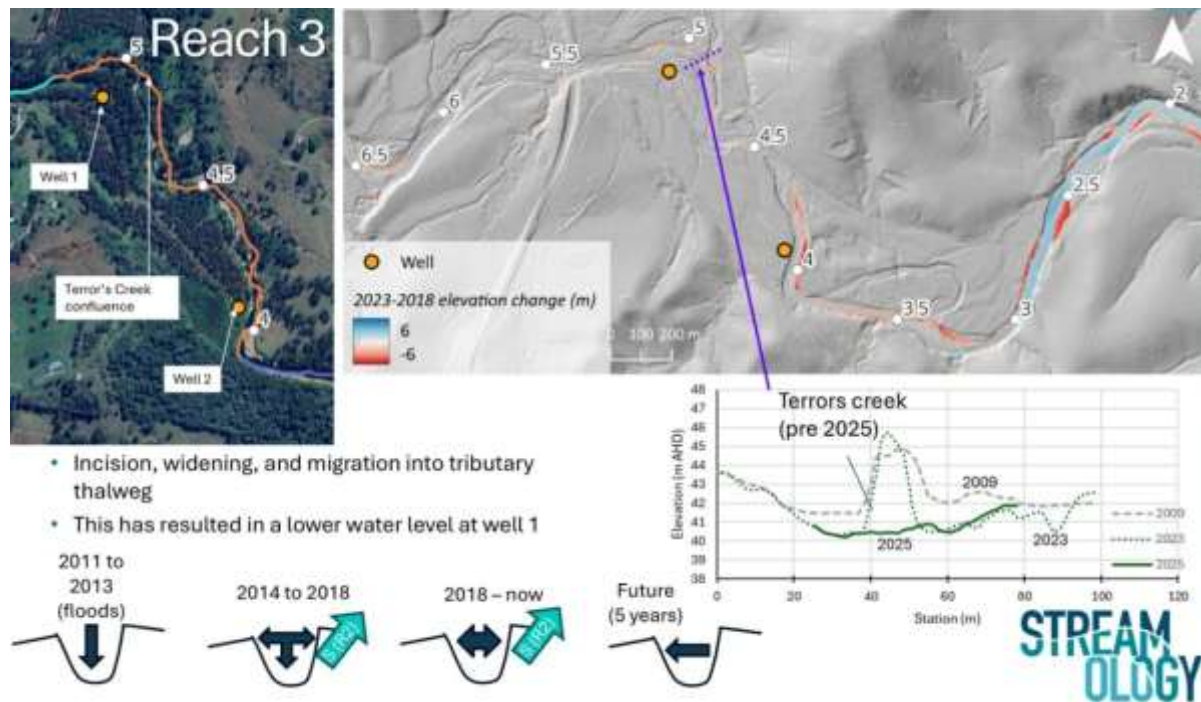
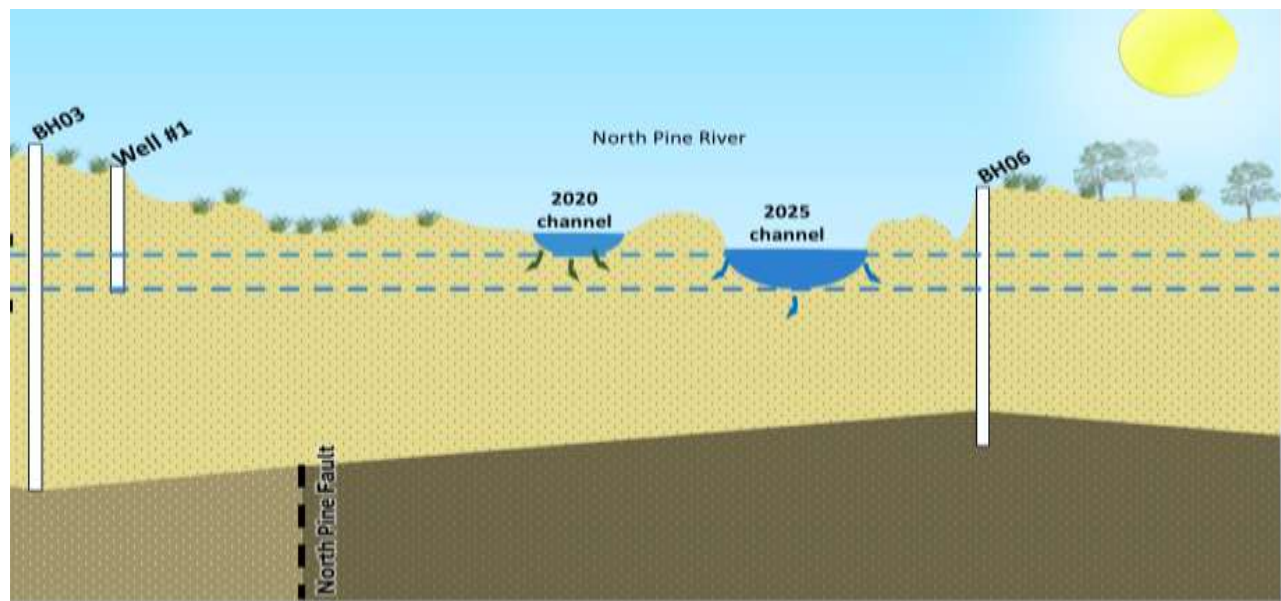
The Dayboro groundwater wells rely on hydraulic connectivity between the river and surrounding alluvial aquifers. However, progressive channel incision and migration have lowered river levels relative to the floodplain aquifer and shifted the active channel away from key production wells. This has reduced recharge efficiency while simultaneously increasing sediment delivery to North Pine Dam. Historically, many erosion-management approaches within SEQ have focused on localised bank stabilisation and hard engineering solutions. However, within highly dynamic wandering gravel-bed rivers, these approaches often fail to address the broader geomorphic drivers of change and may redistribute erosive energy elsewhere in the system.

**Figure 6 (a) Summary of geomorphic conditions adjacent to Well 1 and (b) conceptual hydrogeological model relating geomorphic controls to groundwater conditions impacting Well 1**

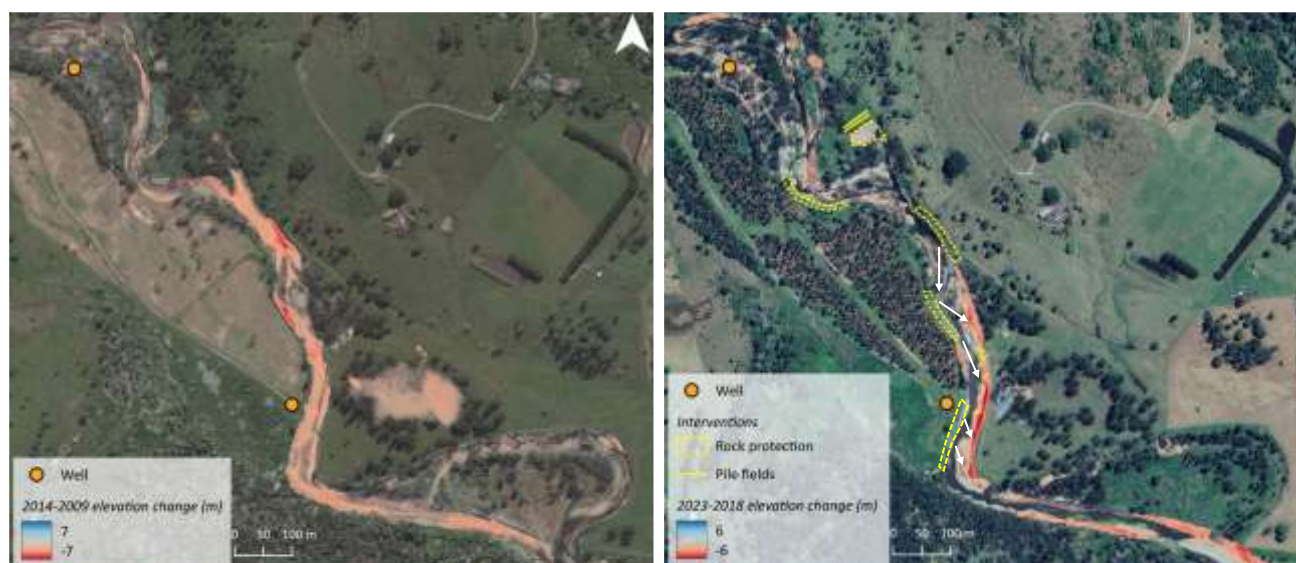
Several structures redirected erosive energy toward opposing banks, contributing to localised excessive erosion and channel widening. Other treatments were partially outflanked during major flood events (Figure 7). These findings highlighted that localised hard engineering approaches are often poorly suited to highly mobile gravel-bed systems where adjustment processes operate across the broader channel corridor.

Figure 7 Elevation changes by 2014 since 2009 (left) and elevation changes between by 2023 since 2018 (right). Interventions implemented between 2015 and 2017 are mapped in yellow

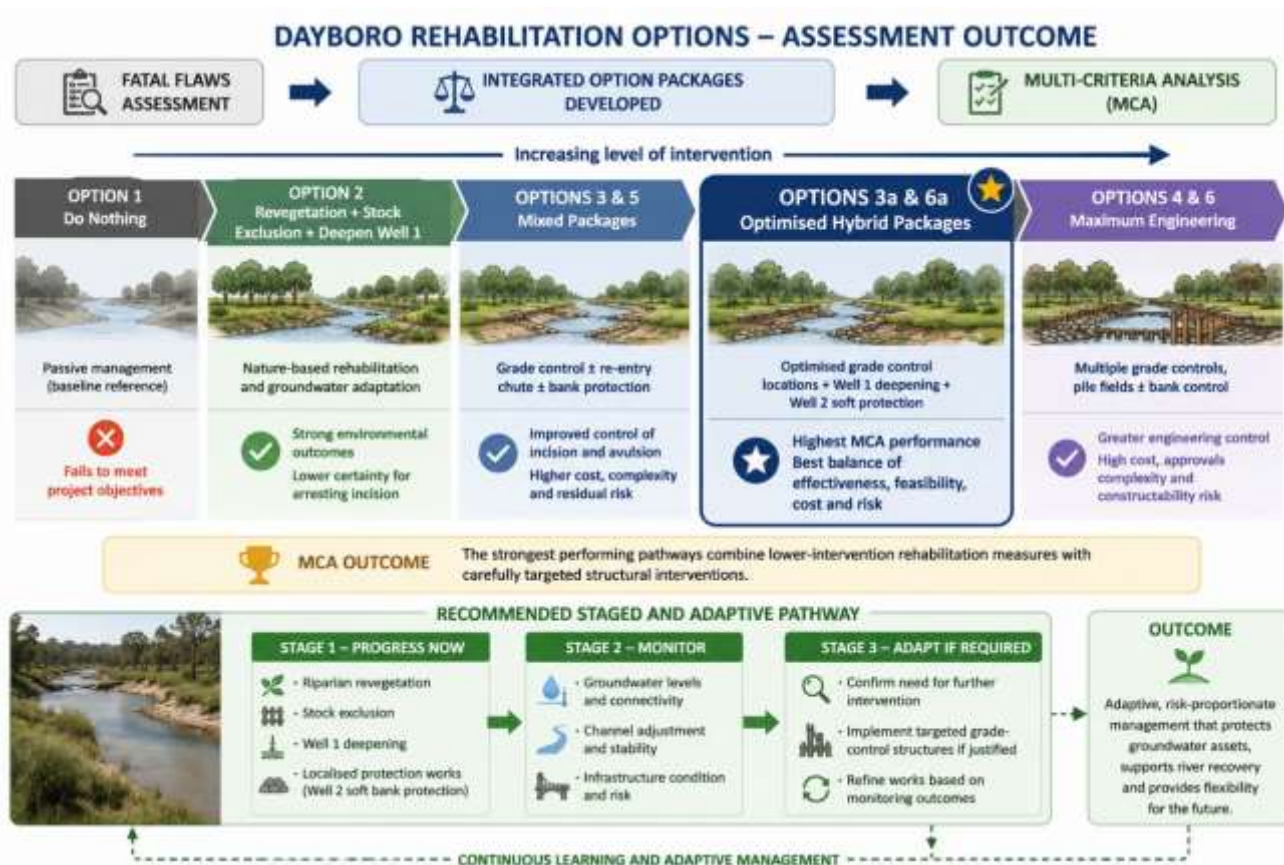
Figure 8 Design of staged intervention approach

The preferred staged and adaptive approach included (Figure 8):

- immediate implementation of riparian revegetation and localised protection works;
- continued groundwater investigation and monitoring;
- preservation of future grade-control pathways if required; and
- deferral of major structural intervention until supported by monitoring and evidence.
