## Rehabilitation of Streams Receiving Inter-Basin Transfers - NSW North Coast

*Tony Broderick<sup>1</sup> and David Outhet*

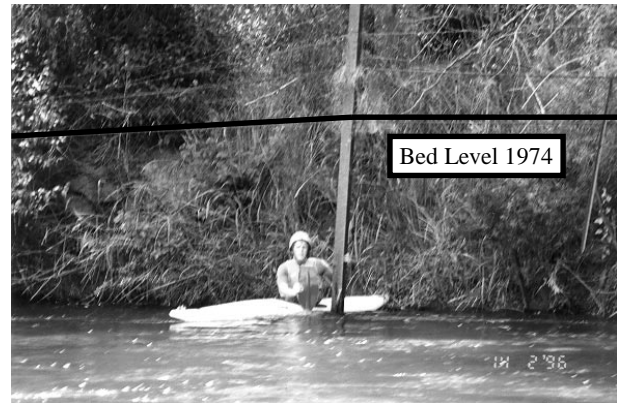
levels. Figure 2 is an example of the evidence of bed lowering. The long profile and the "hanging" erosion control mesh work shows that the creek bed lowered an average of 1.5 metres since 1974, except where solid rock or large gravel armour is present across the whole stream bed.

**Figure 2:** Hanging bottom cable of old mesh erosion control works indicating the amount of bed degradation since 1974.

It was assumed that the erosion control mesh works were designed so that the bottom cable was constructed at bed level. The present day height of the bottom cable was linked with major bedrock rapids to define the prior bed profile of the channel. These rapids are apparent on the 1973 aerial photographs. It was also assumed that the pool and riffle sequence prior to 1974 had a graded long sectional profile (concave in shape and steepening upstream) with local alluvial reaches having constant slopes and steep reaches only occurring at the bedrock rapids. This contrasts with a detailed long profile surveyed in 1997 which shows the location and extent of the bed lowering and the low nickpoints which are still present in the creeks.
