Mary River – Understanding processes and values to inform planning and restoration

Reid J.¹, Ivezich M.², Odgers, T.³, Lindon, D.⁴ and Wedlock, B.⁵

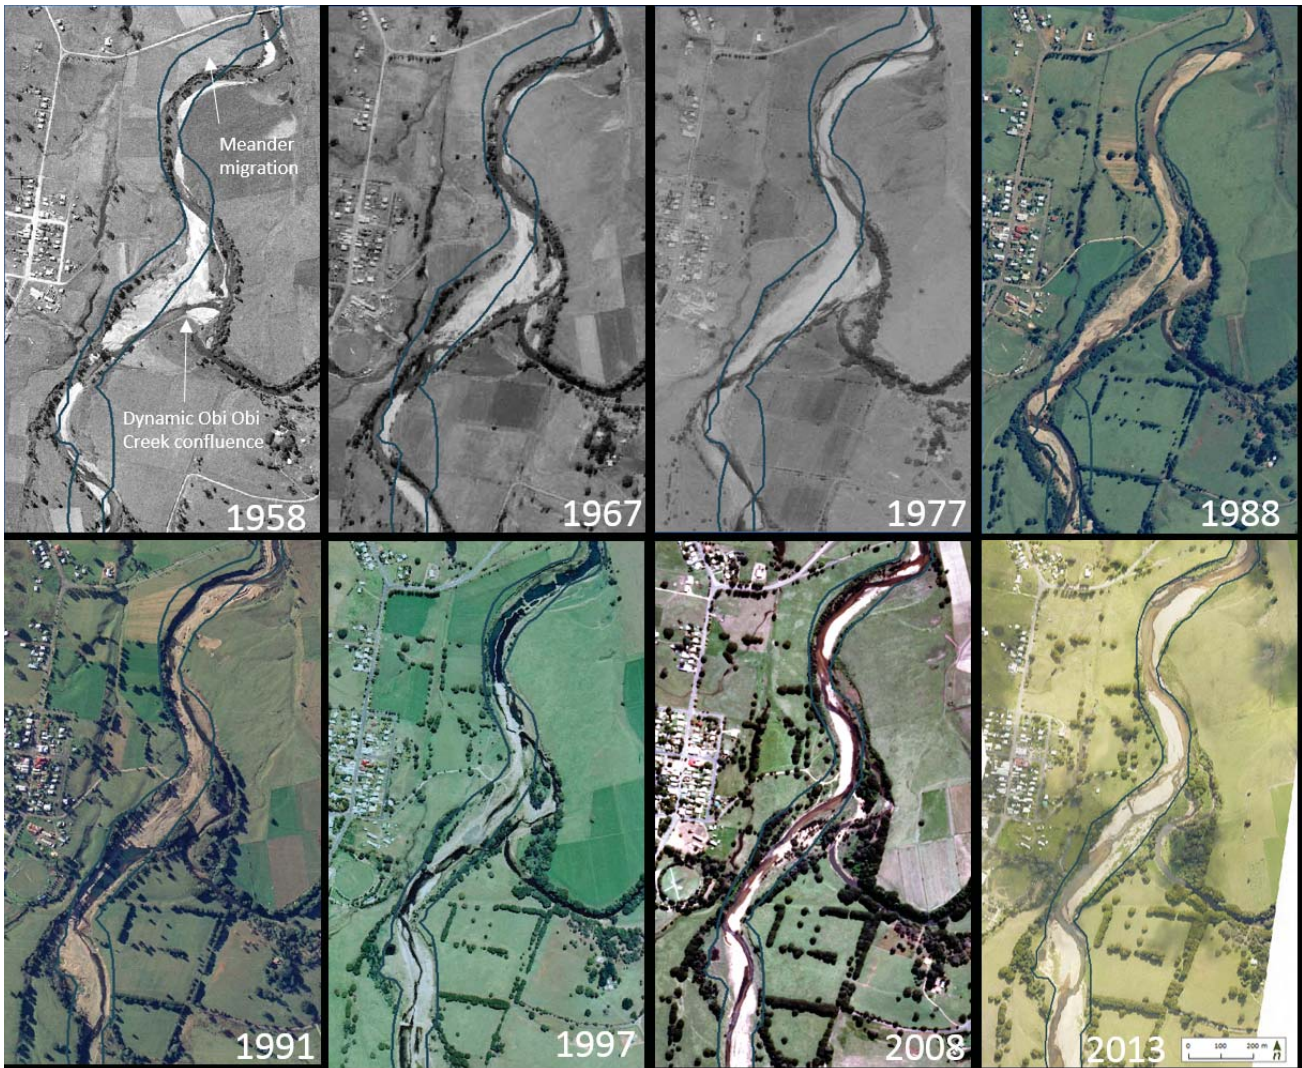
(The river has) “changed beyond comprehension to those who knew it even 50 years ago. It has changed from a deep clean stream guarded by shaded scrub (rainforest) which reached back to the ranges, or by the open forest flats saddle high in the native kangaroo grass, to sand clogged watercourse fighting for its life between eroded banks held by thinly scattered trees.”

Figure 2. Comparison of historical imagery near Kenilworth which indicates significant meander migration, channel widening and straightening since 1958. The blue lines show 2013 bank alignment

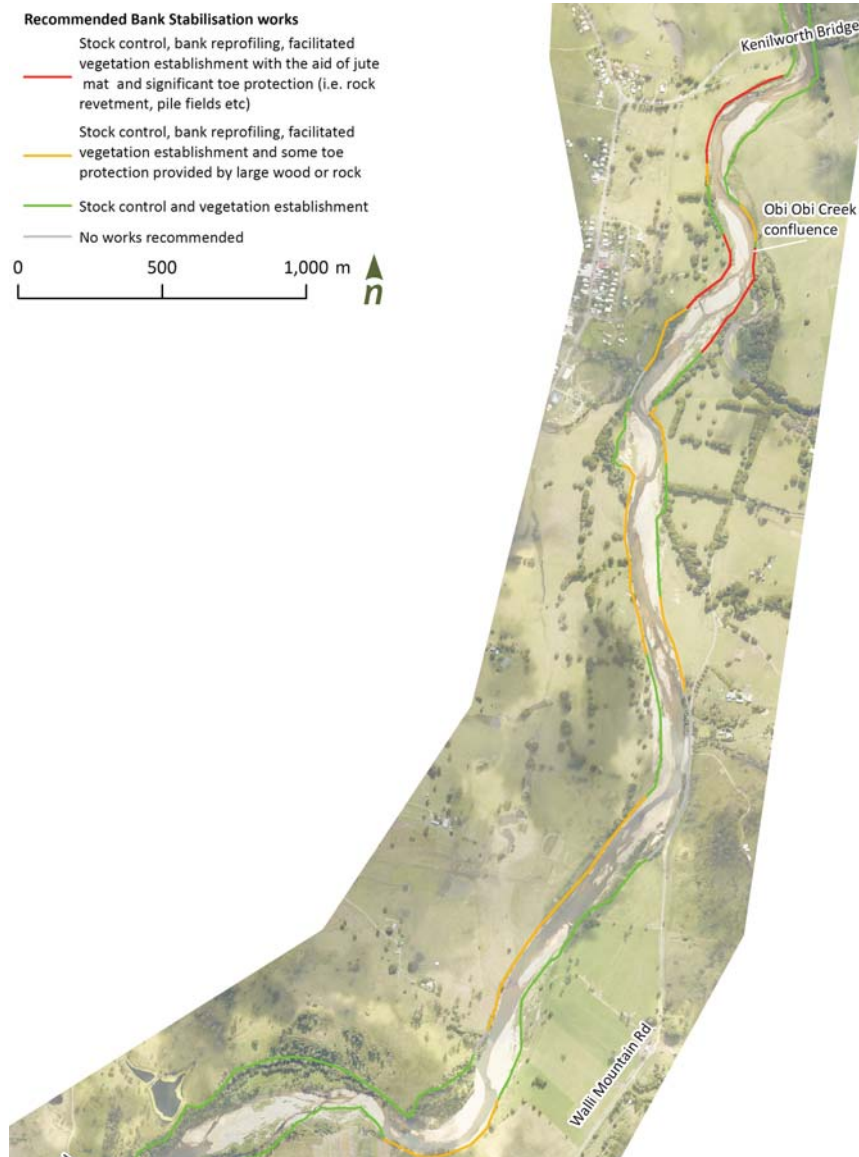
Even when the land that is eroding is of limited economic or social value the stream bank erosion still has consequences in the form of impacting downstream water quality and habitat. As a result wherever there is high to very high erosion potential there is still moderate to high risk to the system. The risk for the reach is shown in Figure 3.

Figure 3. Recommended bank stabilisation works based on risk assessment, risk ranges from high in red to very low in grey

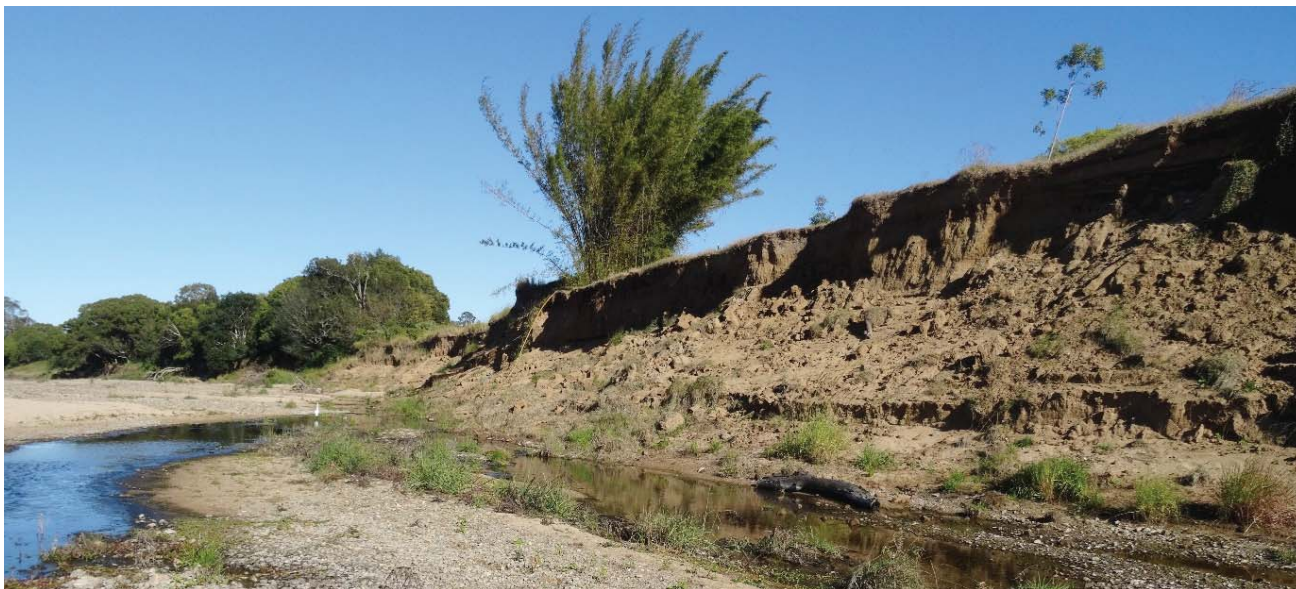
A high risk zone on the outside of a meander was identified as a site for stream restoration works. The site is within a Sunshine Coast Council (SCC) reserve opposite the Obi Obi Creek confluence. Bed and bank erosion has caused substantial loss of public land and increased channel width by up to 70 m in the most affected area. Between 2008 and 2013 approximately 70,000 m³ of sediment loss occurred from this area. The bank is currently near vertical and ongoing erosion was likely without management intervention (Figure 4). Due to the steep nature of the bank and location within a public reserve the bank posed a public safety risk. Additionally, the site is within a known Mary River Turtle nesting reach of the Mary River and is located just upstream of the sub-surface Seqwater water offtake, which is the town's water supply. The water offtake was at risk due to the erosion of the sand filter provided by the depositional bar at the site.

Figure 4. Before works - Mary River, Kenilworth (view looking upstream 7/7/2014)

The rehabilitation works included bank stabilization through bank reprofiling (battering) and revegetation and the installation of pile fields with associated rock protection. The pile fields also enabled natural bank habitat suitable for the establishment of vegetation for the majority of area (as opposed to rock revetment). The pile fields also promote sediment (sand) deposition along the lower bank and surrounding the water offtake, improving the filtration of town water supply. Some limited rock beaching at the toe of the stream bank upstream of the pile fields was also required. The works were completed in July 2015 and pioneer species have begun to colonise the works (Figure 5). A recent flood reached the top of the pile fields and the works were unaffected.

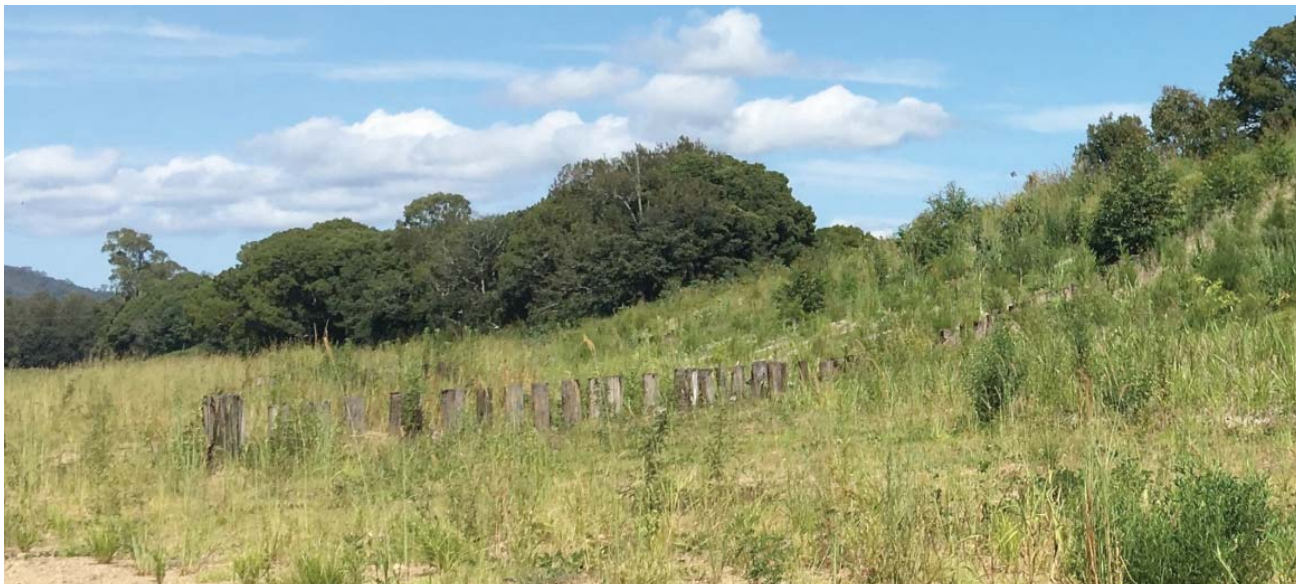
Figure 5. Post works - Mary River, Kenilworth (view looking upstream 26/03/2016)
