Things of stone, wood and running water: Twenty years of River Rehabilitation on NSW North Coast

Broderick, T¹

¹ North Coast Local Land Services, 24-26 Mulgi Drive South Grafton, 2460. tony.broderick@lls.nsw.gov.au

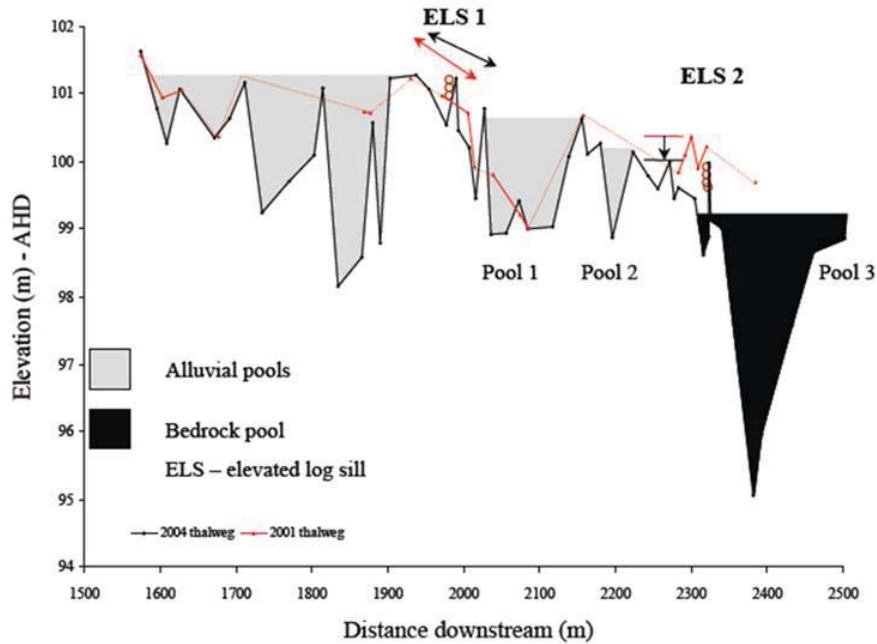
Whilst Cohen (2004) suggests the lower bed levels (0.2m) recorded upstream of ELS 2 were more likely due to localised changes in upstream low flow planform than bed level incision, observations during flood events indicated ELS2 influenced minimal backwatering effects due to the relatively large cross sectional area

immediately upstream. Additionally, unlike ELS2, ELS1 included timber pins radiating from both flanks, increasing the channel blockage area and providing more effective upstream backwatering (see figure two). Future application of the ELS design considered upstream cross sectional area and incorporated timber pin radials and where considered appropriate, timber pin rows in adjacent flood chutes.

Figure 1: Changes in bed level elevation between 2001 and 2004 following installation of 2 elevated log sills (ELS) as presented in Cohen (2004). Red and black arrows indicate changes in local gradient at ELS1.

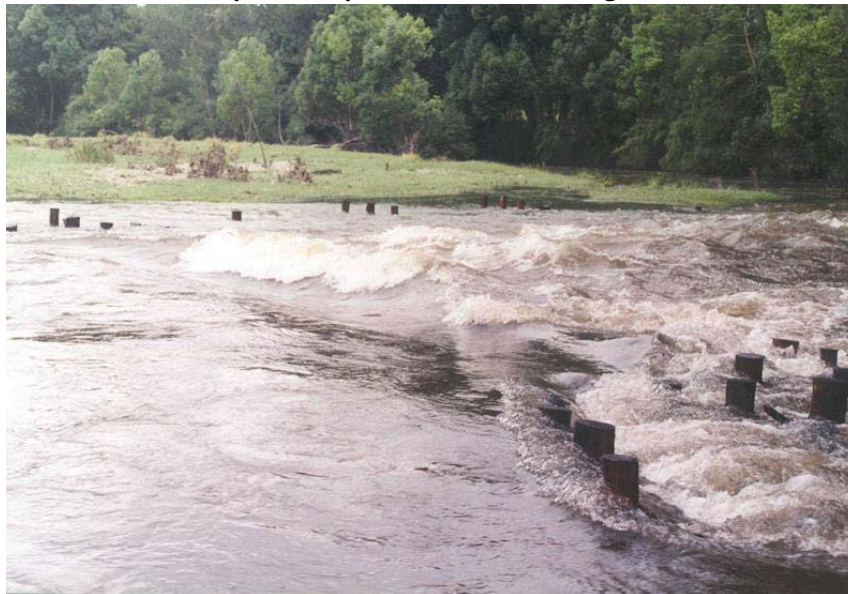
Figure 2: Elevated Log sill (ELS1) with timber pin radials, Orara river with approx 0.6m flow depth above the ELS. Note the influence of timber pins on upstream backwatering and wave formation downstream.

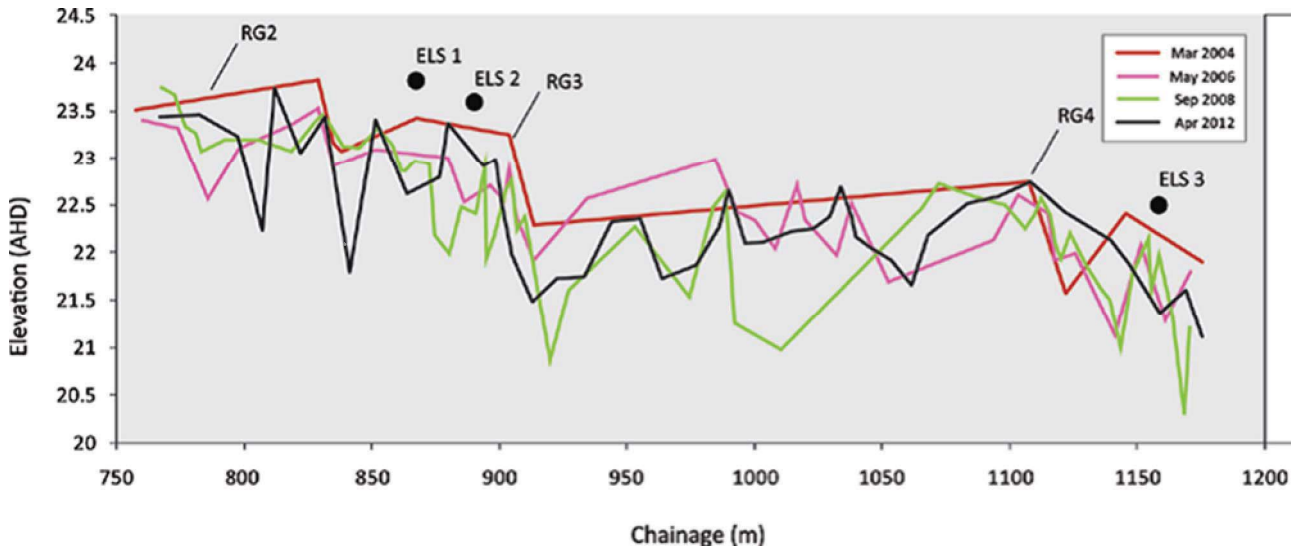
surveys (Daley, 2012) undertaken in 2008 and 2012, indicated no further bed degradation and that riffle crest elevations increased back to 2004 levels (see figure 3). Recent field observations (March 2016) have shown increased bed level elevations with aggradation smothering ELS 1 and 2.

Figure 3: Changes in bed level elevation, Wilson river ‘knickpoint zone’, as presented in Daley (2012). Note increased bed levels upstream of three elevated log sills (ELS) in 2008 following installation in 2007. Surveys were undertaken in March 2004, May 2006, September 2008, April 2012. Locations of four rock girdles (RG) constructed in 2001 are identified.

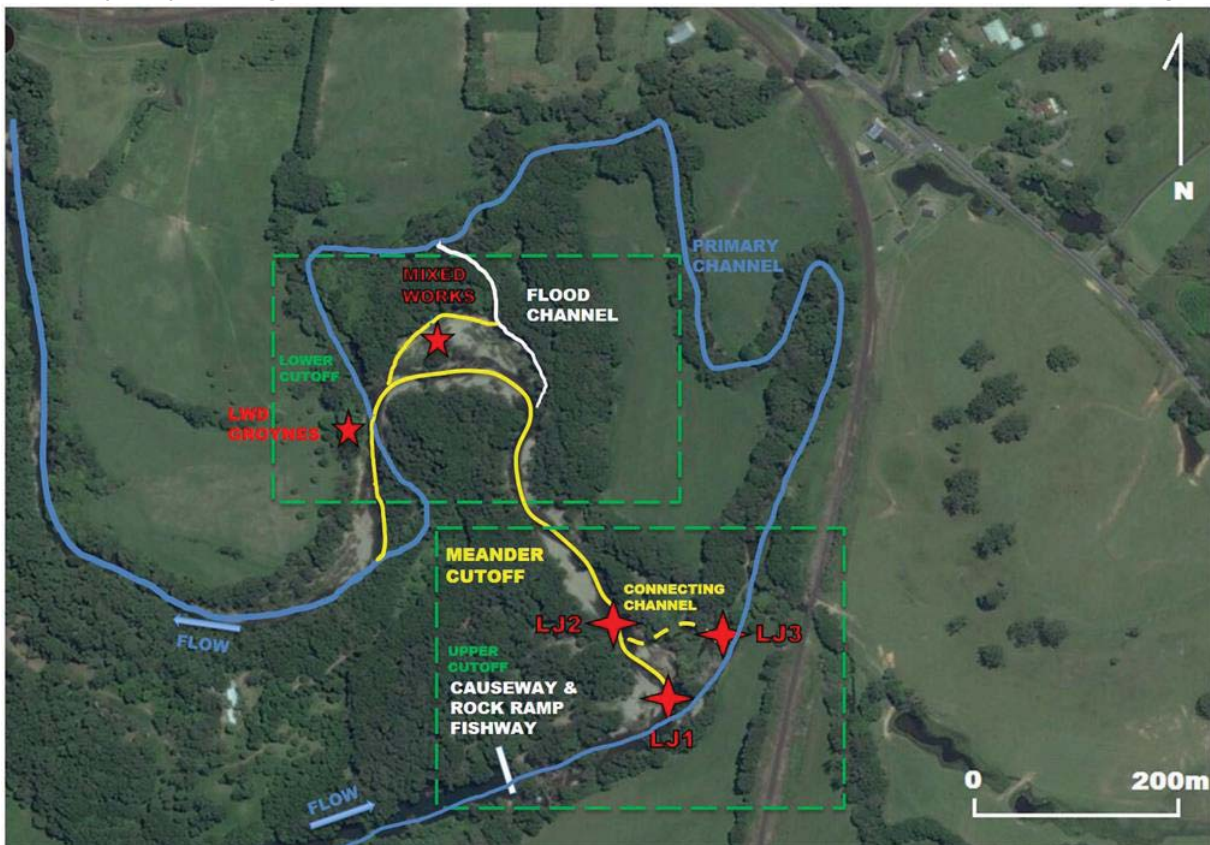
however, during the March 2001 flood event, flows through the primary channel were ‘captured’ by the flood channel resulting in a major meander cutoff (see figure 4). The primary channel (1300m in length), previously supporting high value aquatic habitat became a stagnant backwater and began filling with fine sediment. Channel enlargement increased flood channel capacity to convey flows far beyond that of the primary channel. The meander cutoff channel represented a 40% reduction in low flow channel length (Cohen, 2004) with a likely greater proportional increase in hydraulic gradient.

Changes in the alignment and increased volume and velocity of flows through the meander cutoff, led to river right bank erosion and further channel shortening in the Orara river immediately downstream of its downstream confluence with the meander cutoff (see figure 4). The cutoff channel, a source of large volumes of eroded coarse and fine sediment led to downstream aggradation. Upstream of the meander cutoff, knickpoint retreat threatened to erode bed levels supporting large areas of aquatic habitat, a road crossing and a stream gauging station.

Figure 4: ‘Skews Quarry’ rehabilitation reach, Orara river, Karangi showing project areas within the upper and lower areas of the meander cutoff. Three log jam locations (LJ1, LJ2, LJ3) are identified at the two flow exit points from the primary channel to the meander cutoff channel. The flood channel identifies the former flow path prior to gravel extraction, associated avulsion and downstream channel shortening.

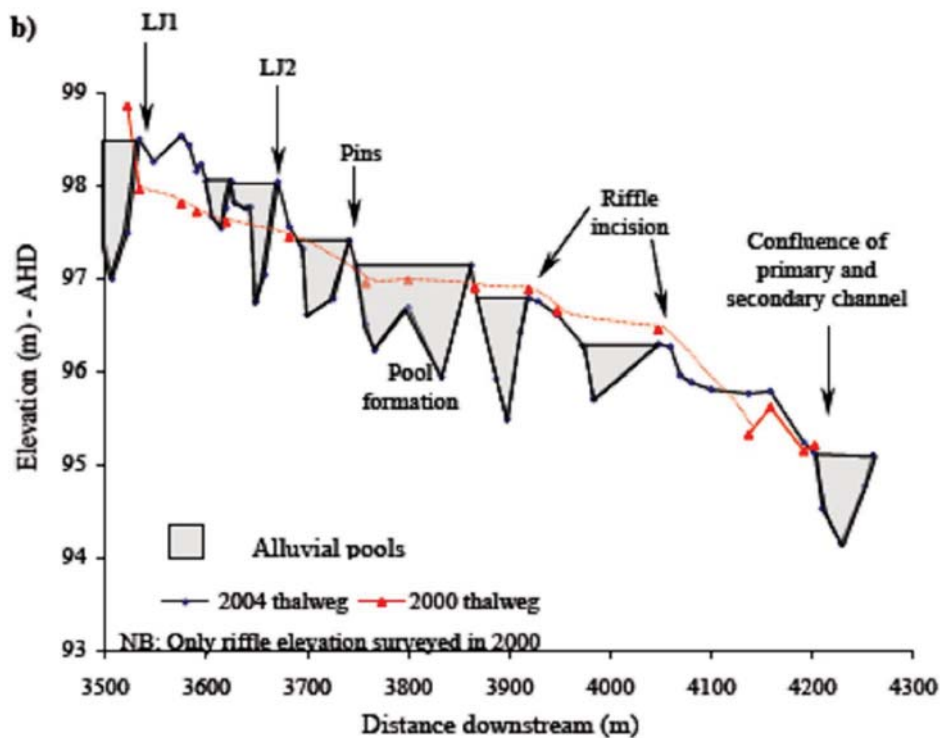
To reduce upstream hydraulic gradient and velocities through the cutoff channel, a 55m wide LWD jam (LJ2) was constructed in July 2002 across the width of the cutoff channel immediately downstream of where flows overtopping LJ1 and LJ3 converge (see figure 4). Approximately 80m downstream of LJ2, a row of timber pins, were driven into the bed across the width of the channel at an approximate height of 0.9m, to reduce upstream hydraulic gradient and promote upstream deposition, bar development and riffle crest elevation. Whilst, the middle of the cross channel spanning LJ2 was washed away in October 2004, the remaining structure continued to serve as a channel constriction reducing the channel cross sectional area to approximately 65% of the previously eroded channel in this location. Comparison of before (2000) and after works (2004) long section survey data (Cohen, 2004) showed increased riffle crest elevations of 0.5m and 0.3m upstream of LJ2 constriction and pin row, respectively, with pool development at the LJ2 constriction (60m x 1.5m deep) and downstream of the pin row (90m x 1m deep). However, channel incision and lateral bank migration continued in the lower 300m of the cutoff (see figure 5), prompting further works (see figure 6).

Figure 5: Comparative bed level elevations between 2000 and 2004 survey data showing bed level rise in the upper area of the cutoff channel associated with works and riffle incision in the lower cutoff channel.

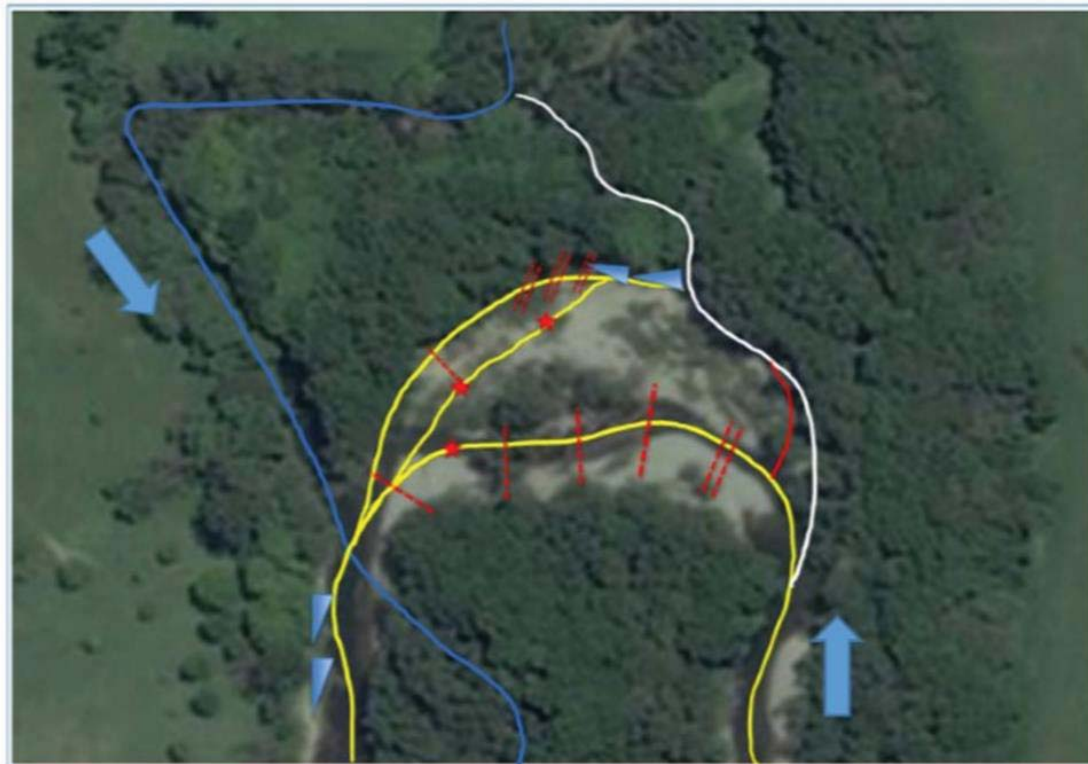
Figure six: Works undertaken in the lower meander cutoff and the primary channel downstream of the confluence. LWD groynes (—) timber pin groynes and rows (//) ELS's (★) were constructed on river right of the cutoff and primary channel in 2005. In 2012 timber pin rows were constructed through the incised river left flood chute and gravel was relocated to reopen the low flow path (—) to river right and flood channel. Flow path is indicated by arrows →

In March 2005 constructed works included two elevated log sills (ELS) and timber pin rows to address bed incision and and a series of LWD deflector and timber pin groynes to address river right bank erosion in the cutoff channel. The first LWD groyne was located at the exit to the 'original' flood channel (see figure six) with the additional objective of 'attracting' flows into the flood channel to maintain hydraulic connectivity with the primary channel (see table two). Two LWD deflection groynes were also constructed where altered alignment of flood flows through the meander cutoff eroded the river right bank of the primary channel downstream. Comparative analysis of long section bed level elevation data shows ELS's and associated timber pin rows were effective in addressing upstream channel incision (see figure 7). Between 2004 and 2008 riffle crest levels, ~20m upstream of ELS1 and ELS2, increased by up to 0.25m and 0.15m, respectively with downstream pool scour of ~0.6m (see figure 8). For the same period, the timber pin row constructed at the downstream end of the meander cutoff promoted bar formation of up to 0.9 m in height and 30m in width and raised bed levels in the low flow channel by 0.18m, providing significant gravel accumulation and channel contraction.

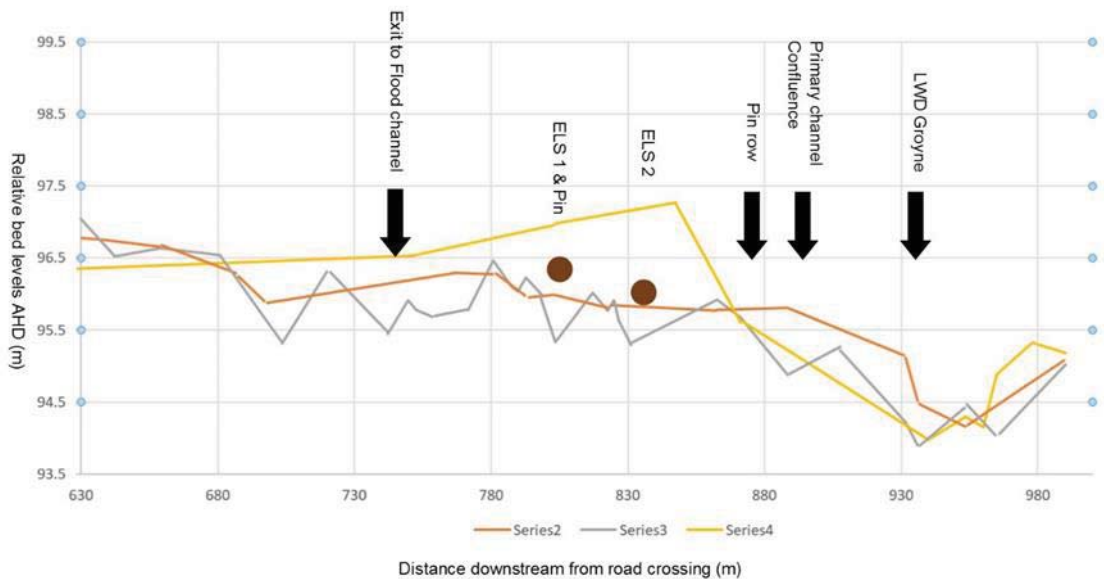
Figure 7: Comparative bed level elevations in the lower meander cutoff area. Note the increased bed level elevation between 2004 (series 2) and 2007/8 (series 3) upstream of ELS1 & pin row, ELS2 and pin row.

Increased pool scour was recorded at the exit to the flood channel and downstream of the LWD groyne in the primary channel for the same period. Increased bed elevations in 2011 (series 4) were associated with channel incision and shortening through an adjacent flood chute on river left.

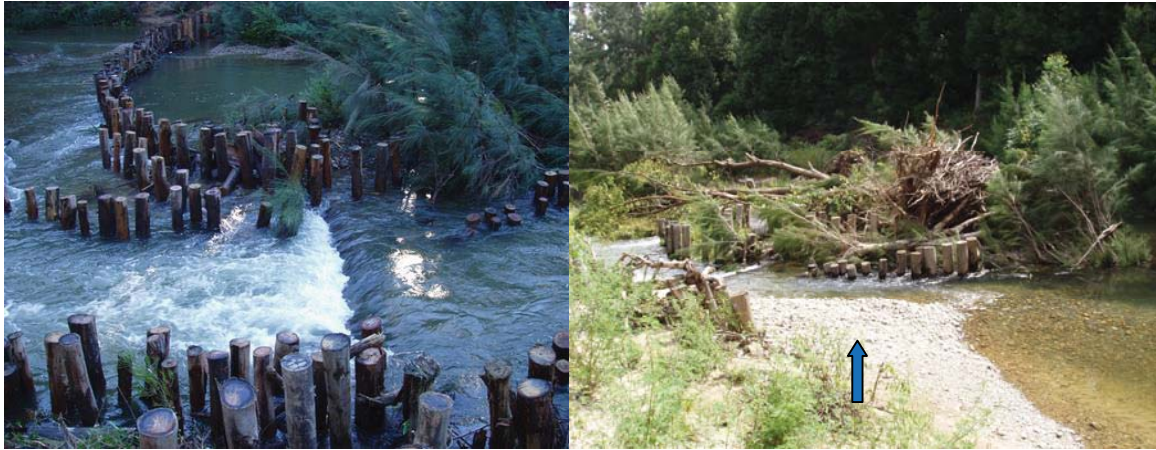
Figure 8: Elevated Log sill 1 (ELS 1) and timber pin row in lower area of meander cutoff channel in June 2005 (left) and March 2006 (right). Note backwatering effects upstream of ELS1 and timber pins in June 2005 and deposition (see arrow) in March 2006 elevating upstream bed levels.

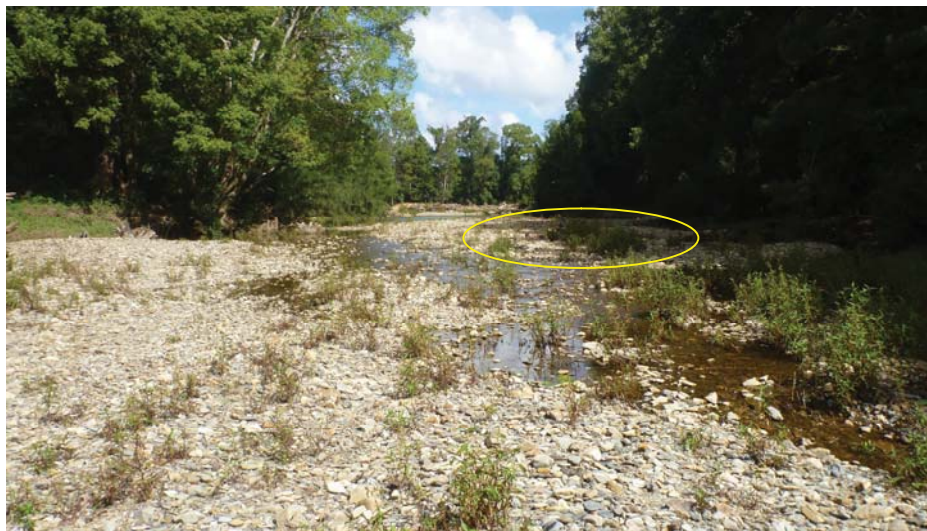
Figure 9: View upstream (February 2013) towards upper area of meander cutoff channel with LJ1 in the background. Timber pin row 1, constructed 0.9m above natural surface in 2002, located approx. 20m upstream of photo point. Some pins are evident on right of photo, the remainder buried under gravel.

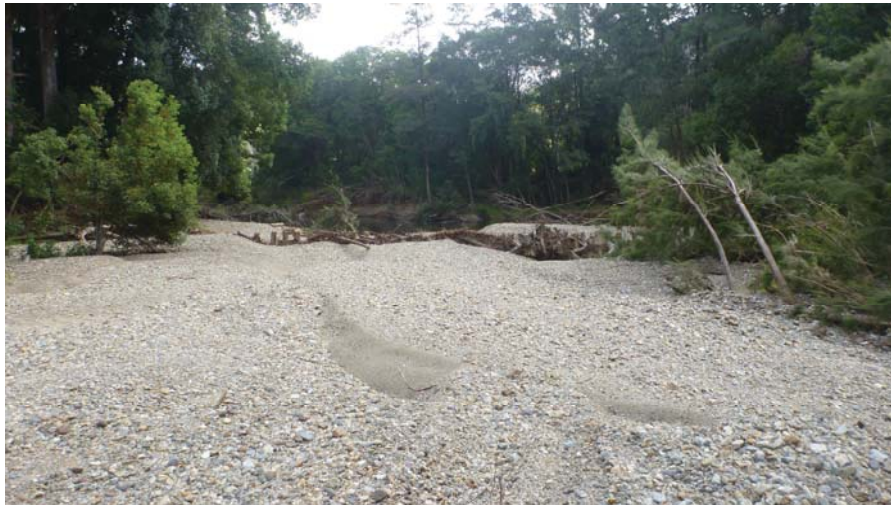
Figure 10: View downstream through river left flood chute of lower cutoff channel towards its confluence with the primary channel showing aggradation upstream of the timber pin row. River right low flow cutoff

channel is located behind the trees on right of photo. Note the near perpendicular alignment from this river left flood chute towards erosion on right bank of primary channel downstream in the background of photo.

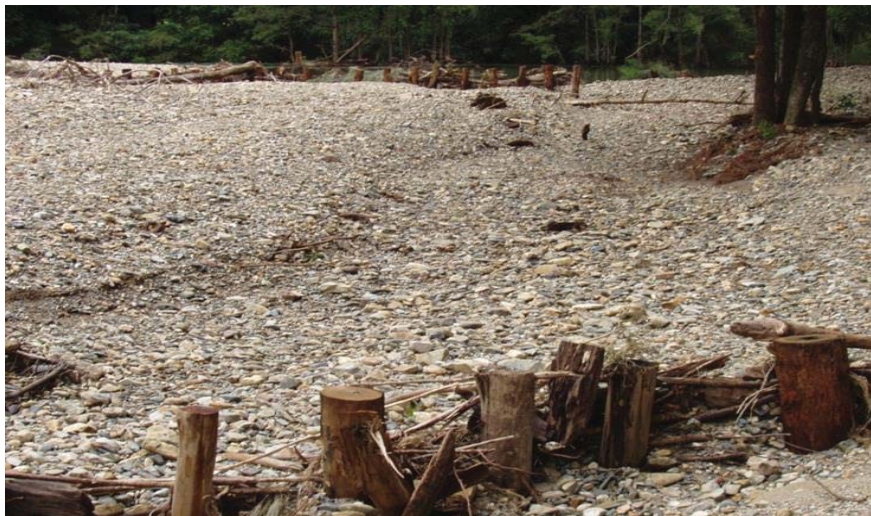
Figure 11: View upstream through the river left flood chute of the lower cutoff channel (3 February 2012). The photo shows gravel aggradation upstream of a series of timber pin rows constructed at 0.9m above natural surface. The timber pins in the foreground were subsequently buried during a flood event one week later and an additional pin row was installed in late 2012 between these two rows, resulting in further aggradation and elevation of the incised flood chute following 2013 floods.

In Oct 2011 the LJ1 breach was repaired with an inset rock ramp structure, whilst works in the lower area of the cutoff channel focused upon shifting the thalweg back to river right to promote flows through the flood channel, reducing gradient and aligning flood flows exiting the cutoff channel with the river right LWD deflection groynes downstream in the primary channel. This involved the relocation of gravel deposits to reopen the river right low flow path in the meander cutoff channel and the construction of timber pin rows across the incised flood chute on river left (see figure 6). The most upstream timber pin row was strategically located so backwatering effects would promote the flood flow path to river right and deposition on river left (see Figure 12). Distance between each timber pin row was primarily determined by anticipating the upstream extent of backwatering effects so as to reduce velocity between the pin rows.

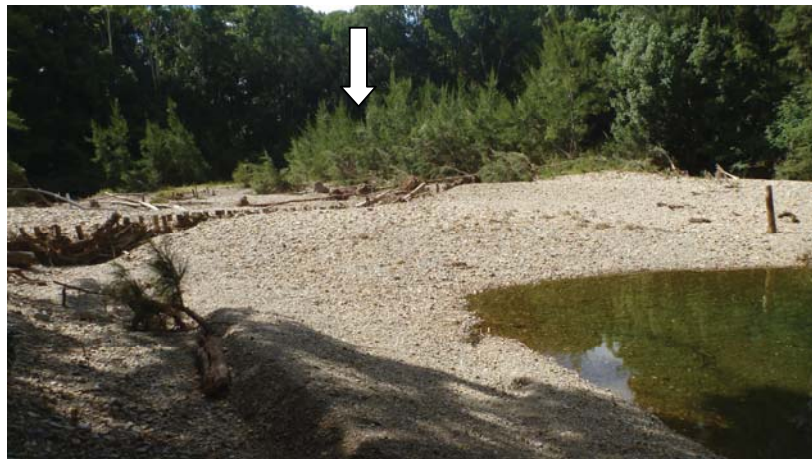
gradient through the cutoff channel. Timber pin rows raised bed levels by up to one metre throughout the 80m length of the river left flood chute in the cutoff channel (see figures 10 & 11) with backwatering effects of the most upstream timber pin row effectively promoting flow to river right (see figure 12). Observations indicate the river right to have once again become an active flood flow path in line with rehabilitation objectives. Overall aggradation in the lower half of the cutoff channel since the beginning of 2012 has led to low flow connectivity to the primary channel being through the ‘original’ flood channel.

Figure 12: Cross section view showing up to 0.9m bed aggradation upstream of timber pin row in the cutoff channel river left flood chute after a second flood event in February 2012. In the background on right of the photo is the river right low flow channel which exits to the ‘original’ flood channel in the middle of photo indicated by the arrow.
