Watercourse Survey in the Bremer Barker Catchment

Meredith Gibson and Beryl Belford¹

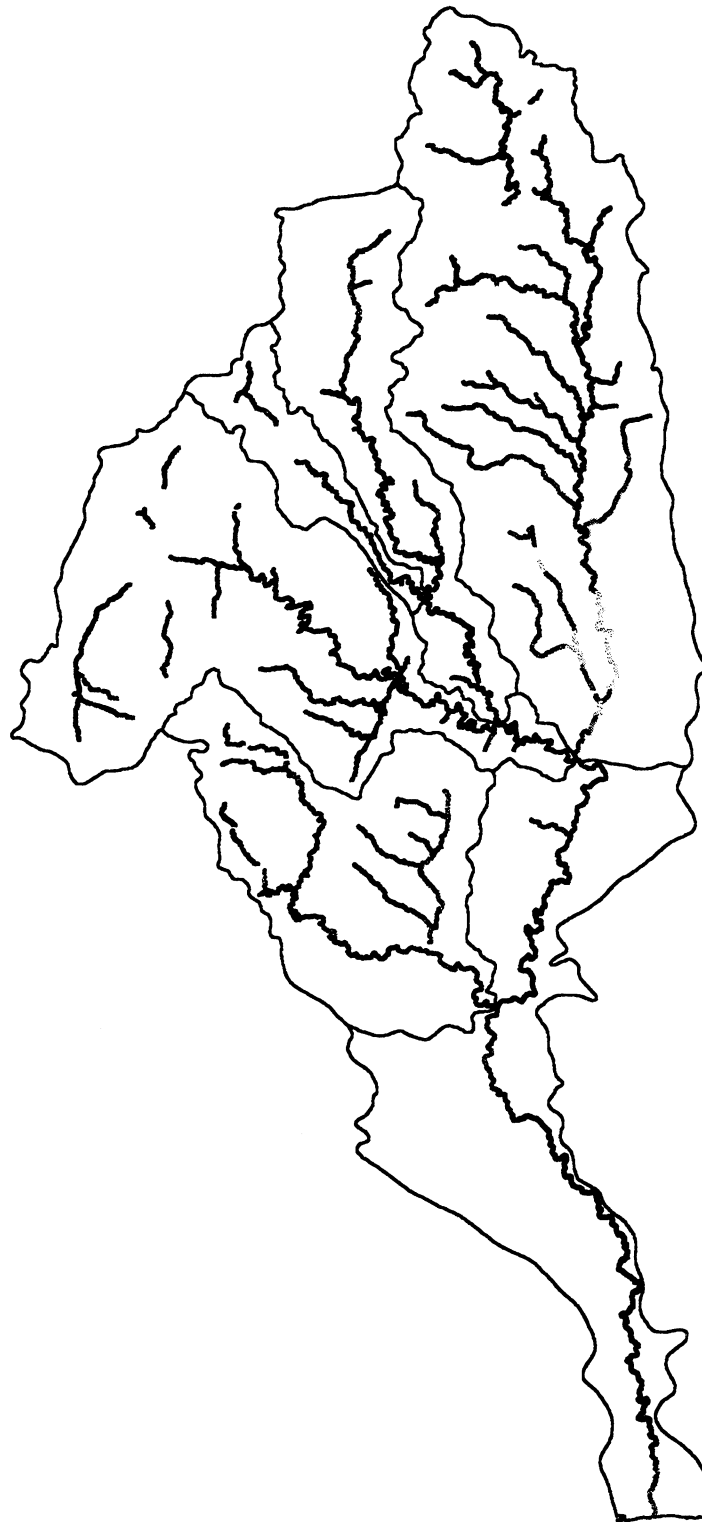
FIGURE 2 : BREMER BARKER CATCHMENT STREAM CLASSIFICATION

Measuring sites were selected from representative sections along each reach. Ratings assigned to vegetation cover and erosion enabled a map of the Bremer Barker catchment to be produced showing stream classification (Figure 2).

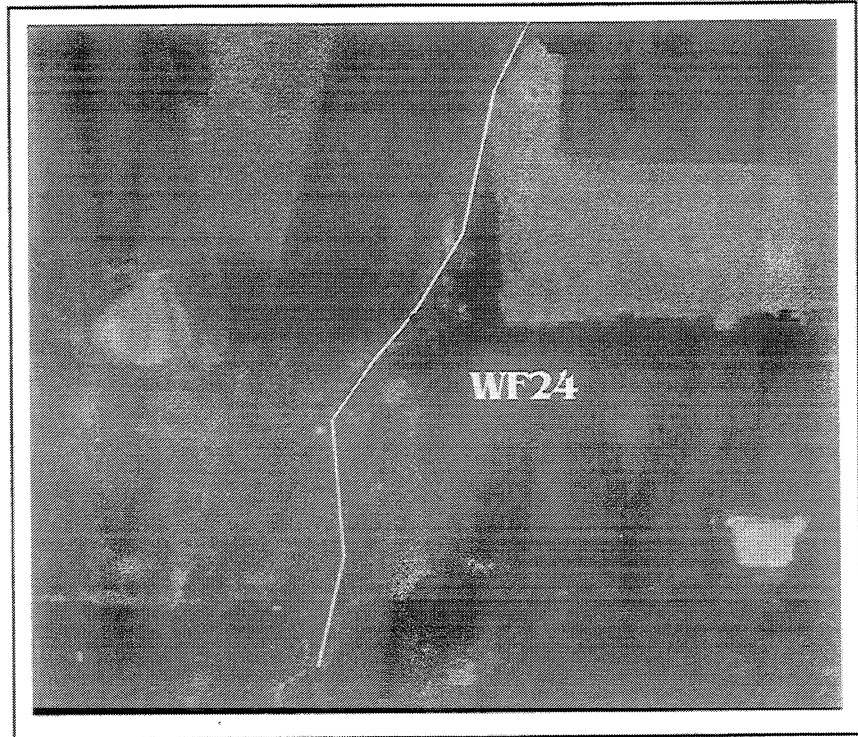
PHOTO NO: 27/28

Fallen trees in creek. Photopoint on left hand bank facing downstream. Transect begins approximately 10m downstream from large *E camaldulensis*.

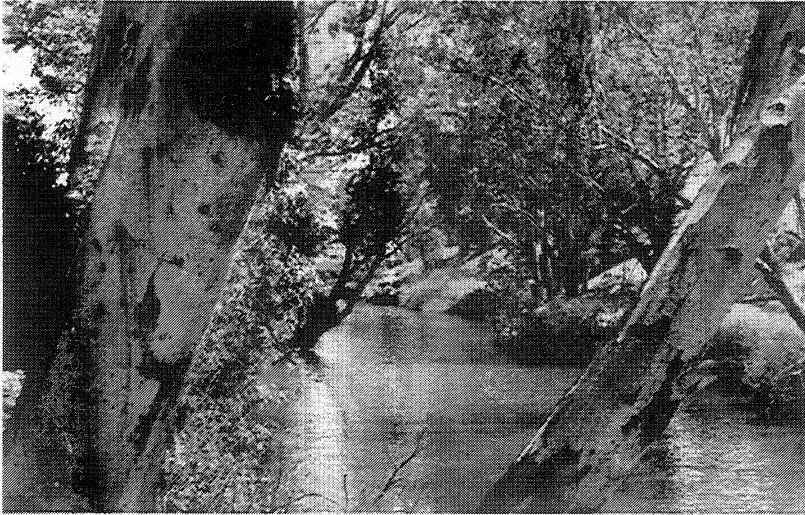
GOOD

- ◆ Good toe vegetation
- ◆ Good riparian vegetation
- ◆ Variety of native species
- ◆ Fallen logs which provide fish habitat
- ◆ No evidence of bank erosion
- ◆ Restricted stock access
- ◆ Permanent water

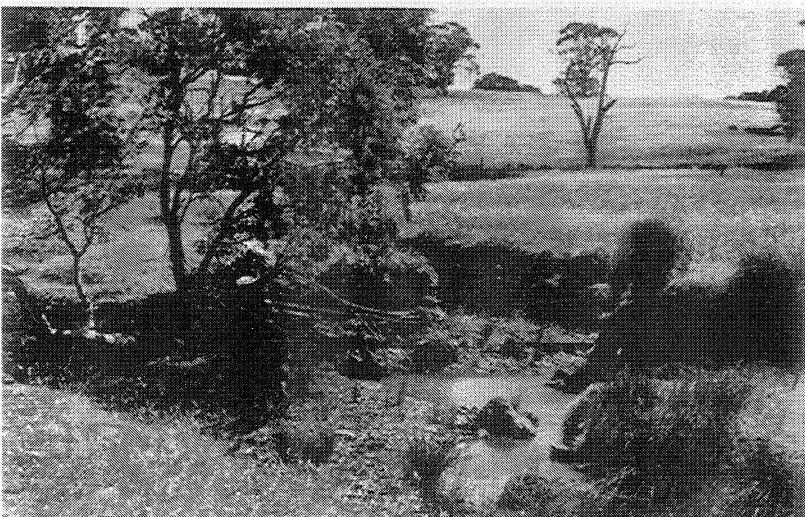
MODERATE

- ◆ Sparse toe vegetation
- ◆ Some riparian vegetation
- ◆ No evidence of bed deepening
- ◆ Fallen logs which provide fish habitat
- ◆ Some bank erosion
- ◆ Unrestricted stock access
- ◆ Some permanent pools

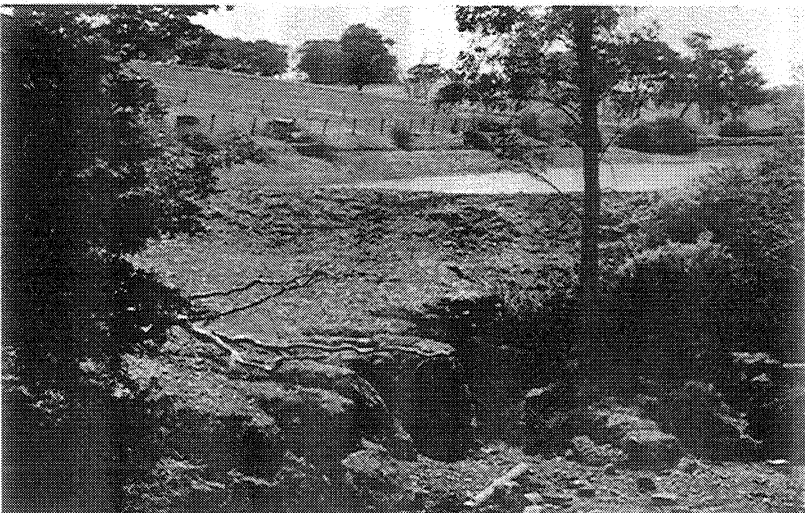
FAIR

- ◆ No toe vegetation
- ◆ Some riparian vegetation
- ◆ Evidence of toe erosion
- ◆ Evidence of bank erosion
- ◆ Unrestricted stock access
- ◆ No permanent water
