River Red Gum dieback investigation, Malcolm Creek, Craigieburn

Clifton C¹, Treadwell, S², van den Hove R³

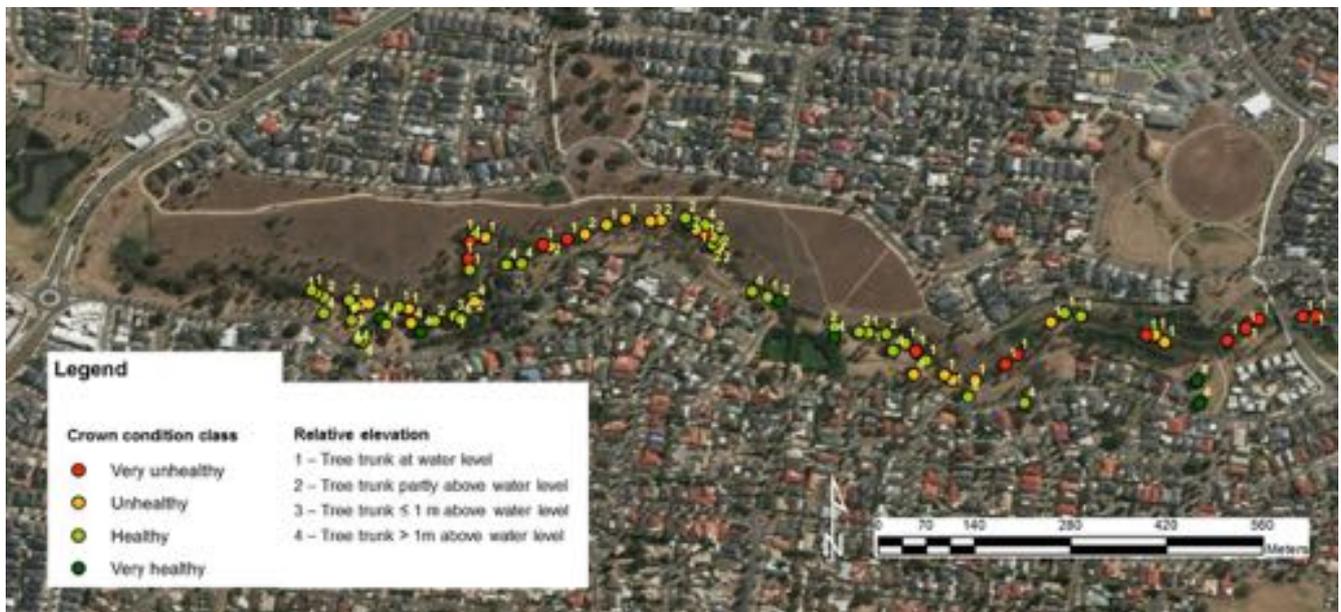
Based on the sum of assessment scores for the remaining three criteria, the overall crown condition score was divided into four health classes ranging from I Very unhealthy to IV Very healthy (see Figure 1). Average scores for the three criteria were approximately 3 (of 5), indicating that the mature FRG trees overall were in fair condition.

Fourteen trees were included in the poorest crown health class (I), including the five dead trees (Figure 1). All of the dead and very unhealthy trees were located within the channel of Malcolm Creek (relative elevation class 1). Two thirds of the unhealthy (class II) trees also had this same level of exposure to flows along Malcolm Creek. The FRG trees located away from the creek were mostly in healthy or very healthy condition (Table 2; Figure 1).

Figure 1. Location of trees included in this investigation, their overall crown health and relative elevation classes (ESRI background imagery).

Urban development within Malcolm Creek catchment is already well-advanced and without intervention in stormwater management systems, there is little prospect of altering what appears to be the key determinant in the FRG dieback observed along the creek. There are several opportunities to address stormwater flows along Malcolm Creek in ways that reduce waterlogging. The operation of the upstream detention basin (located to the west of the study area; Figure 1) could be changed to hold smaller dry season flows and

extend periods of low or no flow. Stormwater harvesting could also be introduced to reduce inflows to the basin and/or to Malcolm Creek. These changes would prevent (or at least reduce) flows from small rainfall events from entering the creek and could also allow more frequent or a longer period of drying along its lower reaches.
