Is my river health intervention project working? Results and lessons learned from 10 years of riparian works monitoring in the Melbourne region.

1. Melbourne Water, 4003. Corresponding author email: Apanie.wood@melbournewater.com.au.

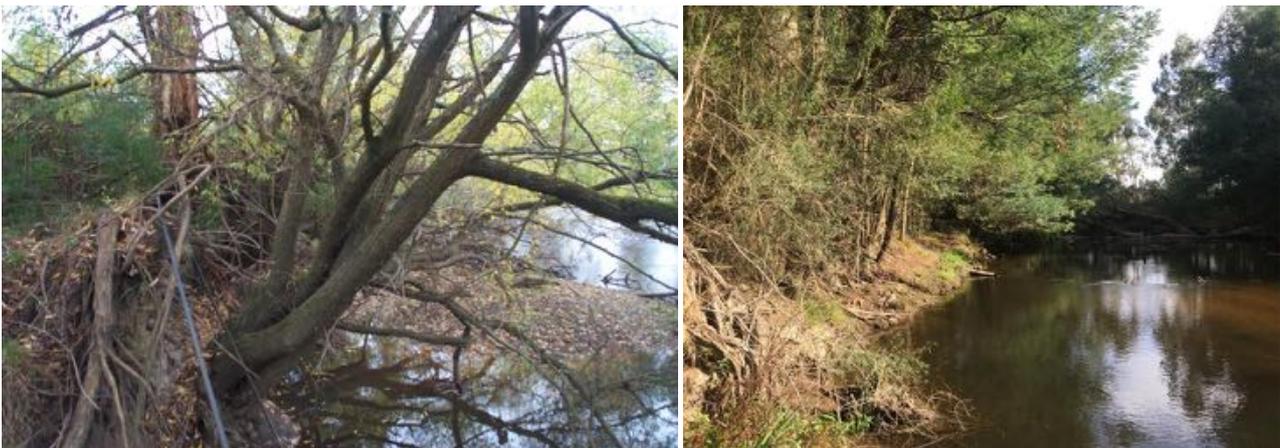
The site was openly grazed and the frontage contained crack willow and a number of weeds including Hawthorn, Blackberry, Jerusalem Cherry and Tradescantia. The native vegetation was mostly limited to mature Silver Wattle and the occasional Manna Gum.

Figure 0-1 Yarra River upstream from Transect 1 - willow infested pre-works and established native vegetation 10yr post works

Willows were felled, the shoot system removed with stumps painted with herbicide and left in situ to rot. Other weeds were controlled and the frontage was revegetated with a range of tree, shrub and ground layer species. The entire frontage, approximately 450 m long, was fenced with an offset of approximately 15 m from top of bank. Most of the follow up maintenance, principally weed control, has been undertaken by the landholder.

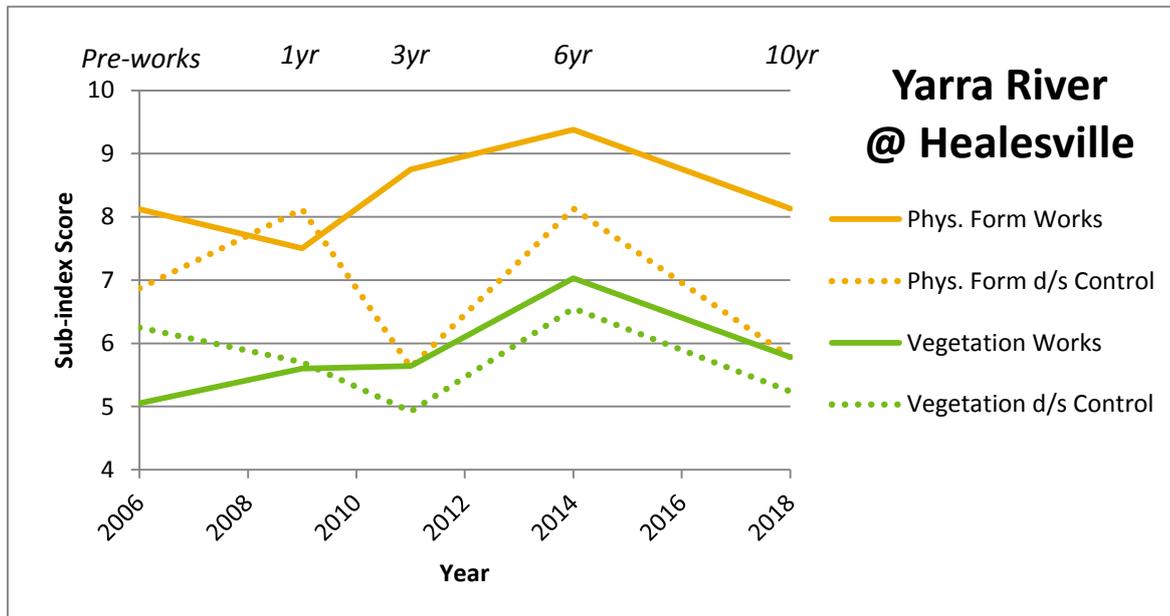
- **Physical Form** – The Physical Form showed an initial decline 1yr post works due to a slight reduction in the instream large wood score. This is likely due to many willow branches/trunks being removed from the

river during the willow control works. That metric improved in the following five years and then fell back to baseline condition level at the 10yr assessment.

- **Streamside Zone** – The Streamside Zone showed improvement in condition immediately after works and continued to improve to the 6yr post works assessment before slipping down in condition at the 10yr post works assessment.

Figure 0-2 Yarra River @ Healesville Sub-index score movements up to 10 years post works

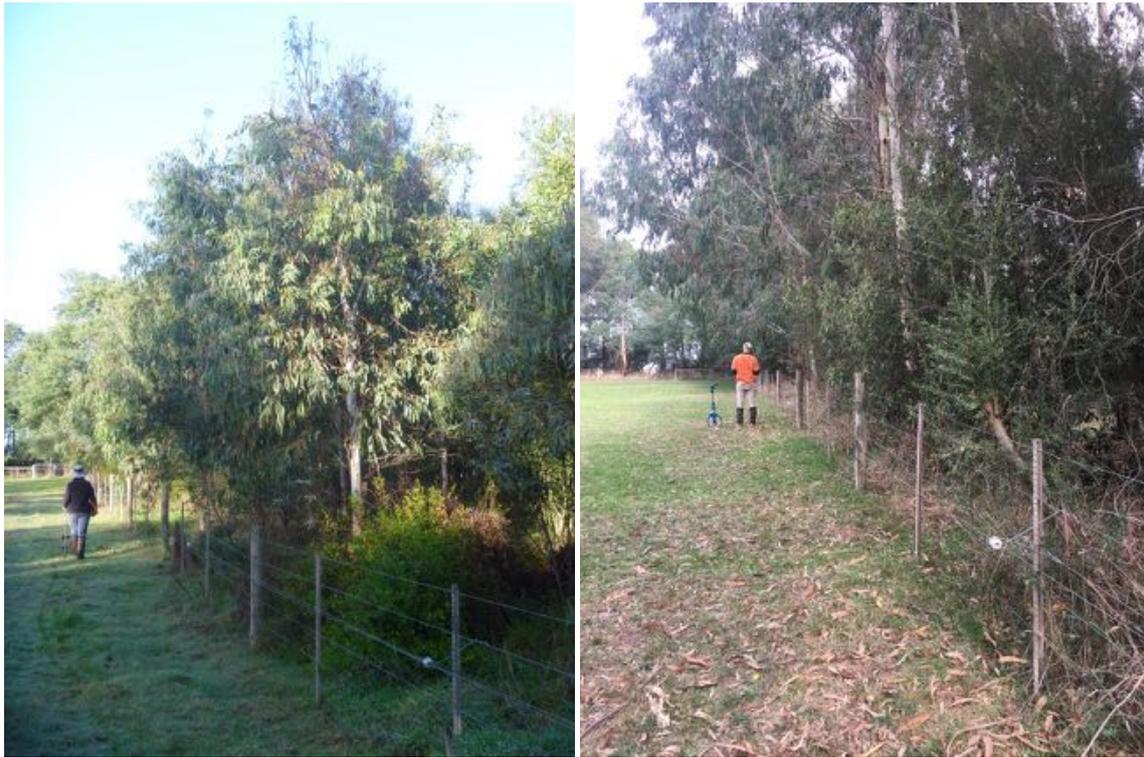
- **Tree Canopy Cover** – This metric showed a steady increase post works until the 10yr assessment when the score dropped appreciably because the cover was too high. The EVC benchmark specifies a cover percentage that is likely found in a 'mature and apparently long-undisturbed state of the same vegetation type'. If the canopy cover is greater than 150% of the prescribed benchmark cover, the score is reduced. As tree revegetation matures, it is found to be reaching canopy classification around the 10yr mark and has relatively dense projective foliage cover compared to a 'mature and long-undisturbed state'. Over the longer term this canopy will thin and is expected to return to a projective foliage cover closer to benchmark.

Figure 0-3 Tree growth from 6yr (sub-canopy lifeform) to 10yr (canopy lifeform)
