Assessing the efficacy of a reach scale stability management program: the Mary River, Queensland

Ivezich et. al –The efficacy of a reach scale stability management program: the Mary River, Queensland

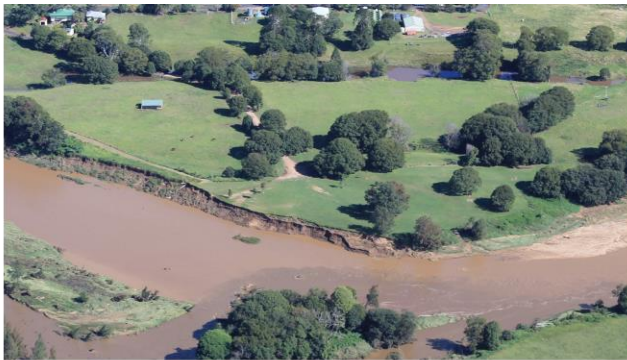
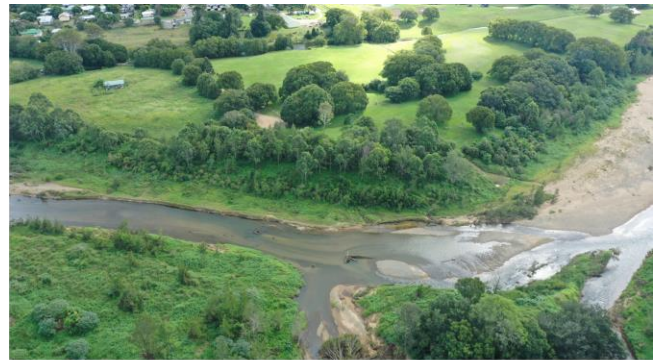
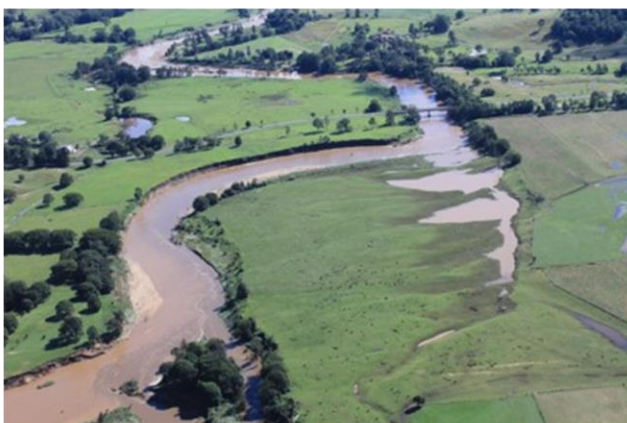
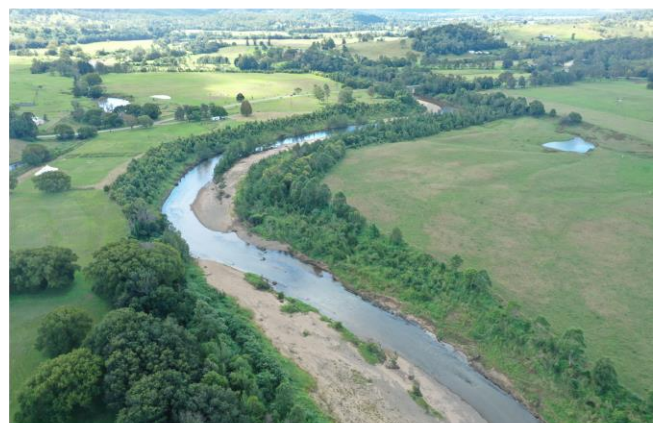
Kenilworth Park - 2015

Kenilworth Park - 2024

Samples - 2015

Samples - 2024

Figure 1. Images before (left) and after (right) of the works within the Mary River adjacent to Kenilworth

The bank condition prior to the works throughout the reach consisted of steep, near vertical outside meander banks with exposed sandy-loams to sandy-clay alluvial sediments (see Figure 1). Banks retreated as a result of toe scour and subsequent gravitational mass failure. Hydraulic modelling indicates the shear stresses required to mobilise the exposed alluvial sediments along the toe are frequently exceeded in even small to moderate flow events (Alluvium, 2014). As a result, it was predicted that bank retreat would continue unless managed.

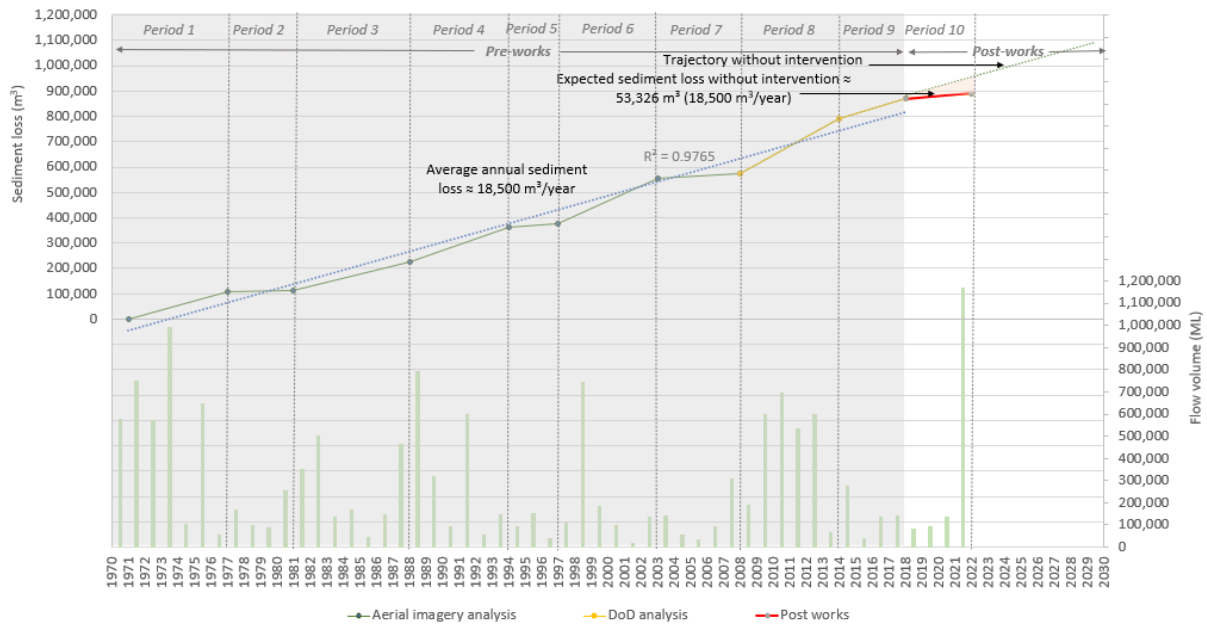
Figure 2. Cumulative sediment production from the Mary River Kenilworth reach, and annual flow volume since 1971. The pre-works periods (1-9) is shown in the grey shaded box along with the linear line of best fit. The post works period (10) is also shown. The colour of the erosion line shows the erosion rate assessment method (i.e. aerial imagery or DoD analysis) for each period.

The cumulative sediment production along with annual flow volume in the 48 years between 1971 and 2018 (Period 1 to Period 9) are shown in Figure 2. Rates of bank erosion (and hence sediment production) are typically larger during the wetter periods and less in drier periods. Despite the variation in erosion in wet and dry periods, over the 48 year period rates of bank erosion, and hence sediment production, is remarkably consistent over time ($R^2=0.98$) with an average annual sediment loss of 18,500 m³/year.

The sediment production volumes post works were estimated using the DoDs as shown in Figure 2 and Figure 4. A summary of the sediment loss estimates is provided in Table 1. Compared to the baseline erosion rate the efficacy of the works across the assessment period at the four major stabilisation sites is between 95.4 – 99.6 %. Across the reach the efficacy of the works across the assessment period is 81.8 %. Note the reach scale estimates included areas where no stabilisation works were undertaken and areas where there was revegetation only.
