## Lower Caboolture river bank stabilisation – Two years on

Margie Dickson<sup>1</sup>

<sup>1</sup> Healthy Land & Water, Meanjin (Brisbane), QLD, 4000. Email: [margie.d@hlw.org.au](mailto:margie.d@hlw.org.au)

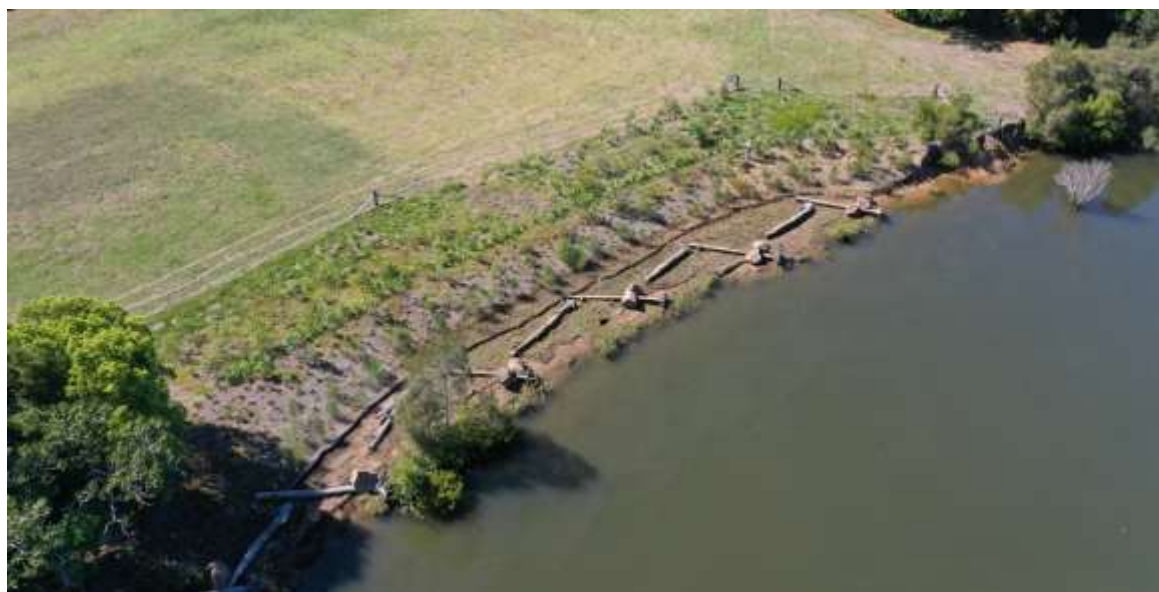
**Figure 1 Site B1 showing the intertidal bench with rootball logs and plain logs arranged to break up boat wash and provide a sheltered environment for mangrove establishment. Construction winter 2023. Photo September 2024**

The design is described in detail in the 11ASM Paper *Restoring mangroves for bank stabilisation on the Caboolture River* (Dickson and Ivezich, 2024). In essence, a 4m wide gently sloping intertidal bench was created near the top of the intertidal range to support mangrove establishment. Hardwood logs were pinned on this bench in an arrangement designed to break up boat wash energy and provide a protected zone for mangrove establishment (See Figure 1 and Figure 2). There was no further intervention on the bank or bank toe below the intertidal zone.

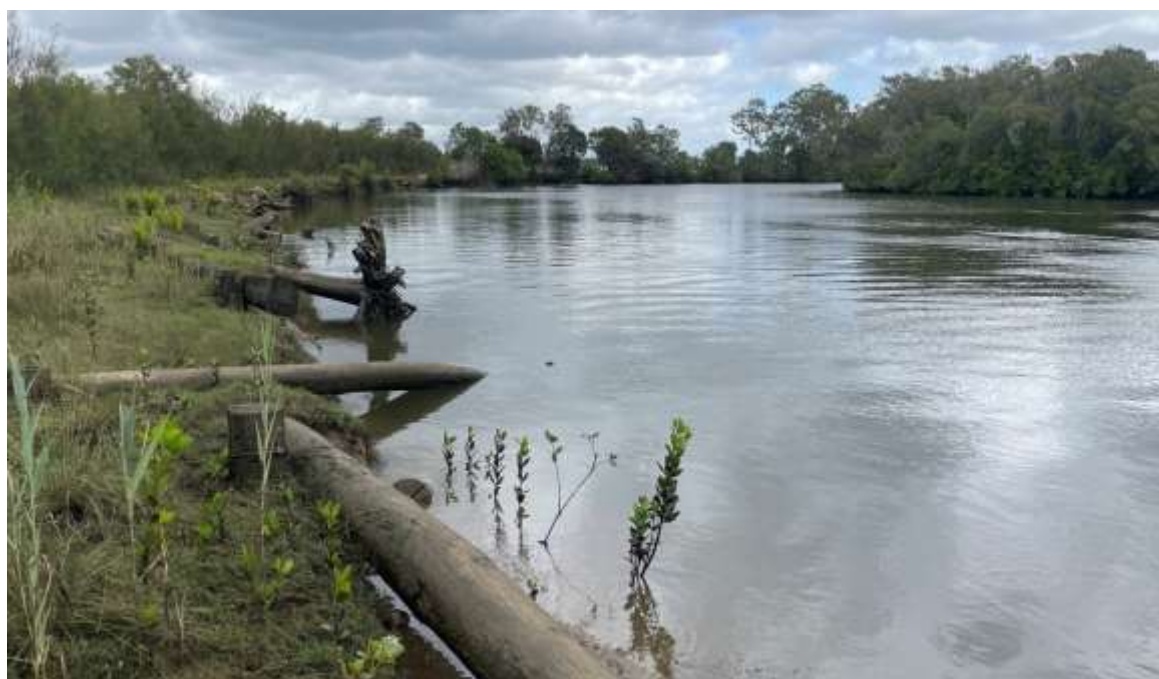
**Figure 3 Site 5 showing an area with log rotation, loss of boulders and modest bench erosion. This area is still progressing consistent with the design intent. Construction Spring 2023. Photo May 2026**

It is acknowledged that nature-based solutions require time to develop resilience, as vegetation establishes and matures. Some level of continued erosion should reasonably be expected during that time and were accommodated within the design. In this case, rootball logs were fixed using a single pile close to the bank and a pair of boulders near the riverward edge of the bench (See Figure 2). This design allows the log to hinge downwards if the front of the bench erodes, keeping the rootball in contact with the bank surface, interacting with flow and providing ongoing protection from boat wash (Figure 3, Figure 4).

This mechanism performed as expected following high flow events in 2024 and 2025. The pattern of log movement also illustrated the varying influence of fluvial scour along the length of the sites. Typically, bench erosion and hinging movement of the rootball logs was observed towards the downstream end of the remediation sites. At the downstream end of Site 5 (Figure 3), boulders placed against the rootball logs have dislodged and disappeared, the rootballs have rotated from pointing upstream to pointing downstream and there is a visible gap between the end of the log and the vegetation, where the bench has retreated slightly. However, the rootball logs remain in contact with the bench and the water and are still providing protection from boat wash. This site is considered to be progressing consistent with restoration intent.

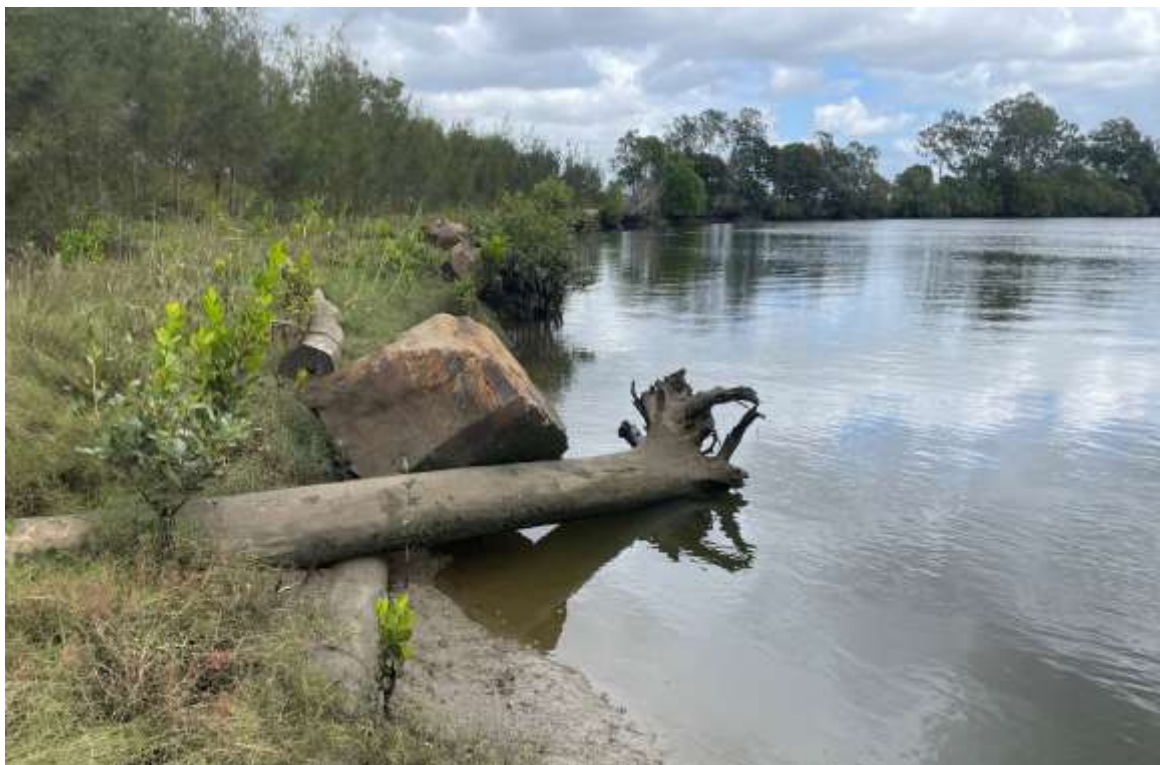
**Figure 4 Acceptable bench adjustment. One boulder dislodged, but the rootball remains in contact with flow. Complete groundcover of intertidal vegetation, with mangrove saplings growing slowly. This site is progressing consistent with the design intent. Photo May 2026. Construction Spring 2023**

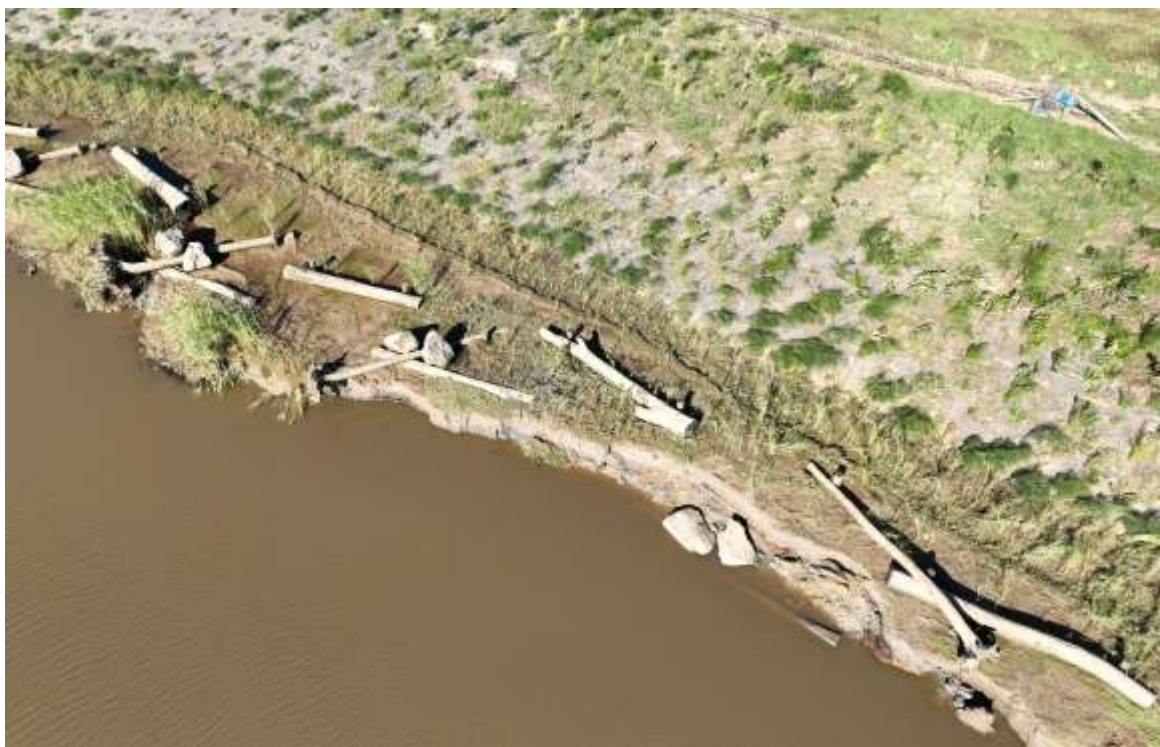
On one of the sites (site 24), the stabilisation works extend along an inside bend and an outside bend. Accelerated bench retreat and hinging of logs was only noted on the outside bend portion of the site, which is expected for an erosion mechanism driven by fluvial scour and loss of the bank toe below the intertidal works.

Site 24 was constructed through winter and spring 2024, and experienced significant flow in March 2025. At this stage, the intertidal bench had not yet established continuous groundcover or mangrove saplings. During the March 2025 flood event, severe bank retreat along some sections of the site left

insufficient width of bench to establish a fringing mangrove community (Figure 5). Consequently, the intervention is considered partially unsuccessful at this site.

**Figure 5 Site 24 showing bench as constructed (left of image) and a section of severe bench erosion and log movement (right of image). In this location, the restoration is considered unsuccessful as there is very limited remaining intertidal zone to support future establishment of a resilient mangrove fringe. Photo March 2025 (post flood), following construction winter 2024**

The restoration design focuses on the upper portion of the intertidal zone, guided by observed elevation of mature fringing mangrove communities in adjacent sections of the river. However, fluvial scour of the submerged bank toe remains a threat to restoration works. An adapted design, currently submitted for approvals, for a proposed site in a tidal reach of the Caboolture River has incorporated short pilefields interspersed between the tidal bench wood placement, with the aim of providing additional protection to the bank below the intertidal zone. However, there are also constructability limits and considerations for boat navigation of the river. Consequently, full mitigation of the risk of toe scour may not be possible and a level of risk assessment is still required within project investment decision-making.

- At Site 24, fluvial scour has emerged as a dominant driver of erosion, and the rate of bank retreat has outpaced establishment rates for the marine vegetation on some areas of the site. An adapted design has been proposed at an upcoming site on the same river, incorporating short pilefields for improved toe protection beyond the edge of the intertidal bench.

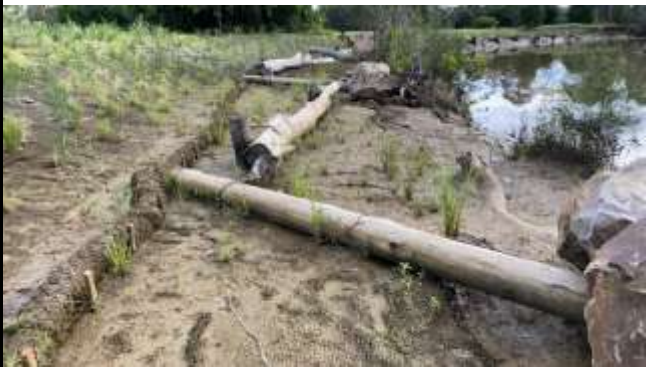
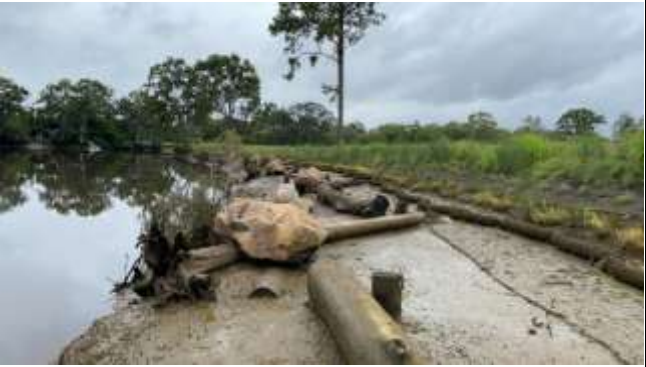
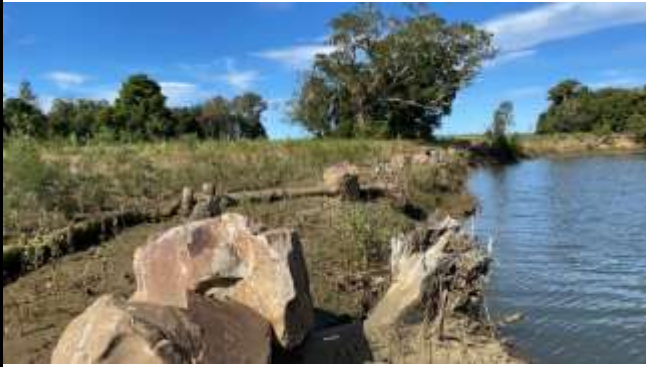
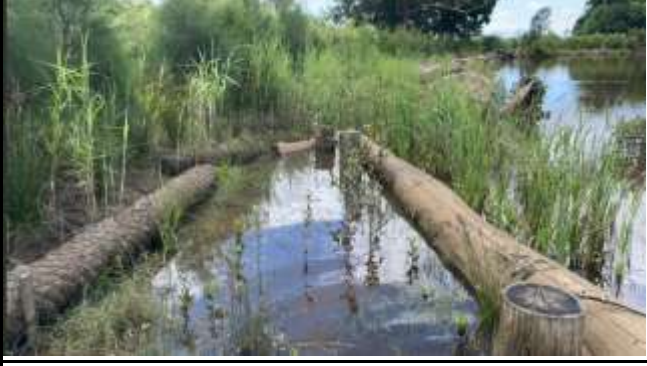
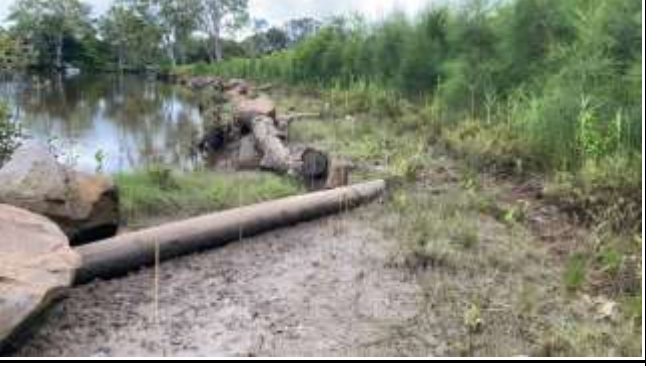
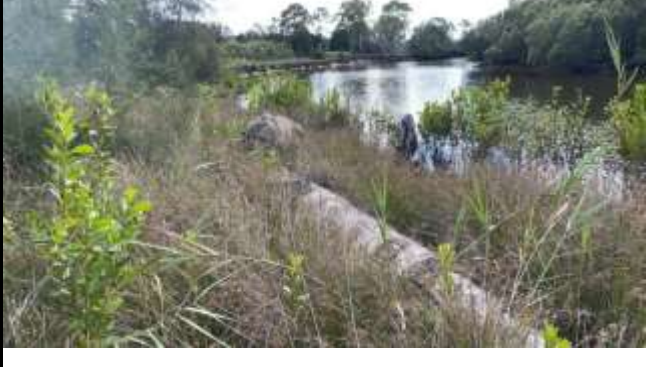
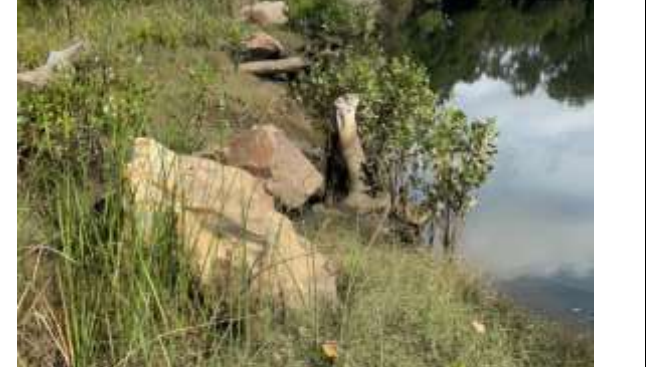
**Table 1 Time series illustrating establishment of 100% intertidal groundcover over 12-18 months**

Within the restoration time scale to date, other fast-growing intertidal species are playing an important role in providing groundcover and surface protection of the intertidal bench. They also build ecological and physical complexity, which assists in capturing additional mangrove propagules. As captured in monitoring quadrats and illustrated in the photo series below, establishment of diverse intertidal vegetation generally approached 100% groundcover in 12-18 months. No effort has been made to manage the species mix during this establishment process, and all of the species present are native and considered either desirable or acceptable. There was some debate about the inclusion of *phragmites australis* in the planting mix as it can form dominant monocultures, but it was ultimately included and is establishing alongside mangrove propagules in several areas (Table 1).

| Site B1 | Site 5 |
|---|---|
| 4 months post-construction<br> | 3 months post-construction<br> |
| 6 months<br> | |
| 13 months<br> | 12 months<br> |
| 2 years and 4 months<br> | 1 year and 6 months<br> |
