# Ten years of learning from catchment-scale stream stabilisation: Lessons from Laidley Creek, South East Queensland

## Abstract

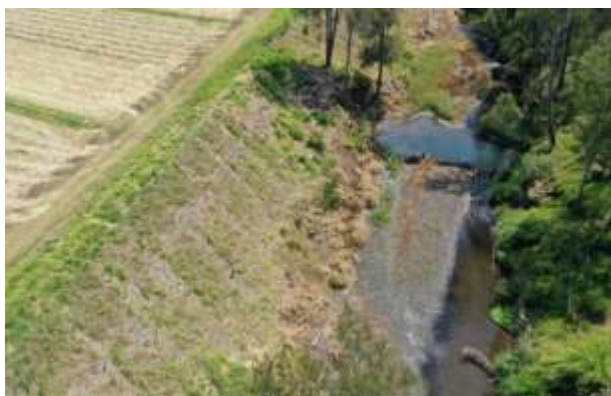
**Figure 2 Cross channel structure looking downstream, with sediment deposition upstream and the formation of a bench that is commencing to revegetate (08/10/2024)**

For instance, Figure 2 highlights the build-up of bed material and the formation of a bench on the upstream end of a cross-channel structure, and the commencement of bench revegetation. Figure 3 illustrates LiDAR comparisons between 2023 and 2024 downstream of a cross-channel pile structure. The figure shows evidence of in-channel deposition. Despite a large degree of success, bank eddy scour immediately downstream of the cross-channel structures has been observed. In line with

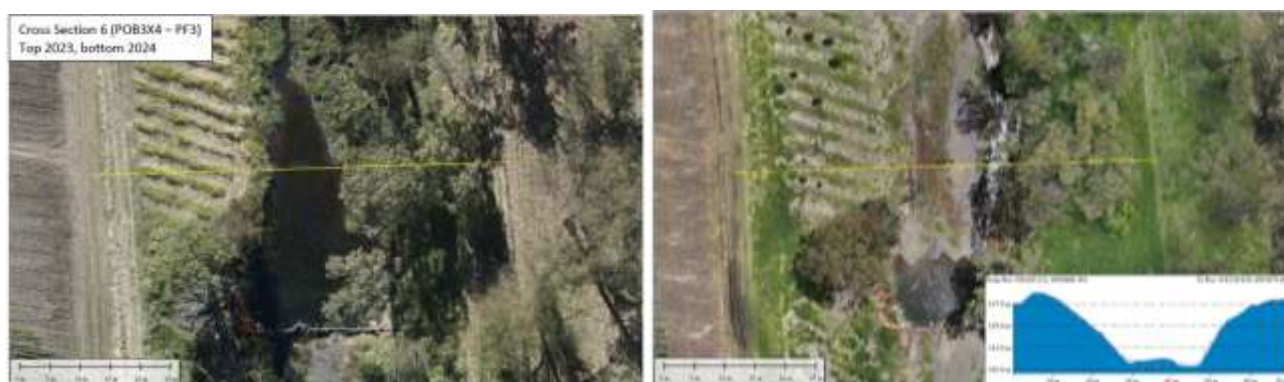
**Figure 3 2023 and 2024 comparison of revegetation at a cross channel pilefield, showing development of an upstream bench and riparian vegetation strengthening (Parker et al., 2024) a) 2023 b) 2024. (Parker et al, 2024)**

adaptive management principles, this observation has resulted in design modifications, such as increasing the extent of bank toe rock armoring in the 2025 project implementation. The data collected to date continues to support the premise that the timber cross channel structures are acting as effective grade control structures (Parker et al. 2023), creating upstream in channel deposition and downstream scour pool (Rutherford et al, 2000).

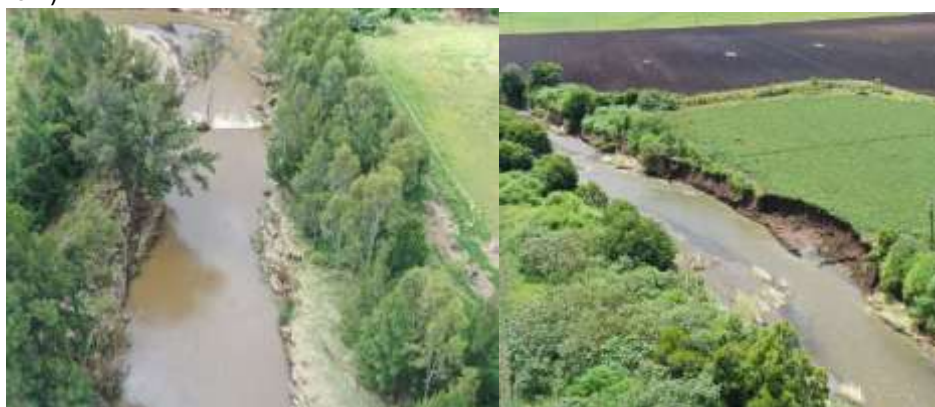
**Figure 4 Aerial photos post Cyclone Alfred (March 2025) - Left -2017 stabilised bank, Right - untreated bank**

Figure 4 provides graphic evidence of the success of the Laidley Creek remediation effort, comparing the impacts of Ex-Tropical Cyclone Alfred flood flows on two nearby reaches, the first remediated; the second yet to be remediated. Supporting the visual evidence of increased bank stability, LiDAR capture is undertaken every two years to monitor changes in channel and bank geomorphology. In addition, as approximately 2 km of the remediation work undertaken to date were funded through a formal nutrient offset investment, more detailed sediment accounting was undertaken along this reach to quantify and verify sediment erosion which was avoided (Figure 5). The works avoid circa 12,000 tonnes of sediment

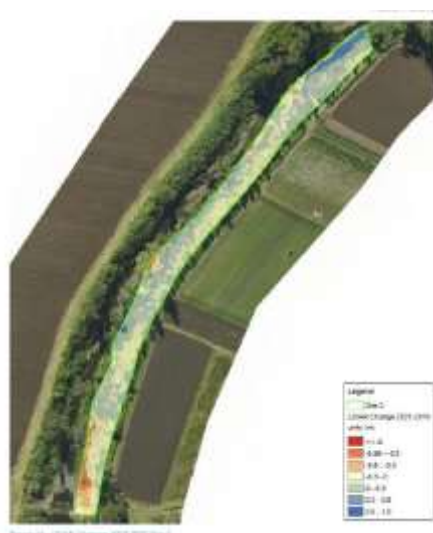
**Figure 5 LiDAR elevation changes between 2021 and 2018 – Site 1 (changes greater than 30 cm)**

pollution per year; and, importantly, have trapped (resulted in deposition of) an estimated 800 tonnes/yr (Table 1).
