## All the best intentions (and information): Using multiple and sequential data sources to inform the large-scale rehabilitation of the Cann River, East Gippsland, Victoria

Sean Phillipson<sup>1</sup> and Alex Sims<sup>2</sup>

<sup>1</sup> East Gippsland Catchment Management Authority, Bairnsdale, Victoria, 3875. Email: [sphillipson@egcma.com.au](mailto:sphillipson@egcma.com.au)

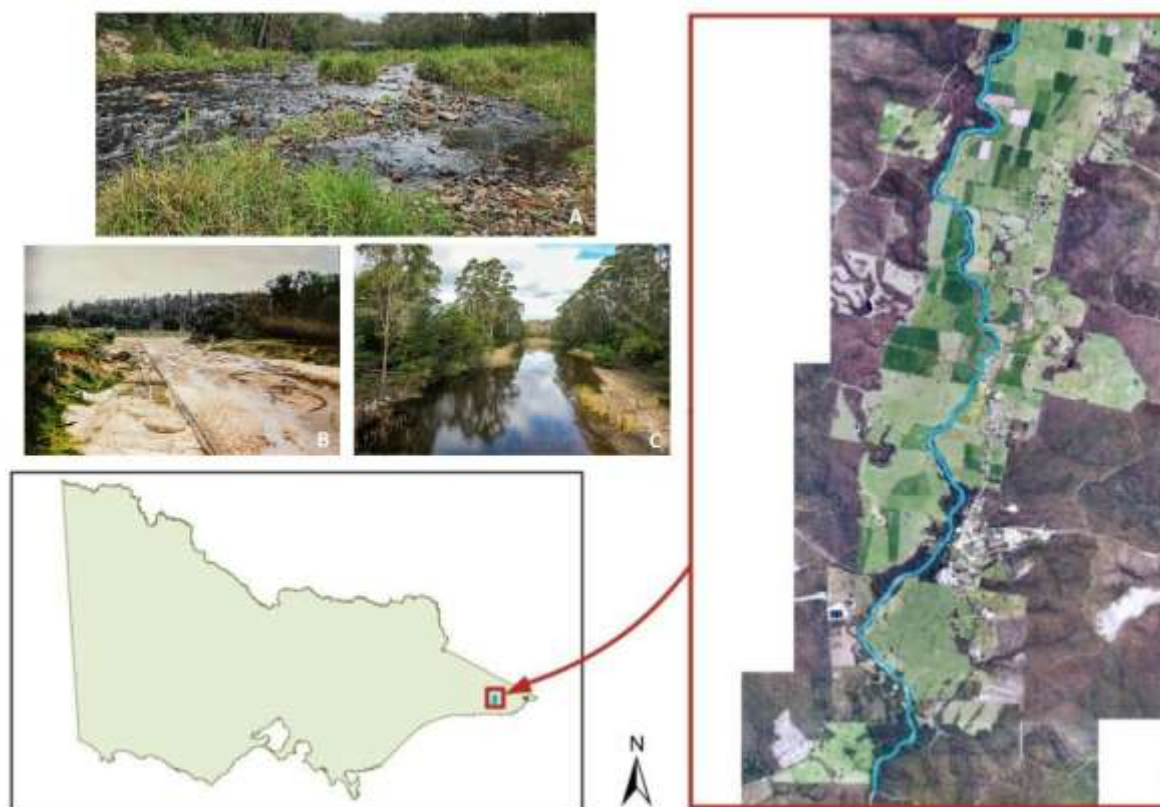
**Figure 1 Location map. Inset images A) Rock chute downstream stream of the West Cann Bridge B) and C) Observed channel change since 1969 (left), 2018 (right) (adapted from Alluvium, 2022)**

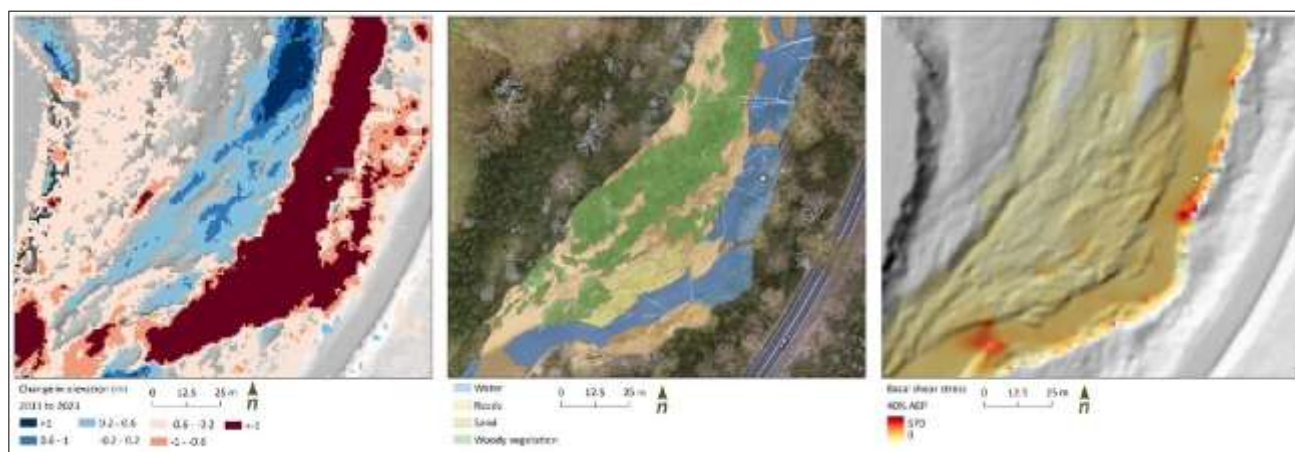
**Figure 3 Monitoring datasets used in the Cann River (left) DEMs of difference, (middle) mapping of vegetation change, (right) modelled shear stress (40 % AEP) (Alluvium, 2024)**

The availability of repeat LiDAR and aerial imagery has shifted the assessment from testing change at selected cross-sections or individual sites (often selected as ‘representative of broader reaches of river’) to measuring patterns of erosion, deposition and vegetation change across much larger areas. This allows rates and patterns of channel adjustment to be assessed at higher spatial resolution and over a broader extent than was previously possible. It also allows flood impacts to be bracketed by pre- and post-event datasets, making it easier to separate event-driven change from longer-term recovery or adjustment trends.
