# Take nobody's word for it: Rock, wood and rebellion in rehabilitation

Logan Zingus<sup>1</sup>

<sup>1</sup> Program Coordinator, NSW Soil Conservation Service, Jaarra (Mid North Coast Region), New South Wales, Australia. Email: [logan.zingus@scs.nsw.gov.au](mailto:logan.zingus@scs.nsw.gov.au)

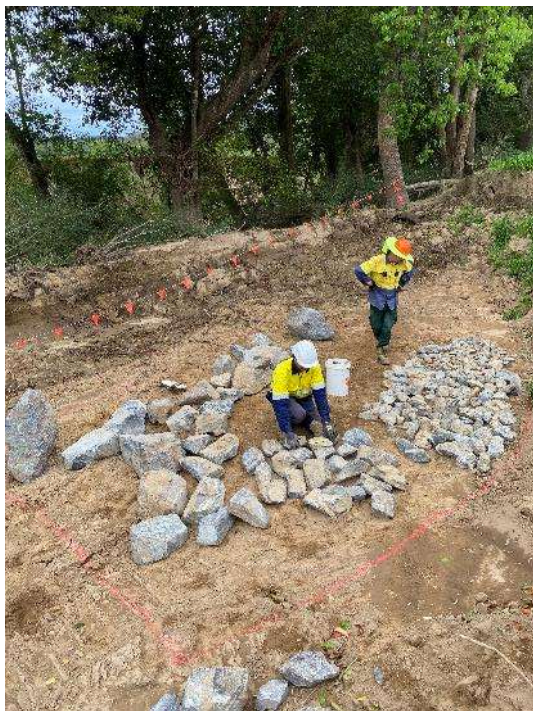
**Figure 1** Sorting shot rock to test d50, Nambucca River, Bowraville September 2025

Below the average water level to a launch rock toe, shot rock (quarry run material with fines removed) was blended with larger armour rock particles as an armour layer. The armour rock was added to increase the average particle size, as determined by manual sorting (Figure 1) and improve mechanical interlock. This 'void-filled' revetment produced a cost-effective mechanically strong matrix of armour. Above this, a soil-filled blend of shot rock, armour rock and topsoil was placed and planted with *lomandra hystrix*, *carex spp.* and *juncus spp.*, providing a mid-bank that is both cheaper to construct and more ecologically functional than bare rock. Above this treatment, the upper banks were battered and revegetated as per standard revegetation treatment.

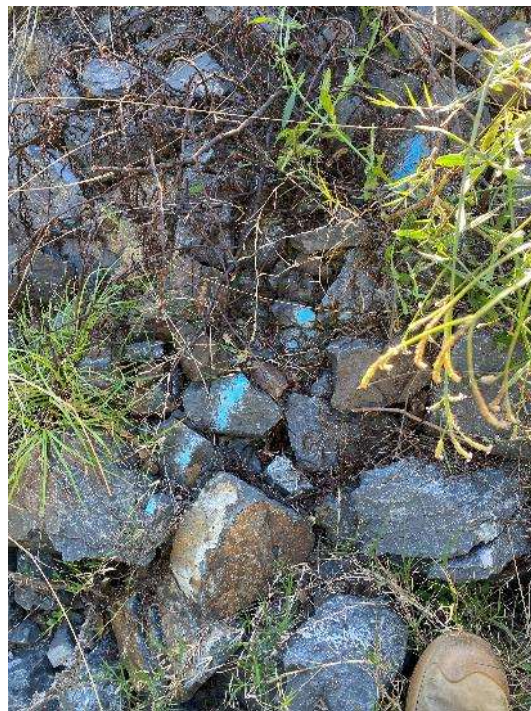
**Figure 2** Witness mark showing small rock stable after flood event. Five Day Creek, Comara May 2024

At one site on Five Day Creek in the Macleay Catchment of NSW, witness marks (a term borrowed from mechanical engineering where a line is drawn between meeting surfaces to check for movement) were painted on the rock at various locations prior to flood events associated with ex-Tropical Cyclone Alfred. After the event, the marks were inspected and showed rock movement substantially below that predicted by standard sizing equations (Figure 2). Vegetation establishment in the soil-filled zone was vigorous (Figure 2). At Kennaicle Creek in the Nambucca Catchment, the configuration performed

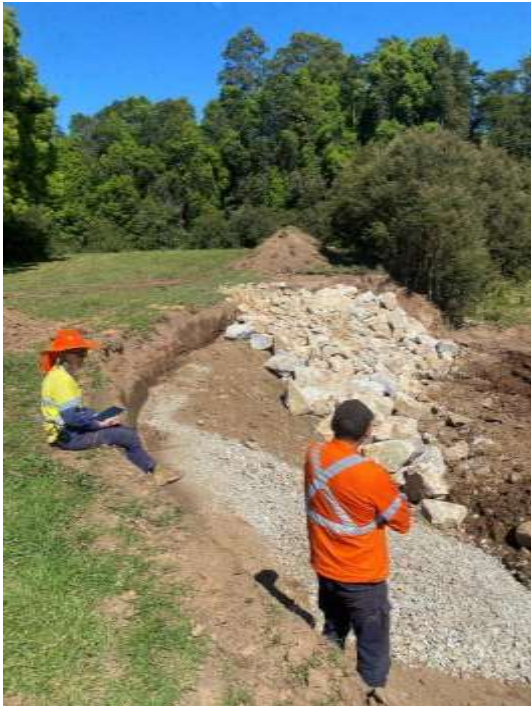
**Figure 3 Granular filter with armour rock overlay, granular filter at Kennaicle Creek, Missabotti, September 2024**

Using guidance and specifications from Witheridge (2021), a granular filter layer was constructed using a 200 mm graded aggregate quarry rock 20-70mm under the armour layer in Kennaic Creek (Figure 3). The aggregate was sized to bridge the gap between the native bank material (sandy loam) and the overlying rock without allowing fine particle migration as the standard approach in geotechnical applications but less commonly applied in bank revetment in NSW. The installation was simple, reduced the need for manual labour, and as a result costs were marginally higher than geotextile (~15%) although minor relative to the total project costs. Performance through subsequent flood events was comparable with adjacent geotextile-lined sections, with no evidence of fines migration, piping or undermining. The granular filter also provides a more stable substrate for vegetation establishment in the lower bank zone (Figure 4), although it's unclear if roots have penetrated at this early stage.

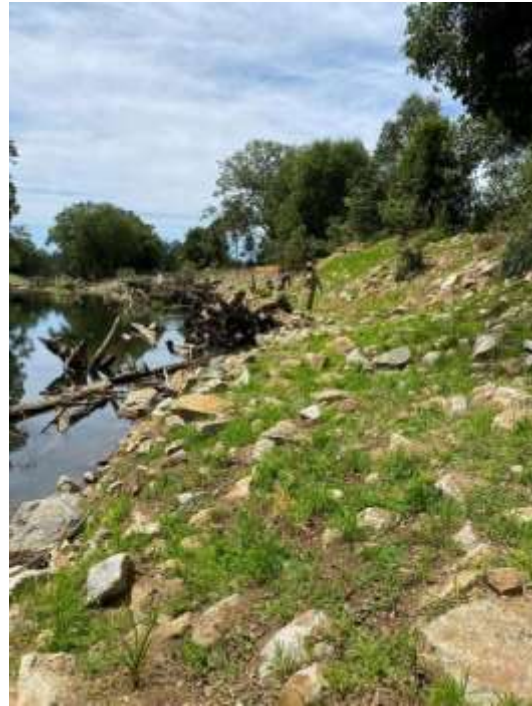
**Figure 4 Soil filled revetment being planted on the Nambucca River, Bowraville November 2025**

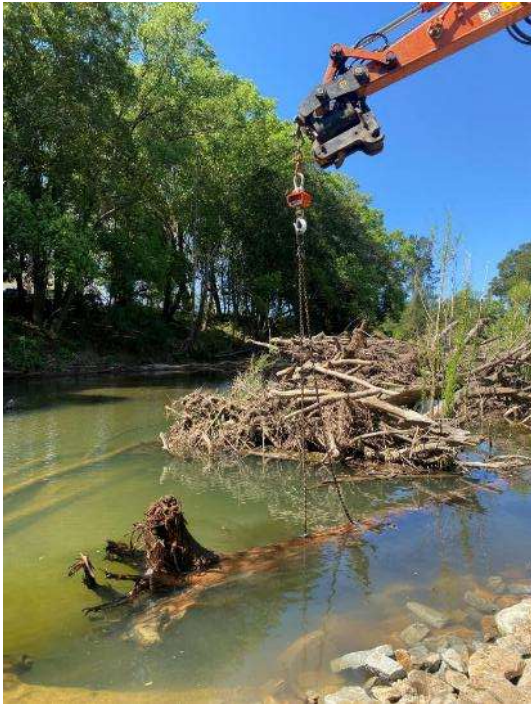
**Figure 5 Weighing log with rootball to test buoyancy. Nambucca River, September 2025**

Buoyancy, determined by timber density which varies between species and with moisture content, can be considered for reducing ballast while retaining stability, especially when actual density can be measured. Natural timber snags lodged in stream channels provide ample examples of stable wood without engineered anchoring if arranged together in messy log jam structures.

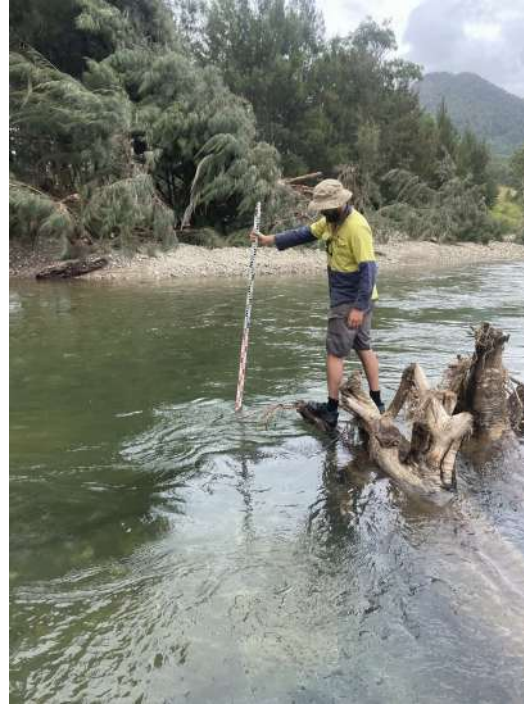
**Figure 6 Scour from installed log after flood, ~ 1.4m deep, Five Day Creek, Comara, May 2025**

A recent large woody debris installation at Five Day Creek aimed to use passive anchoring both to enhance the wood's function and reduce costs given the site's long distance from materials. Rather than blanketing the structures in rock or using fixed anchors and cable, stability was designed through placing two logs together for additional friction; keying logs into rock between 1-1.5m; and hydraulic resistance from the wood volume and density itself, as tested by weighing the log underwater to measure buoyancy (Figure 5). Stability was monitored after multiple flood events, including ex-Tropical Cyclone Alfred. Wood remained stable at ballast below standard specifications, which commonly require two thirds of rock cover and one third of the log in the channel. Following ex-Tropical cyclone Alfred, surveys showed that the log installations remained in position despite high-velocity flows and

extensive saturation of the soil over months (Figure 6). In some cases, channel changes during the flood improved rather than degraded performance through deposition behind the log, and an increase in channel cross-section through scour at the tip.
