## The advent of post European Erosion in a Valley Swamp

**ABSTRACT:** *Incision of Scrubby Creek was initiated when human intervention exposed subsoils with an erosive cocktail of high sodium ( $\text{Na}^+$ ) concentrations, alkaline pH and humic material associated with buried swamp deposits to streamflow. Such conditions coupled with clay cracking generated by wetting and drying cycles within the drain itself were critical for subsequent rapid erosion, rather than catchment wide changes. Although subsoils were potentially dispersive, actual losses from the cliffs were governed by the imposed hydrological setting, with the greatest erosion evident during the period of greatest change shortly after the original swamp was drained.*

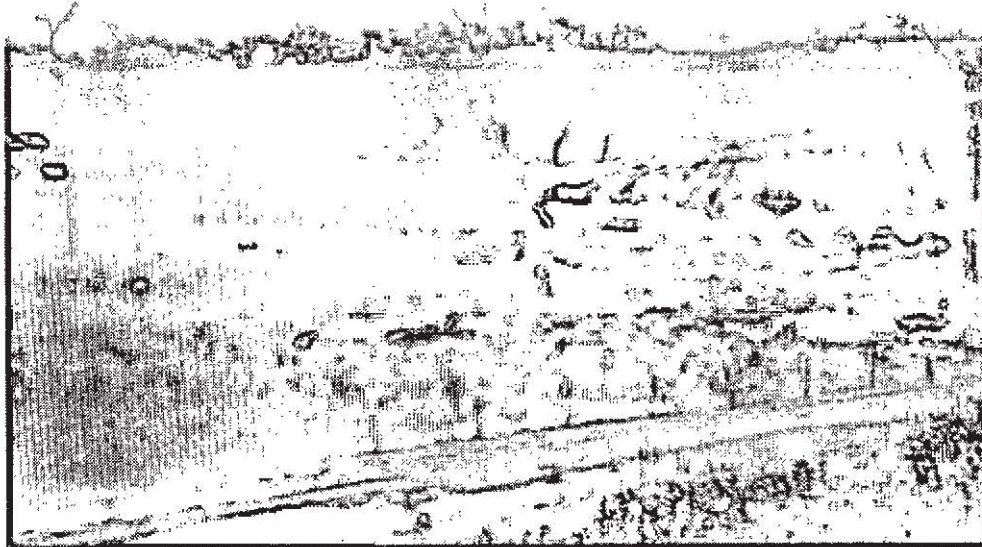
**Figure 2.** Comparison of the Humevale Primary School Site in 1906 and 1991

**Above:** Primary School site in 1906 looking North. Limited incision is already evident and vegetation has been removed. Note, stock access track.

Humevale Primary School. The magnitude of this erosion is depicted in Figure 2. Erosion along the lower reaches was less severe with no incision evident beneath an aqueduct bridge constructed in 1886.

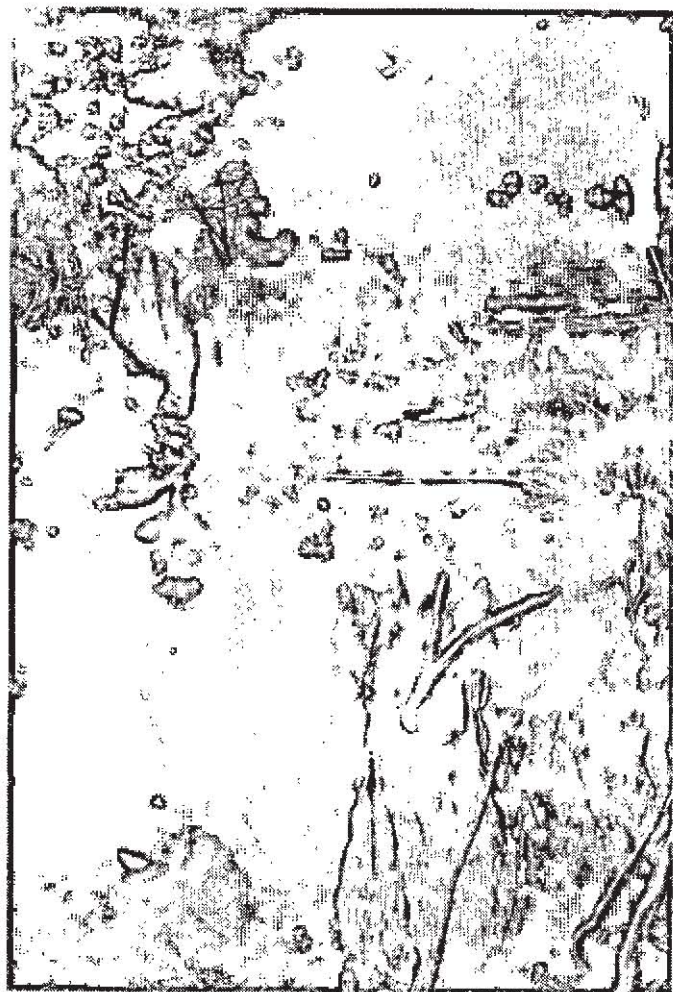
**Right:** The same site in 1991 looking west. Note the creek now follows the road alignment depicted above. The fence provides a common reference point. Concrete footings from the school toilet block cling to the edge.

Preferential erosion in the zone of moisture fluctuation at the base of the cliff produced a characteristic undercut (Figure 2). Greater undercuts were evident where drying cycles and subsequent fluvial removal were most severe, such as outside meander bends devoid of stabilising vegetation. Undercuts eventually caused the overlying material to collapse either as small fretting failures or as cantilever collapses where the rate of removal was greatest. The former process where small blocks or slabs 'flaked' from the surface and were subsequently removed was the dominant erosion process.
