The Use of Historical Data in Community River Management Planning

Barry Starr

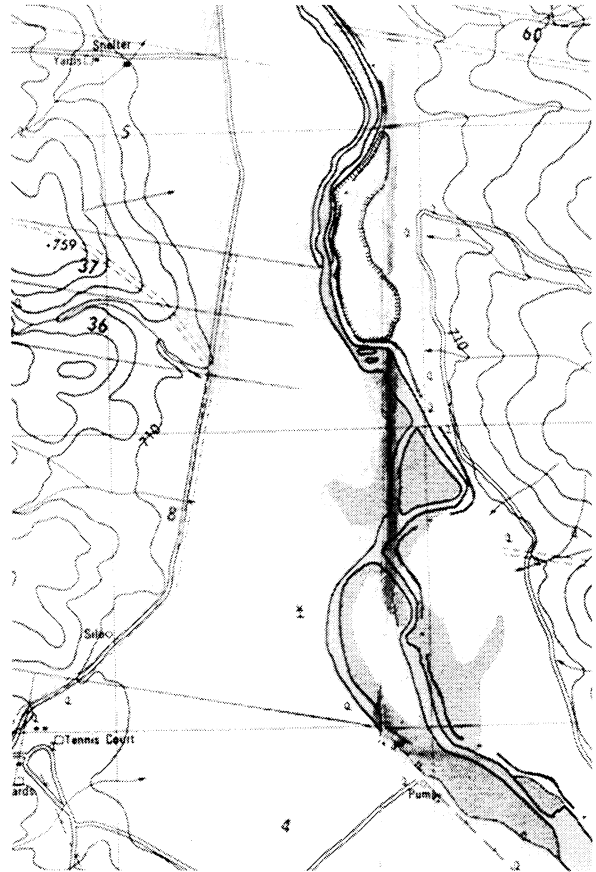
Figure 1: Detail from a 1:25 000 scale topographical map showing the location of a creek channel where it formed the boundary of surveyed portions.

Some topographical maps include cadastral material superimposed on landscape features plotted from aerial photographs. Where these are unavailable the source material ie aerial photographs and parish maps, can be used. As rivers and creeks formed the boundaries of many surveyed portions, their location in comparison to that of the current stream channel will indicate if there has been any net change. Open-ended portion boundaries on topographical maps usually indicate the location of the stream channel at the time of survey (Figure 1). Not only can the extent of movement be ascertained but also a comparison made between channel features. Care must be taken when drawing conclusions on the latter, however, as alluvial material may have filled the prior channel.

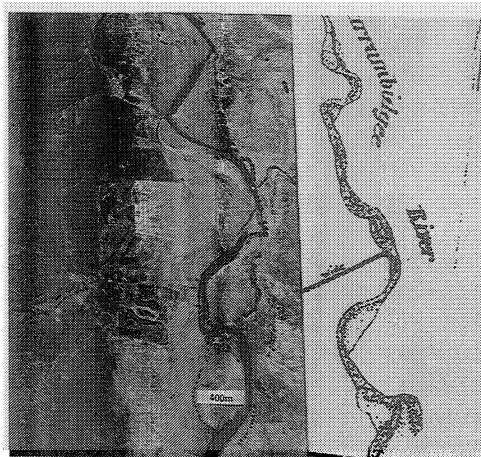
Figure 2: A section of Murrumbidgee River channel that relocated during floods of the 1920s as the result of the deposition of a sediment slug. The location of the channel prior to the events, and as originally surveyed is indicated by the line of willows (from Starr *et al.* 1997)

In 1944, much of the landscape was at its most degraded state since European settlement, with rabbit infestations at a peak, and the impact of drought apparent. In south-eastern New South Wales the impact of the major flooding of the 1920's is also apparent (Figure 2). Aerial photographs have been produced regularly since 1944, providing data by which change can be assessed, particularly in relation to recorded flow events. When using air photos it needs to be noted that:

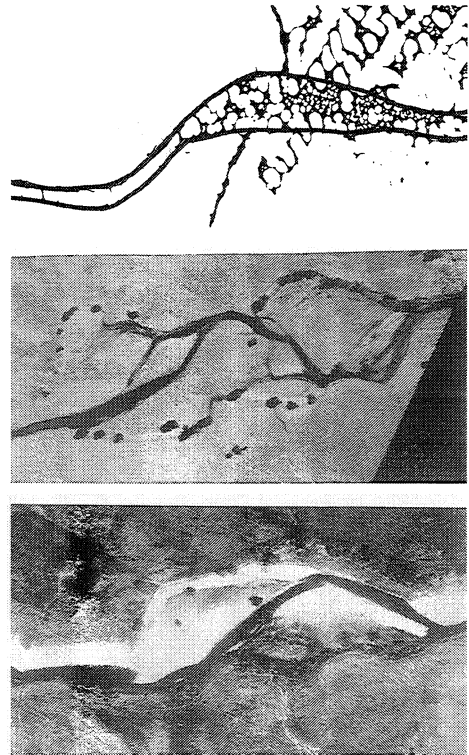
Figure 3: A section of Murrumbidgee River as surveyed in 1867 (upper) bears a close resemblance to the channel 100 years later (lower). Between these times, however, the channel was filled with a sediment slug (middle).

- It is particularly important that all available air photos are used to ascertain absolute, or total, change that has occurred. Conclusions reached from net change of, for example between 1944 and the most recent air photo, may be valid for assessing the headward extension (or lack of) of hillslope gully networks, but must be used with caution for stream changes. Channels not only respond to the flow of water but also to the movement of sediment, often in the form of slugs. These and their impact on the riverine corridor may be missed if a long term net approach is taken to air photo and cadastral map interpretation (Figure 3).

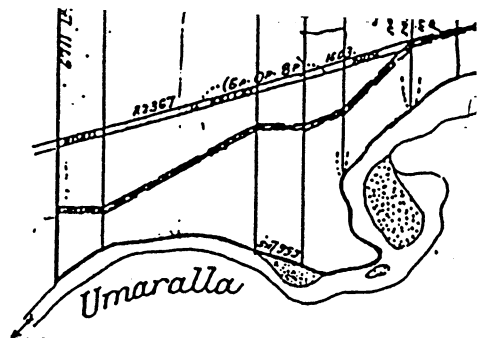
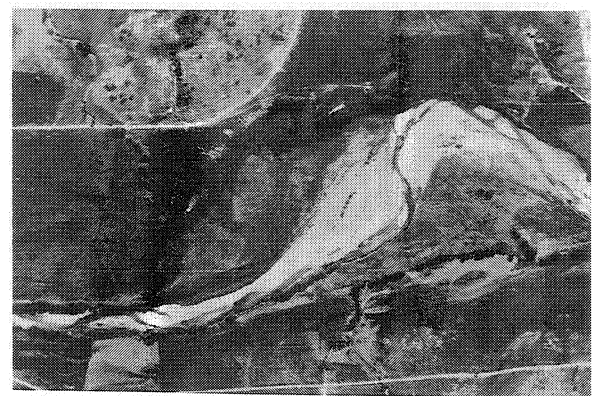
Figure 4: A 1967 air photo and 1871 survey of the Numeralla River. Vegetation moisture variation permit the surveyed point of land and connected bar to be easily located and the extent of meander migration to be measured.

- Air photos show seasonal variations in groundcover. This is particularly valuable in locating prior channels, particularly those surveyed soon after settlement. At times of increasing moisture stress prior channels will be moisture favoured in comparison to adjacent prior banks or bars and will often be clearly discernible. The detail of channels, banks and bars shown in air photos often reflect the accuracy of early surveys on which cadastral maps are based (Figure 4).
- With one millimetre representing twenty-five metres at a 1:25 000 scale, channel changes are often difficult to detect. The relative location of fixed features such as fencelines, buildings or even gullies that are adjacent to, or connected to channels, provide the most accurate means of estimating or measuring change.

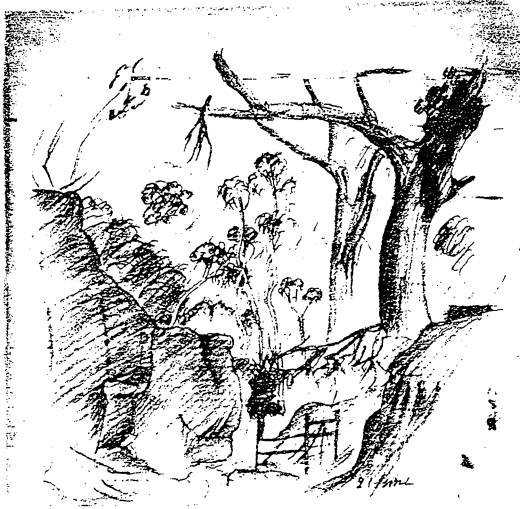
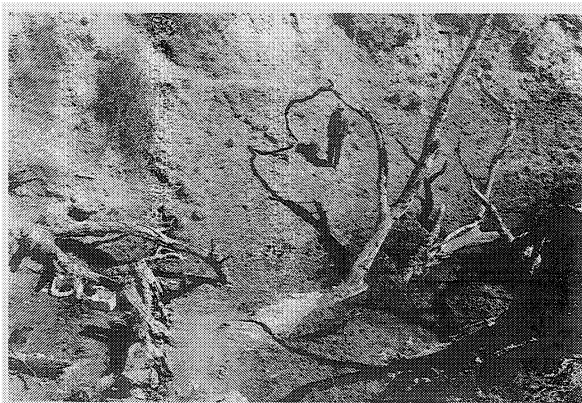
Figure 5: A sketch of "The Well in the Deep Creek" from an 1848 journal of the teenage John William Buckle Bunn of Woden Station ACT (upper). The exposed roots of the *Eucalyptus spp.* indicates then recent channel incision of what is known as Woden Creek. Cross-section comparisons that were made when the tree and well were recently located indicates that channel dimensions of this creek have changed little in the ensuing 150 years (from Wasson *et al.* In Prep)

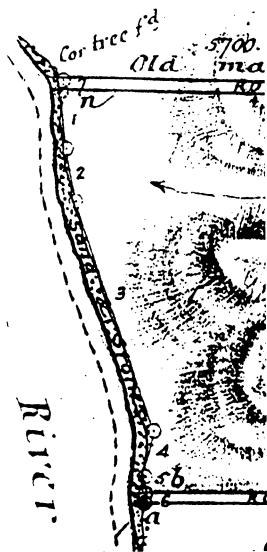
Figure 6: An 1887 resurvey of a portion of land at Lanyon ACT which a change in location of the bank of the Murrumbidgee River since the original survey. The strip of "sand and gravel" corroborates anecdotal material on changes to the river that occurred on and after a major flood of 1852.

Interpretation of planar data is essentially the location and measurement of change. Relic, anecdotal and other on-ground information needs to be examined in a logical manner with erosion, deposition and incision sequences (and various combinations of) being developed from what is usually a scattering of information. It is important that, wherever possible, anecdotal material and written observations be corroborated. This is mainly due to its subjective nature and difficulties in interpreting what the witness actually meant. Corroboration can either be sought through planar or other on-ground data. Examples of the use corroborative data are shown in Figure 6 and Figure 7.

Moore (1982) wrote of major changes that occurred to the Murrumbidgee River at Lanyon (Australian Capital Territory) as a result of a major flood in 1852. Prior to that event the river consisted of deep holes interspersed with gravel beds. Following the 1852 flood the river had doubled in width and had infilled with sand. Extensive bank erosion had occurred. Moore does not reference the source of information of the 1852 change. An 1883 resurvey of a portion bounded by the river does, however, provide confirmation (Figure 5). The original survey was of both banks, not the centre thread of the river. The resurvey shows a new river boundary with the space between that and the prior bank being of "sand and gravel". From the scale it is apparent that a doubling in width had occurred.

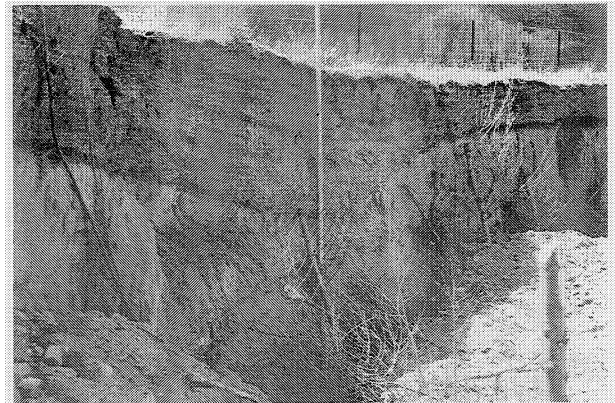
Figure 7: A prior channel infilled with post-settlement alluvium. This channel is of the 1840 dimensions of the Numeralla River as indicated by Stewart Ryrie and is exposed on the now two metre high vertical bank of the river.

Stewart Ryrie (1840), in one of his "tours" of south-eastern Australia encountered the Numeralla River and wrote of it being "... very small, being no more than a running creek, a yard and a half wide. There are many large and deep holes in it". At the same location today the Numeralla River has a vertical bank of two metres height and is forty metres wide. The only deep holes occur at the outside of meander bends. It appears that the channel has expanded markedly since 1840. What Ryrie does not make clear, however, is whether he is writing of the total channel or just the flow of water that was present at the time. The former case is indicated by the presence of relic information in the form of a perched prior channel that is filled with alluvium and is of dimensions similar to that mentioned by Ryrie (Figure 6). It is apparent that, in 1840, the Numeralla River that Ryrie wrote of was a chain-of-ponds, a common drainage feature that has largely disappeared.
