Urban waterway restoration: Daylighting Dandenong Creek

Dandenong Creek, in the eastern suburbs of Melbourne, is a highly modified urban waterway with varying sections of natural stream, constructed earthen channel, concrete lined channel and underground pipe. Melbourne Water, in partnership with the Environment Protection Authority and local councils and community groups is undertaking a program of works to improve the aesthetics and environmental health of a section of the creek between Bayswater and Wantirna through the Enhancing Our Dandenong Creek (EODC) project. This involves re-engaging the creek with parts of its floodplain and daylighting an 800 m length of creek that was piped in the 1960s when major urbanisation was taking place. This paper discusses the design process for the daylighting of Dandenong Creek.

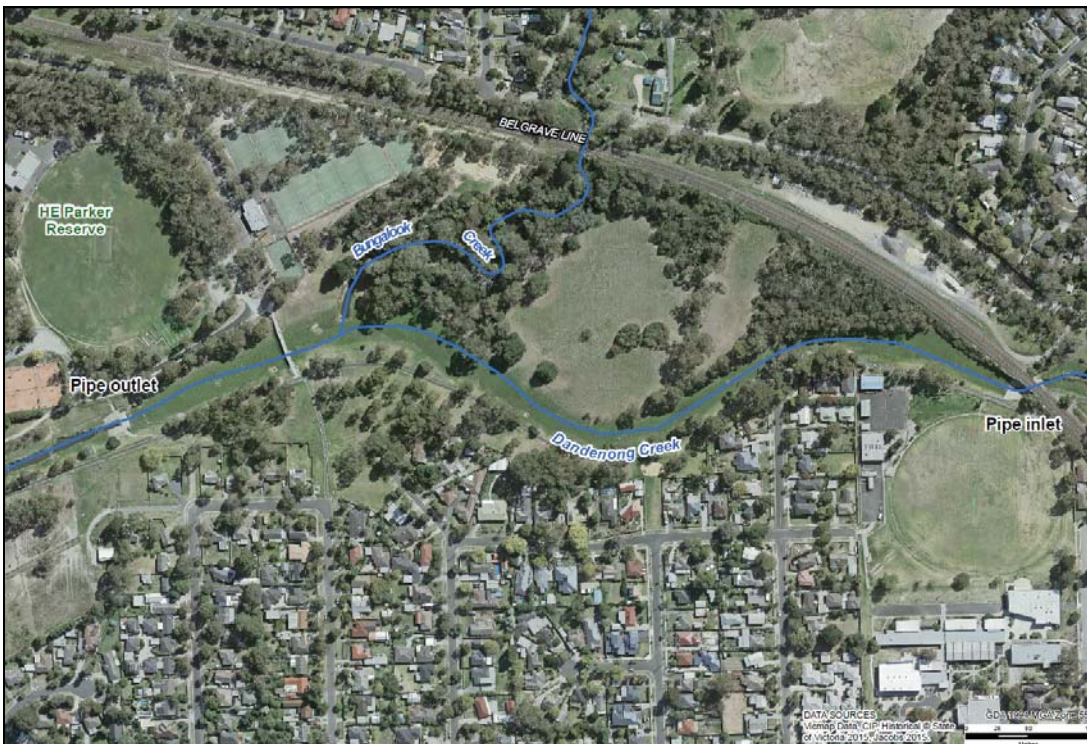
Figure 1. Dandenong Creek study reach

stormwater drainage design is now being challenged and efforts are being made to restore urban waterway health. This paper discusses the design process for restoration of a reach of Dandenong Creek, near Bayswater in the eastern suburbs of Melbourne, specifically the daylighting of an 800 m section of piped creek (Figure 1).

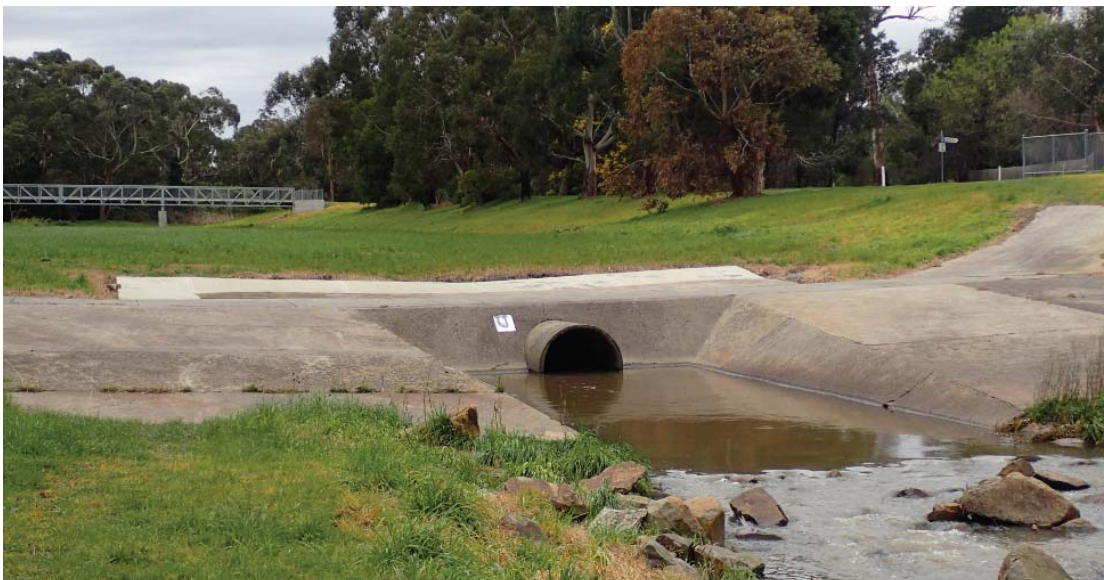
Figure 3. Dandenong Creek showing the existing low-flow pipe outlet and grassed high-flow channel

The creek was de-snagged, channelised and in some sections piped in the late 1960s. This was to improve the hydraulic capacity of the creek and reduce flood risk to newly developed suburbs. In the study area, the creek consists of a low flow pipe overlaid by a broad grassed trapezoidal channel for conveying high flows (Figure 3). The resulting channel is shorter and steeper (Table 1), and with lower roughness, which efficiently passes flows downstream.

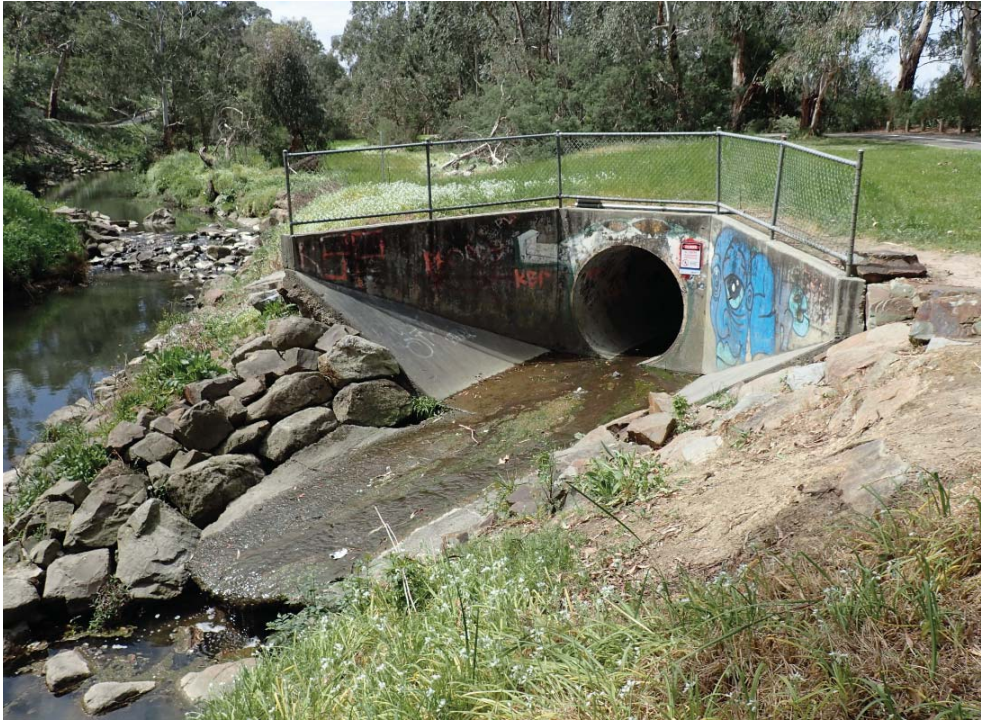
Figure 6. Stormwater input to urban waterways represents a major challenge to waterway restoration.

However, substantial improvement in the overall ecological health of Dandenong Creek is unlikely to be achieved until catchment based activities are adopted that address the hydrological and water quality impacts associated with urbanisation, namely catchment imperviousness and stormwater runoff (Figure 6).
