Instream Habitat Works Trial for Macquarie perch in the Hughes Creek Victoria, a Sand Slug Stream

Glassford et.al. – Instream Habitat Works Trial for Macquarie perch in Hughes Creek

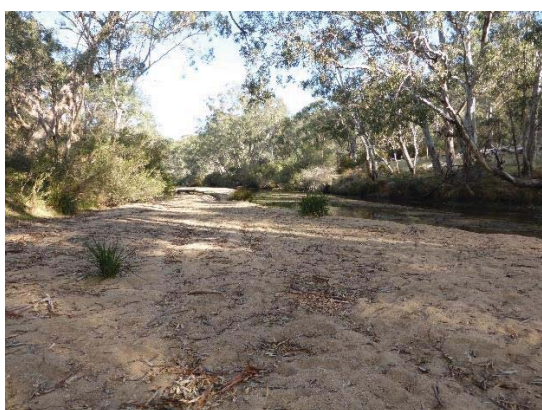
Figure 4. Site 1 view upstream from downstream extent taken 30 April 2015

Site 1 had a large sand slug (>400 m³) along the right bank, with a shallow, narrow flow contained predominantly to the left bank (Figure 4). Site 2 retained a deep pool below which flow was restricted to the right bank by a sand island, before broadening out across a cobble bed and ford crossing (Figure 5). Site 3, a regular fish monitoring site, had been a lengthy deep pool that has become shallow with sand benches established along the left bank and mid-length, a sand slug island (Figure 6).

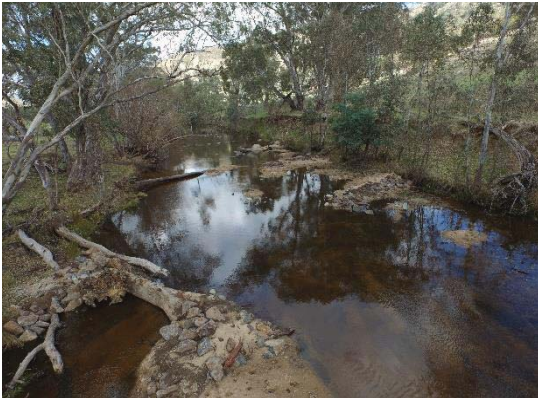
Figure 7. Completed structures at Site 3

As many of the lengths of wood were shorter than required, several pieces were often placed together to overlap and extend the structures length. In each instance, rock was placed either side and on top of the wood to anchor it in place. Where possible, existing rock and other embedded material was also utilised to shore up the structures (Figures 7 and 8).

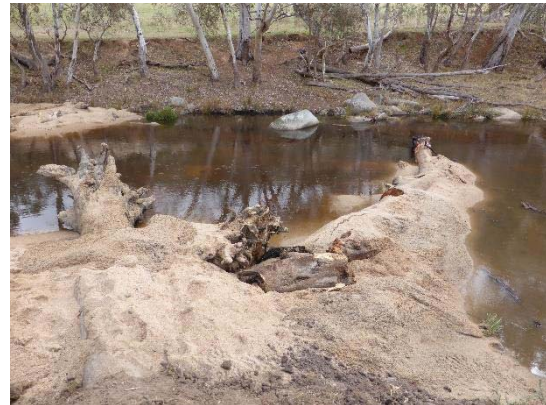
- Downstream angled groyne raised ~20 cm above the bed, to create scour as water passes beneath the obstruction
- Upstream angled groynes placed on the bed to encourage scour around the protruding end

Figure 8. Upstream angled groyne on left and raised downstream angled groyne on right

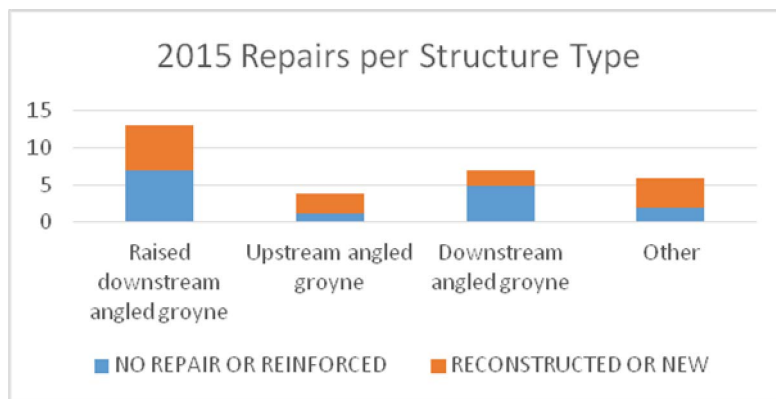
On review of the trial sites on 6 January, many of the large log groynes constructed in channel had moved. Some wood had simply shifted out of designed alignment, while others had been transported downstream 20-30 m, with a further few not found anywhere in proximity. In all instances, rock used remained in situ.

Every length of wood that was keyed in to the bank (partly buried by being either pushed or dug in) remained as positioned. Despite dimensions of >1 m diameter and lengths of 1.5-2.5 m, unsecured wood was most often transported by flow. With almost 50 per cent of all design types failing, there seemed to be little correlation between structure design and its resistance to flow (Figure 11). Where the structures remained intact, the wood used was keyed into the bank and the intended scour has been maintained to some extent, despite the significant reworking of sand at each of the trial sites.

Figure 11. Extent of repairs undertaken post flood 2015 per structure design

In February 2016, works were undertaken to repair and reinforce the trial works to withstand future high flows and thereby enable more accurate assessment of scour depths and longevity per design. In total, twelve structures were reconstructed with longer and more complex lengths of wood. These were keyed into the bank and further secured with anchoring rock (Figures 12a-d).

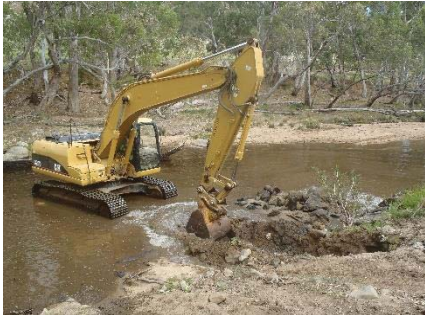
Figure 12a. Trench dug into bank for desired alignment.

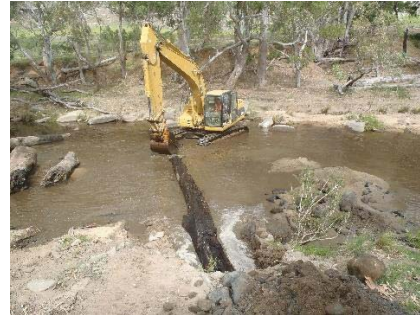
Figure 12b. Length/s of wood placed in trench at desired angle.

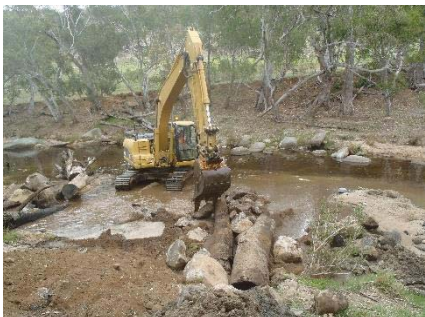
Figure 12c. Anchoring rock placed on and around wood.

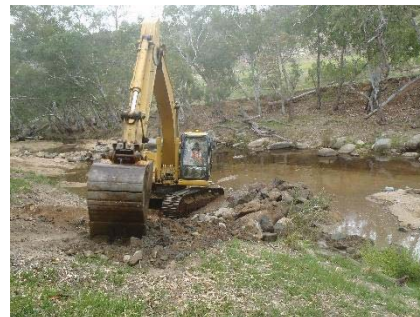
Figure 12d. Trench filled in with soil and compacted.
