Community drive the construction of Engineered Log Jams in South East QLD

Parker N¹, Brooks A² and Bigwood R¹

¹ SEQ Catchments, 17 Lowry Street, Ipswich, 4305. Email: nparker@seqcatchments.com.au

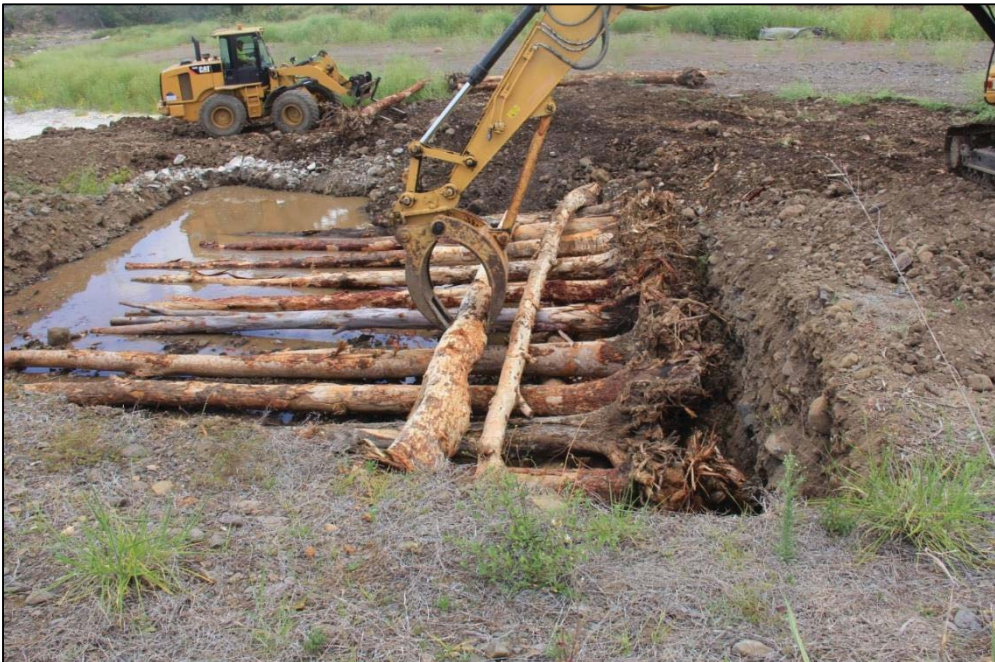
Figure 3 - Precise placement of logs to create the log jams in the Warrill Creek

To construct the log jams, ten metre long hardwood logs were placed in a criss-cross stack, keyed into the creek bank with their roots facing upstream, pinned and tied together with steel cable as per the guidelines of Brooks et al., 2006.

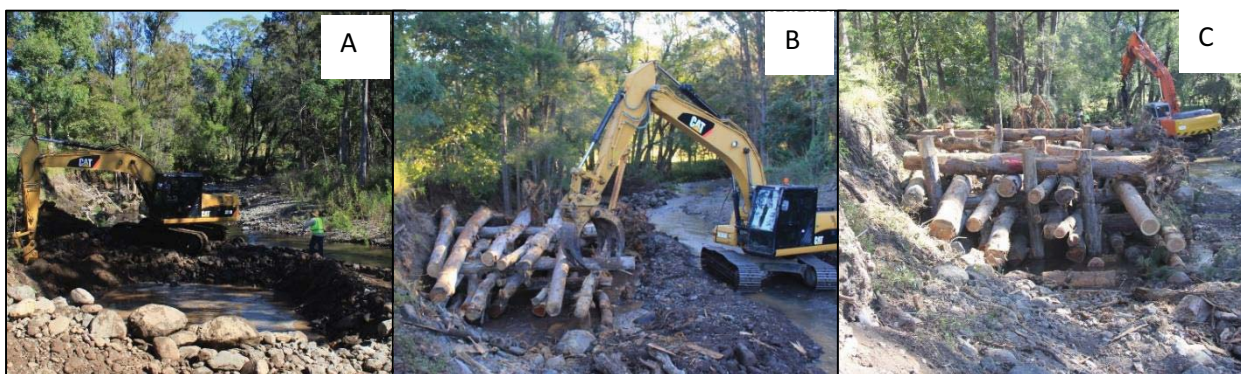
Figure 5 - Construction of ELJ, (A) the pit dug into the creek, (B) placement of logs, (C) completed ELJ

A series of four Engineered Log Jams were constructed as described above to protect 200 m of creek bank and save farmland, which suffered damage during the 2013 floods (Figure 5).
