Return of the ‘Bottomless Pool’ in Yosemite Creek, North Katoomba, Blue Mountains

Smith G¹, St Lawrence A¹, Day C¹, Mahony E¹, Gooderham J², Ellis C³

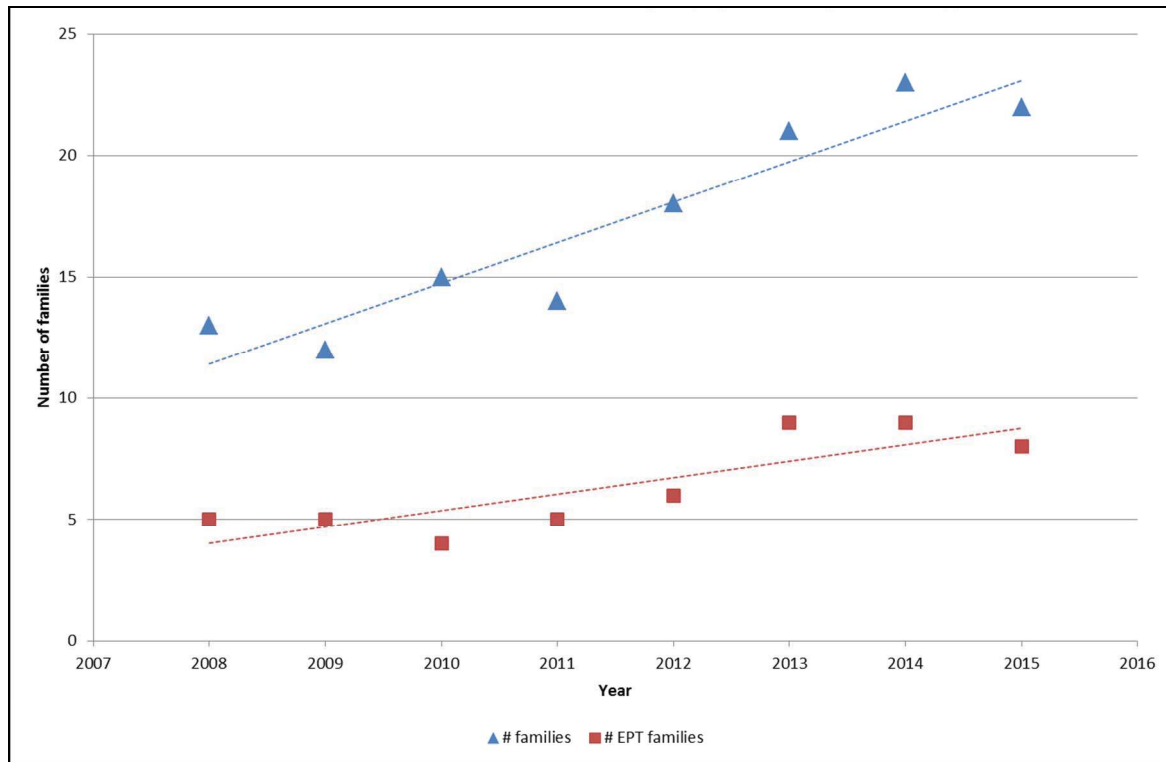
Figure 2. Yosemite Creek Aquatic Macroinvertebrate Diversity 2008-2015

One of the best long-term outcomes for this program has been the improvement in instream biodiversity. Annual surveys showed steady increases in the overall number of aquatic macroinvertebrate families and the number of mayfly, stonefly and caddisfly (EPT) families found at Yosemite Creek (Figure 2). Macroinvertebrate families increased from 12 taxa in 2008 to 22 taxa in 2015, while EPT taxa increased from 5 to 8 families over the same period. The site also improved from an AUSRIVAS Band B rating in 2008 and 2009 to a consistent Band A rating during 2012-2015.

Annual monitoring between 2006 and 2015 showed a significant recovery towards a healthy assemblage of aquatic macroinvertebrates, with a shift from 12 family taxa to 22, and from AUSRIVAS Band B to Band A. Most importantly for the local community, the plunge pool at the base of the Falls is considered ‘bottomless’

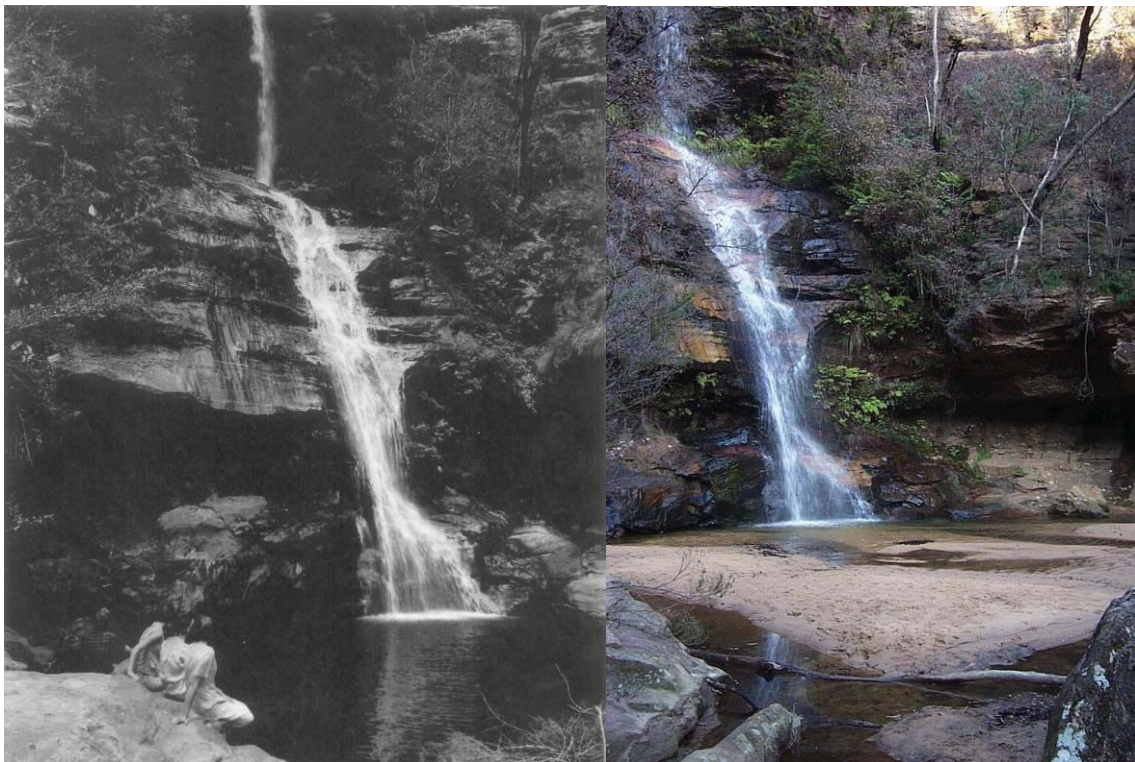
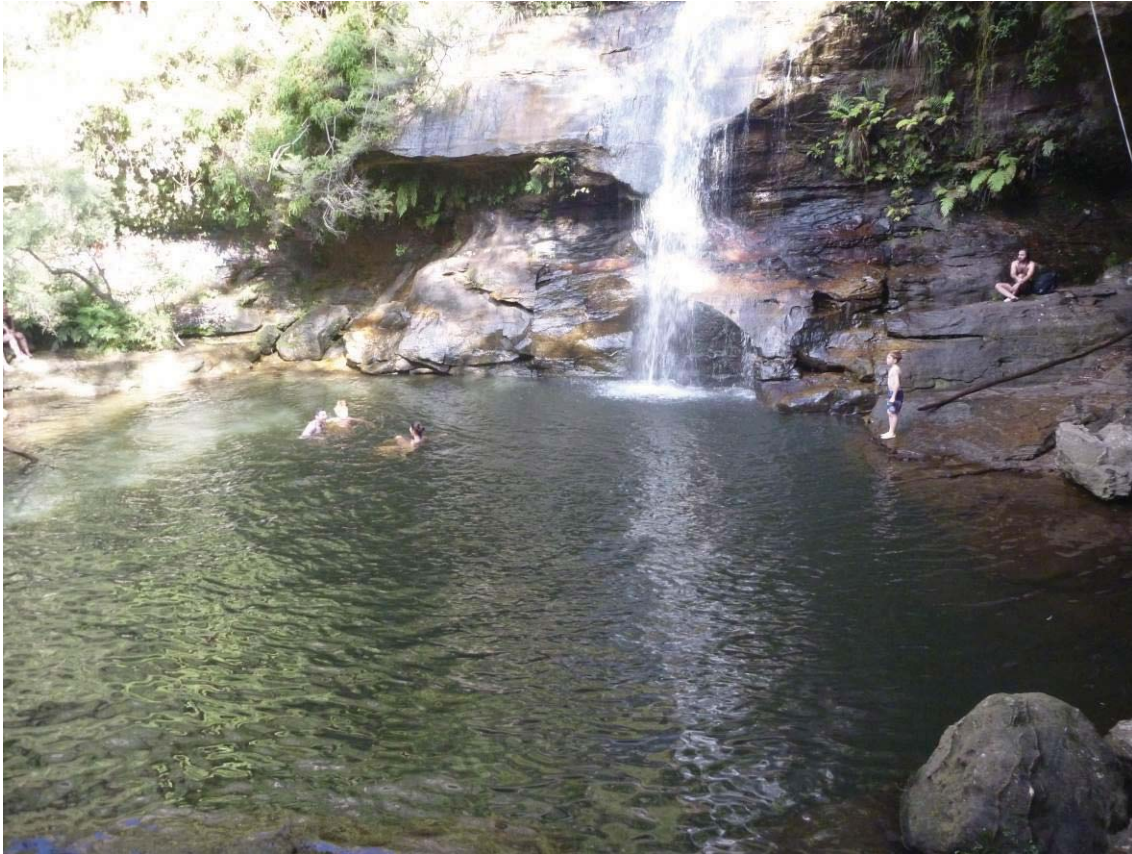
Figure 3. 'Bottomless Pool' at Minnehaha Falls: 1960's, 2006, 2016.

As a result the 'bottomless' pool at the base of Minnehaha Falls has returned and was recently measured at over 30 metres in depth. Through social media and word of mouth it has rapidly become one of the most popular wild swimming holes in the Blue Mountains (Figure 3).

A 1 in 50 Average Recurrence Interval (ARI) storm event provided the final piece to the pool restoration puzzle. For the first time in decades, this large storm event was able to scour out the pool instead of depositing further sediment. Sand pushed out of the pool below the falls was deposited along the creek banks for several hundred metres.
