Detecting cease to flow events in streams using time lapse photography

Patrick Maiden¹, Cheryl Edwards², Peter Lind¹.

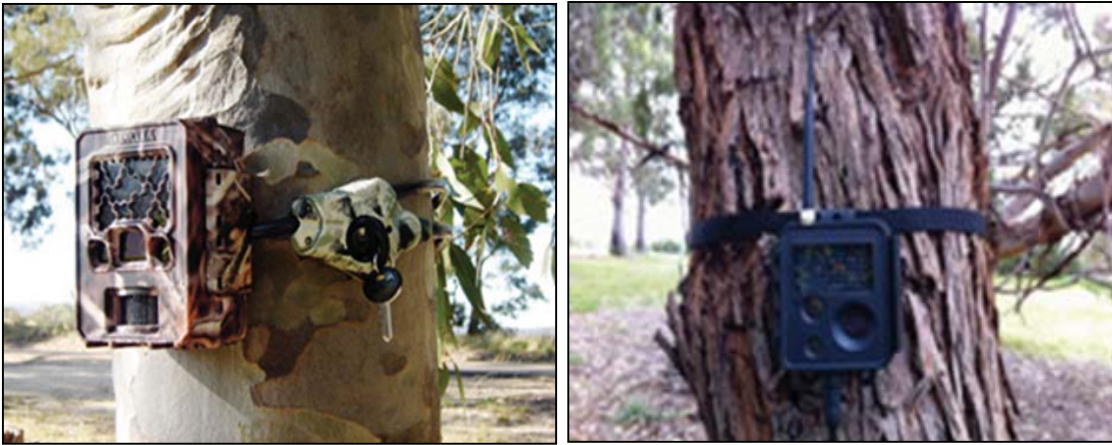
Figure 1. Examples of field based cameras to capture in situ flow levels

The method selected used programmable field cameras installed above or beside the channel, programmed to take photos of the stream showing the water levels on a daily basis (Figure 1). The photos provided a record of the changes in wetted areas in the channel, with the intent of identifying if and when the stream dries up. The cameras were aimed at the area of the waterway that was considered most likely to dry up during a low flow period (i.e. shallow riffle areas, or similar hydraulic controls).

Cameras used were Reconyx Hyperfire HC500 or HC600 (2 megapixel 72dpi image), or a UOV UV564HD (2.5 megapixel, 180dpi). In daylight conditions the cameras took a colour image, whereas in low light conditions, (such as under dense canopy or on overcast weather) the images were monochrome with either a white light or infrared flash (depending on the camera model). Cameras were either mounted on trees or existing structures. If a monitoring site was exposed to public access, a lockable security housing was installed to protect the equipment from theft or vandalism – the loss of images and subsequent loss of monitoring data was considered greater potential cost than the loss of the equipment itself.

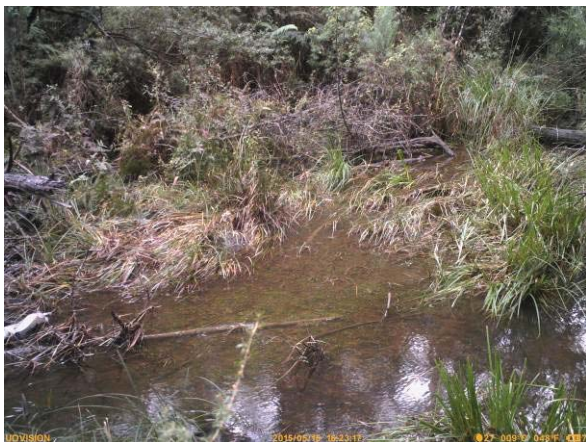
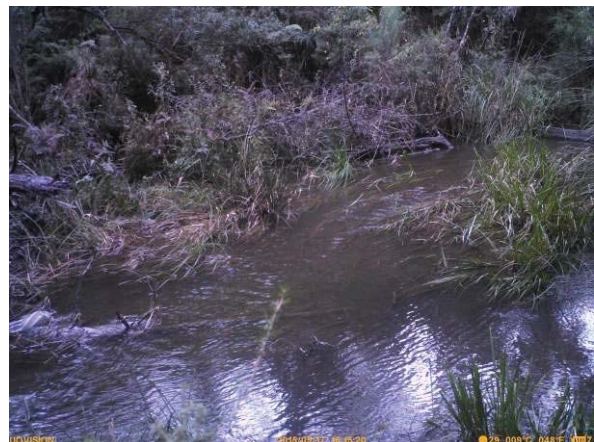
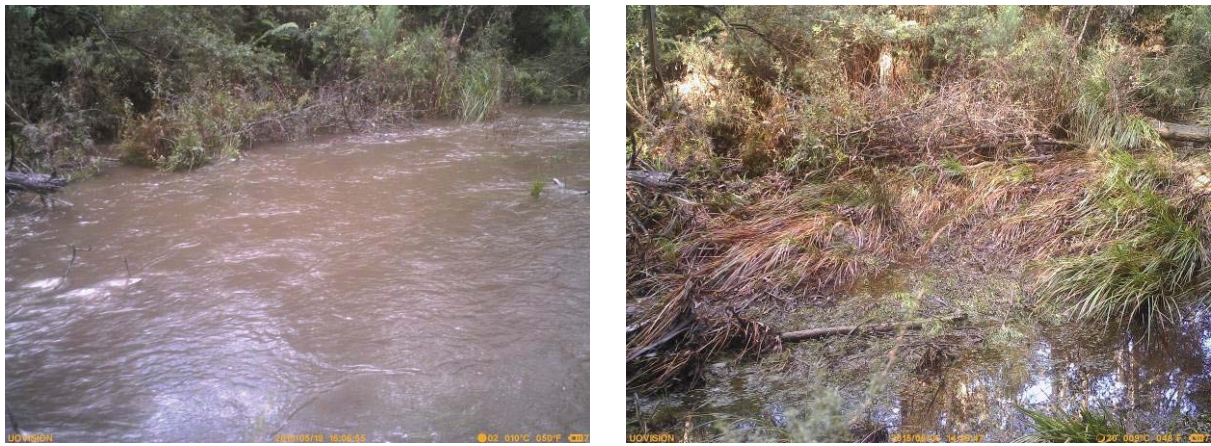
Figure 3. Examples of time-lapse photography for channel engagement monitoring.

Time-lapse photography has also been used for a similar project investigating the engagement of river channels bypassed by tunnels (Figure 3). The cameras were deployed at locations that would confirm whether the bypassed river channel received river flows during a high flow event. The photographic series were compared against the relevant river flow hydrograph, which enabled a determination of the flow required to engage the channel. The use of cameras reduced the time required in the field otherwise required to install flow monitoring equipment sufficiently sensitive to detect range of flow conditions cease-to-flow.
