Managing erosion from vessel wash on a reach of the Murray River

Bowman, H¹. & Small, K².

- 1. Murray Darling Basin Authority**
- 2. Soil Conservation Service**

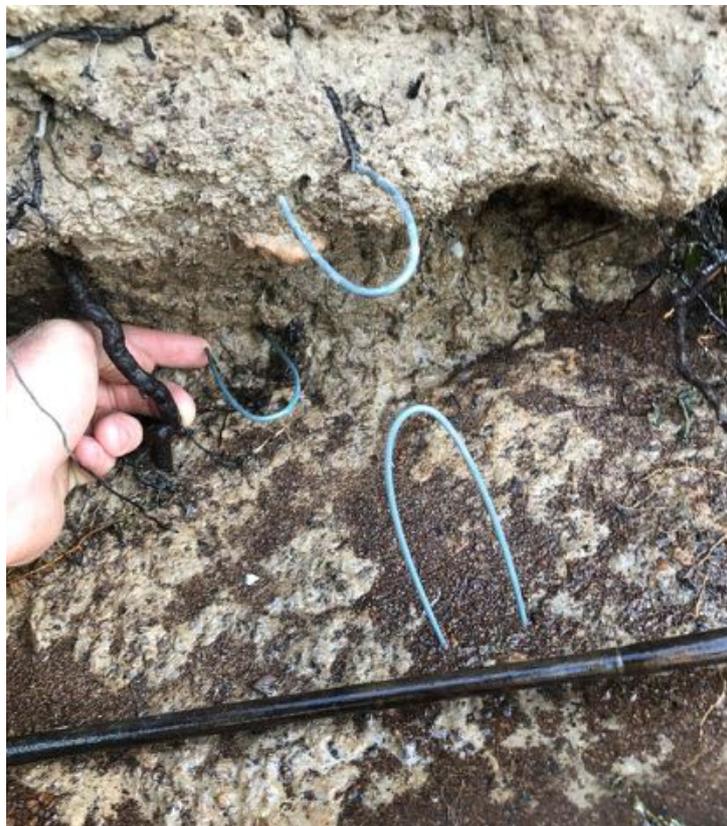
Figure 4. Erosion pins located at water level, 10cm above water level and 20cm above water level. Note the erosion of 1.1cm behind the middle pin in the photo (located at 10cm above water level).

In addition to boat count surveying, erosion pin monitoring was undertaken at six separate locations in the Bundalong area. Erosion pin monitoring consists of driving pins perpendicular to the bank face in line below and above water level so that the top of the pin gives a reference point from which changes can be measured (Figure 4). Three erosion pin monitoring sites were adjacent to boat count survey locations, two additional erosion pin monitoring sites were selected nearby. The final erosion pin monitoring site was selected in the Ovens River where wakeboarding, wake surfing and wake enhancing activities are currently prohibited. Erosion pin monitoring was undertaken overnight (low boating activity period) and during the following day (high wake enhancing activity period) when boat count surveys were conducted. Due to logistical constraints erosion pin monitoring overnight and during the day was undertaken only twice during the 2017/2018 boating season.

Erosion pin monitoring undertaken overnight (during low boating activity) showed negligible change, with no erosion recorded at any site. Conversely erosion pin monitoring undertaken during the day identified erosion at all six sites at and above water level. Erosion rates differed at all six sites, however a maximum retreat of 5cm was observed in a notch at water level between the two busiest boat count survey locations.
