When Perception and Evidence Based Practice Collide – Floodplain and Waterway Management in the aftermath of the 2016 Floods at St Marys, Tasmania

Skipworth J¹ and Buchhorn P²

St Marys is a small town near the east coast of Tasmania which experienced three significant flood events in 2016. The largest event occurred in January 2016 and resulted in extensive damage including above floor flooding to numerous dwellings. The flood event has been estimated to be larger than a 0.5% AEP (1 in 200 year ARI) event and also resulted in significant changes to the waterway through the township.

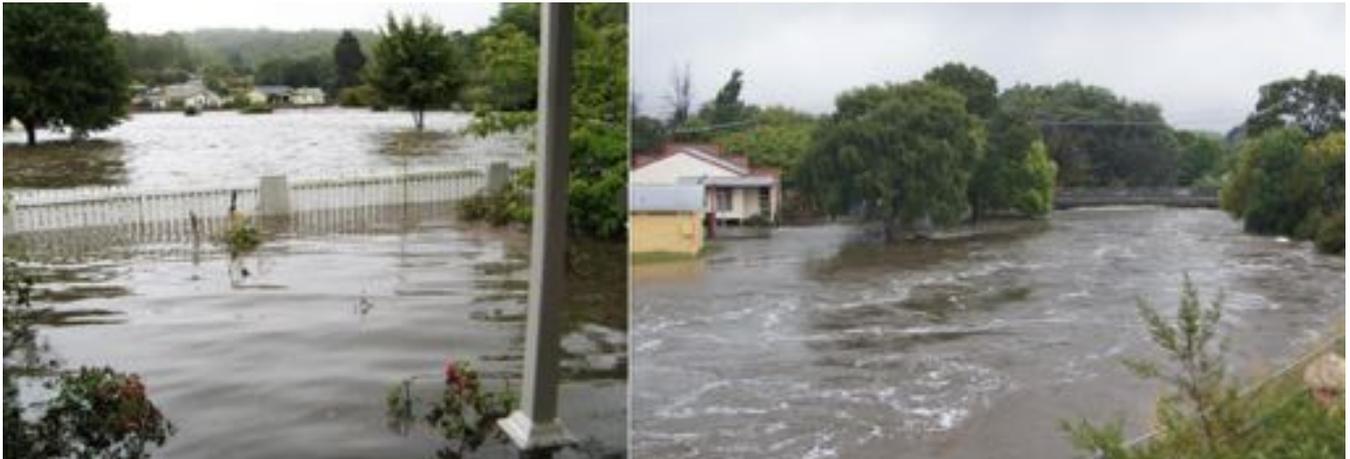
Figure 1. Central St Marys during the January 2016 Flood Event

2016 was a wet year across Tasmania with numerous large rainfall and flood events occurring across the state. Three significant flood events occurred at St Marys with the January 2016 event being the largest. The January 2016 flood event was a result of several wet days and then an extreme burst of rainfall in the early hours of 29th January which has been determined as approximately a 0.2% AEP rainfall event. The resulting flood event resulted in considerable damage to the town, including above floor flooding at several properties.

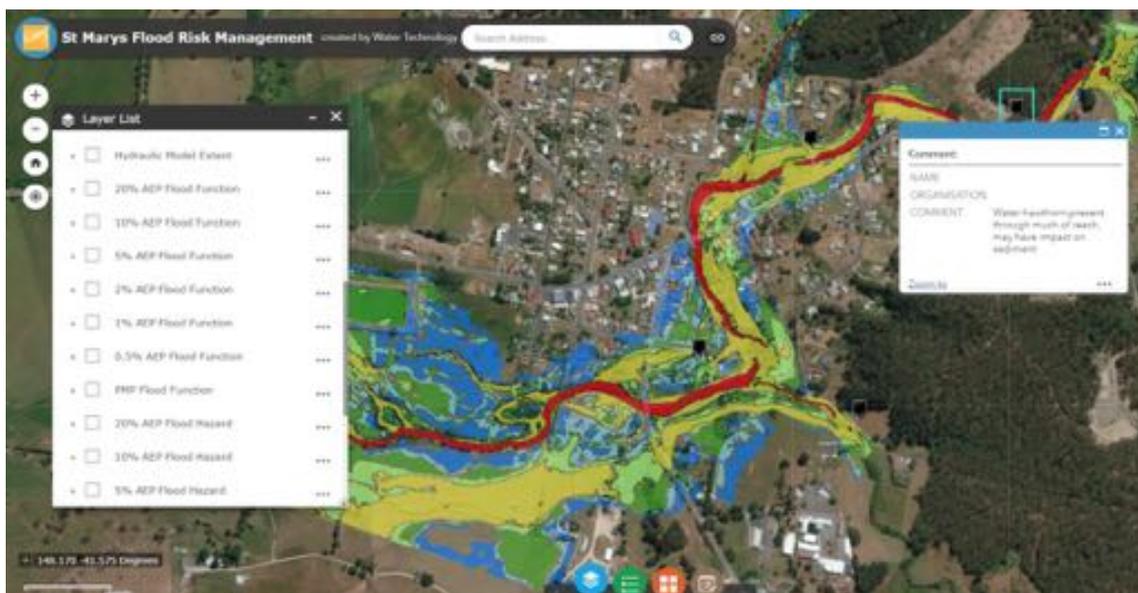
Figure 3. Screenshot from the St Marys Online Mapping Portal

In addition to the consultation described above, the community engagement process was enhanced through the development of an online flood study portal (Figure 3). The portal allowed key outputs of the study to be shared through a “Google Maps” type environment and allowed community members to leave comments and feedback on the findings as well as submit ideas around flood management and mitigation ideas.

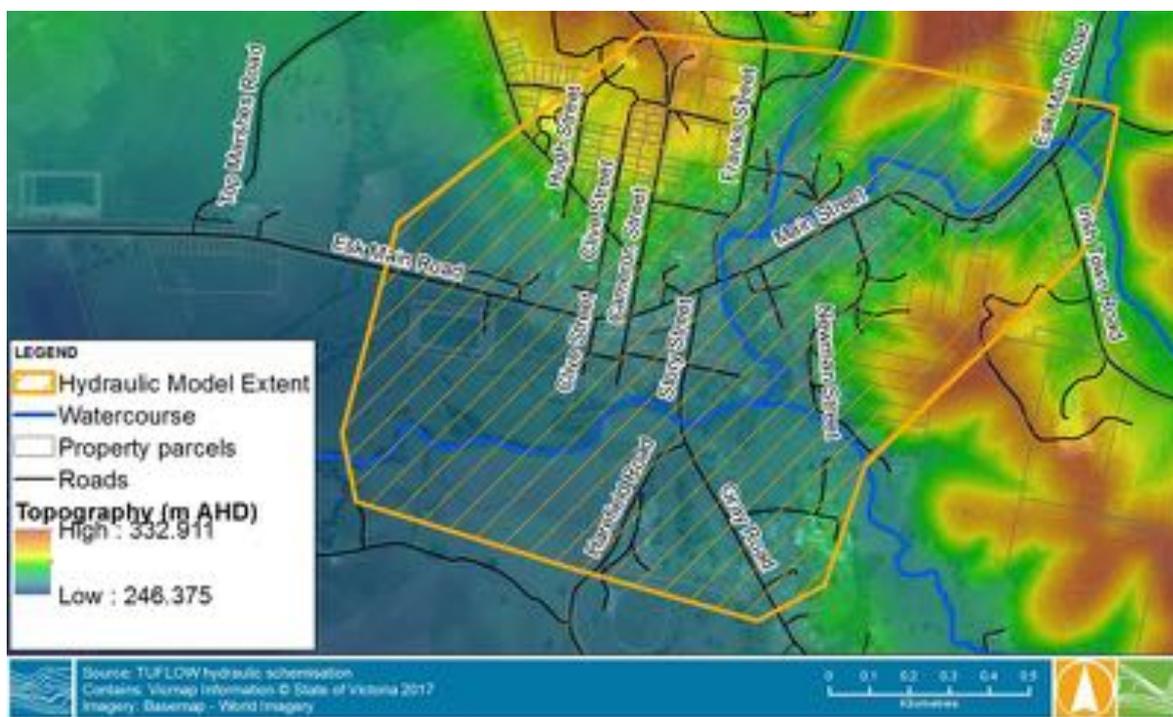
Figure 4. Hydraulic model extent and model DEM (Digital Elevation Model)

Detailed hydrological and hydraulic modelling was undertaken for the project, which was undertaken in line with Australian Rainfall and Runoff 2016. Hydrologic modelling was completed in RORB, while the hydraulic modelling utilised TUFLOW. RORB is an industry standard rainfall and runoff modelling package used widely throughout Australia and was used to determine flows into St Marys, TUFLOW is also widely used and a benchmarked 1D and 2D hydraulic modelling package. TUFLOW was used to determine flood levels, depths and velocities across the township. The hydraulic model extent and DEM (digital elevation model) is shown in Figure 4.

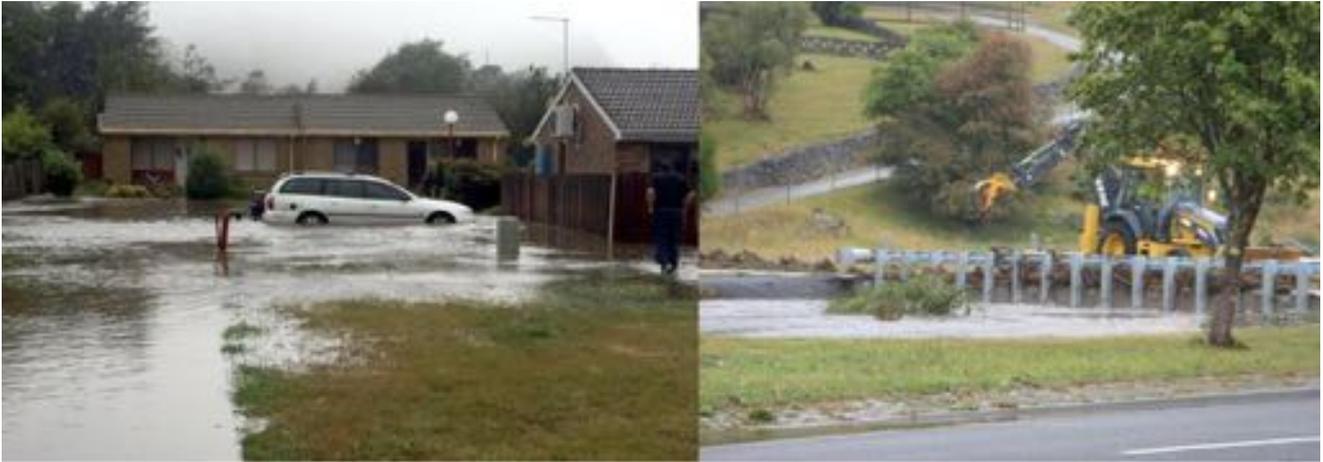
Figure 6. Some of the focal areas of recommended mitigation works - breakouts near Groom Street (left) and flood debris on The Flat bridge (right) during the January 2016 event

Hydraulic modelling demonstrated a ford structure would reduce flood levels in the vicinity of the bridge including down the main street of St Marys and nearby residential properties.

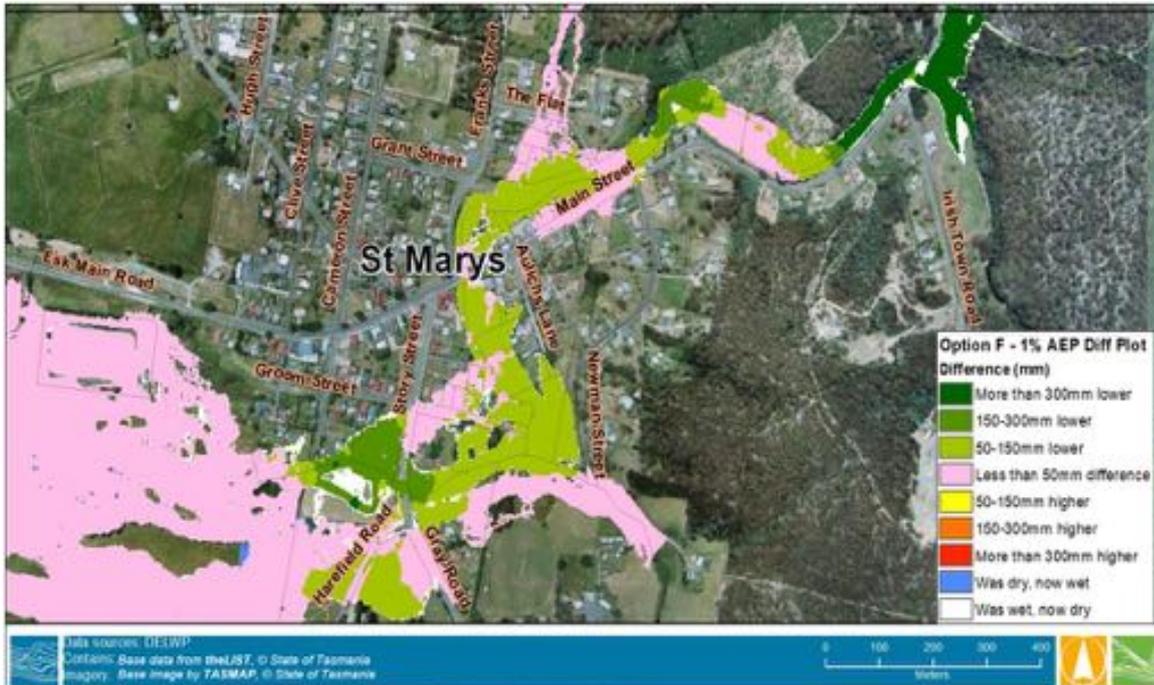
Figure 7. Impact on 1% AEP flood levels with widespread vegetation and debris removal

Several model scenarios were run with varying levels of vegetation clearing, represented by a reduction in hydraulic roughness within the channel and through riparian areas. An example of a difference plot is shown in Figure 7 which compares current 1% AEP flood levels under conditions to an extreme scenario of widespread vegetation along the full length of the rivulet through the township. The results showed that even with such dramatic vegetation works, the flood extent is largely unchanged. There are some localised reductions in flood levels, but residential areas that suffered the most damage largely do not benefit from the vegetation works. The hydraulic modelling helped the community understand the benefits that could be achieved from such works and thus helped inform their decisions around which options should be recommended as part of the plan. It also alerted them to the potential for works to produce side effects and increase inundation risks in places.
