# **Innovative solutions to alluvial gully remediation: a case study from the Great Barrier Reef Catchments**

### *Wearne et.al. -Innovative solutions to alluvial gully remediation in the Great Barrier Reef catchments*

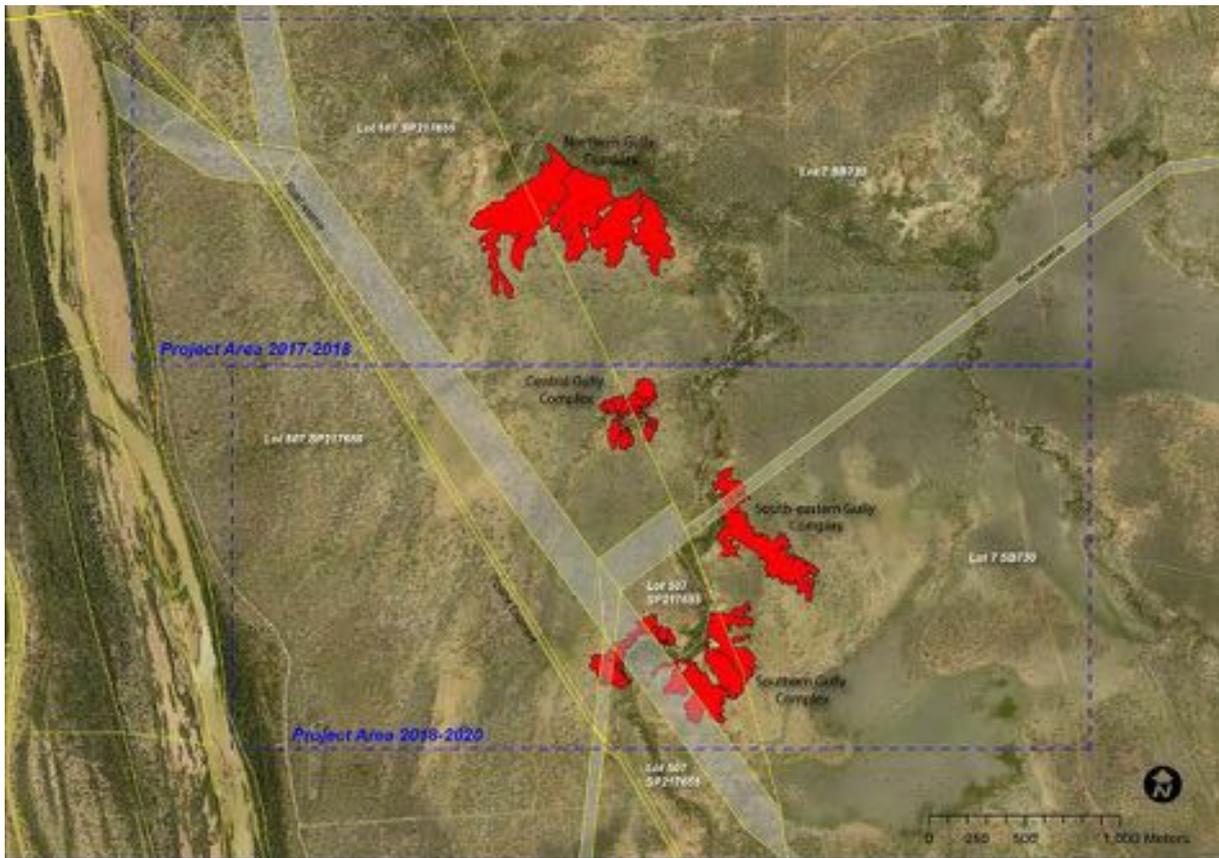
Figure 2 Gully Complex Classification – Project Sites

From this work, three distinct groups of alluvial gully systems were identified (**Figure 2**):

1. The Northern Gully Complex
2. The Central Gully Complex
3. The Southeast Gully Complex
4. The Southern Gully Complex

Initial analysis undertaken through Griffith University as part of the Project (Brooks *et al.* 2017) involved the analysis of high resolution aerial LiDAR data, soil analysis and the identification and classification of major gully complexes within the Project area. This resulted in the identification of the main gully systems which have the highest potential for demonstrating the success of potential treatments in reducing fine sediment export from the Project Area.

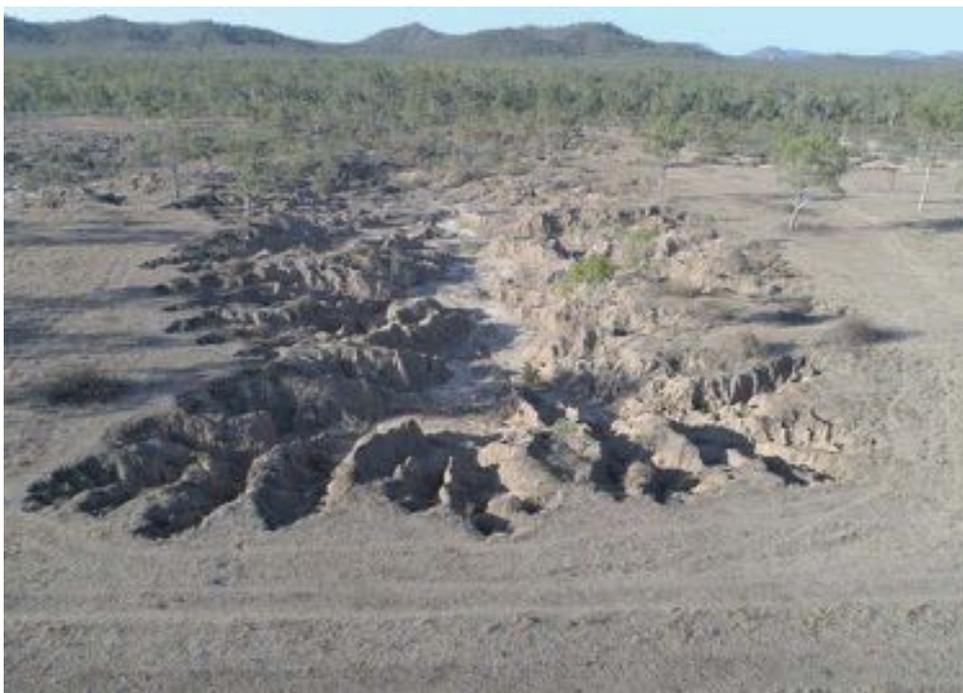
Plate 1 Example of the Northern Gully complex the focus of the current Project

Only the works being undertaken within the Northern Gully Complex form the basis for the current paper. An example of these gullies is shown in **Plate 1**. According to the existing soil mapping, the northern gully complex is eroding into both the duplex and cracking clays, and the fifth gully on the Northern Gully Complex is eroding into the cracking clays.

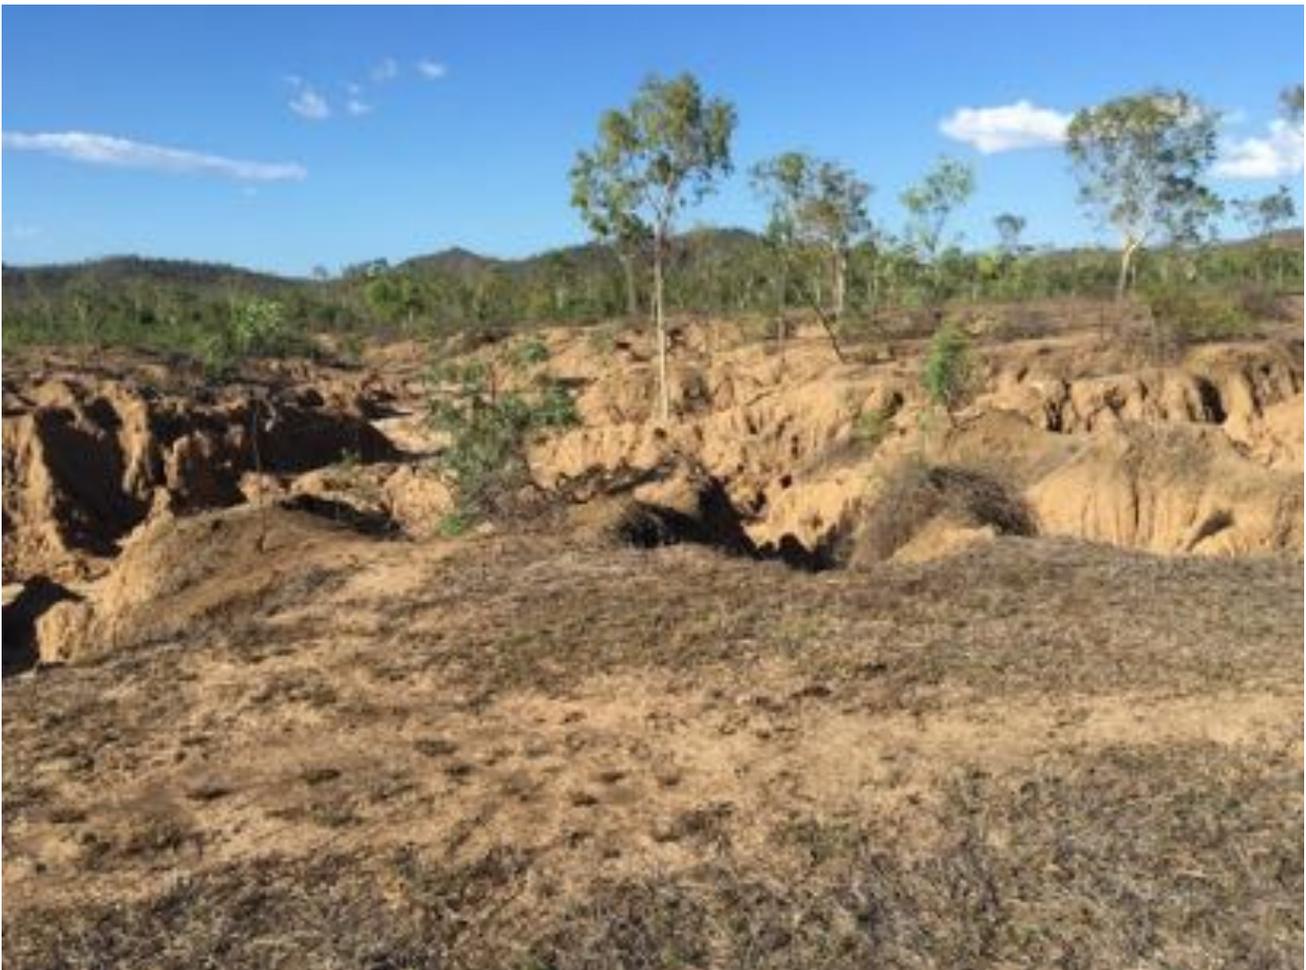
### **Plate 2 Alluvial gully prior to treatment 1 remediation works**

Treatment 1 involved the extensive reshaping and regrading of a heavily incised alluvial gully of 1.2ha. **Plate 2** shows the gully prior to treatment, the following photo sequence in **Plate 3 (a-d)** outlines the approach used. In treatment 1, the heavily incised gully area was initially regraded to a pre-designed landform (**Plate 3a**). Supervision and monitoring during the works stage ensured a balanced cut and fill, therefore reducing costs and earthworks in these large alluvial gullies. The second stage involved capping with a 200mm thick layer of rock and soil from the quarry which occurred following the application of gypsum (18t per hectare) and ripped into the prepared surface (**Plate 3b**). All batters and disturbed areas were mulched (which was seeded with Rhodes grass) following construction works (**Plate 3c**). To ensure sufficient ground cover of the treated gully area, the entire site was re-seeded with Rhodes grass after rain in March 2018 (**Plate 3d**).

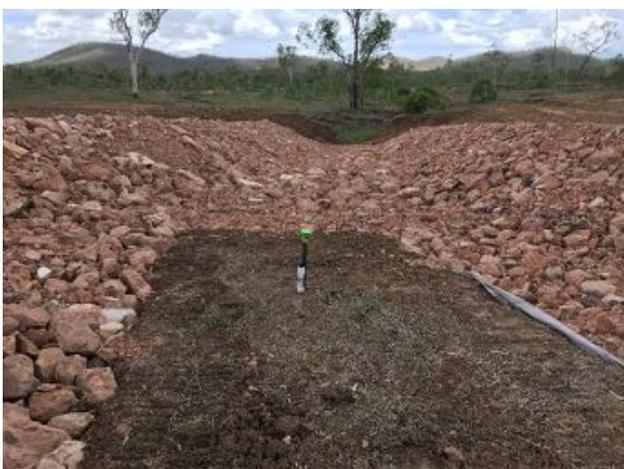
**Plate 4 The rock chute at Treatment 5**

The construction of a rock chute as part of Treatment 5 was designed to stabilize a rapidly retreating gully knickpoint and partial diversion of catchment flow from Treatment 1 down through the chute structure (**Plate 4**). Further work on the gullies below this point are planned for 2018 now the gully head has been stabilised. The rock chute was constructed by excavating material and keying rock into place such that the surface of the rock forms the design surface. All rock, except for rock forming the cut-off walls of rock chutes was underlain by granular filter material, to reduce the leaching of fines of the underlying material and to form a bedding surface into which the rock can settle. The cut-off wall located at the crest of rock chutes was encased with geotextile to provide resistance to flow through the rock beaching and to reduce the leaching of fines of the underlying material.
