Maribyrnong River Erosion Control Project – Floating Boom Trial

Zoe Samson¹ and Michael Bain²

1 Melbourne Water, 990 Latrobe Street Docklands VIC 3008

2 Alluvium, level 1, 105-115 Dover Street Cremorne VIC 3121

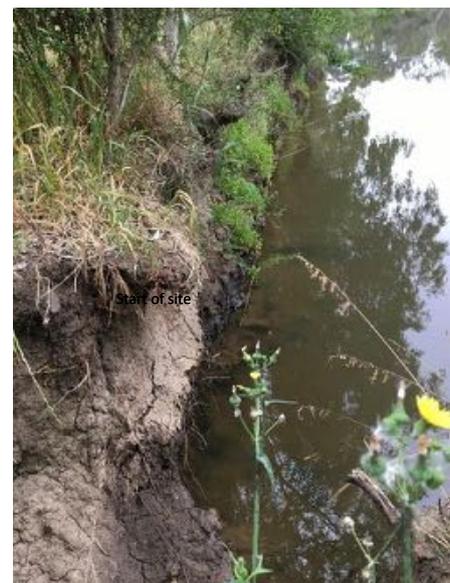
The bank is actively retreating in the study reach, with isolated pockets of retreat observed throughout the reach (refer Figure 2). Tension cracks were observed at several locations, indicating mass failure of the steep bank is a primary cause of bank erosion and retreat.

Figure 2. Example of mass failure and bank retreat at subject reach

It was determined that the principal erosion mechanisms were (i) cracking associated with wetting/drying and (ii) undercutting from wave action.

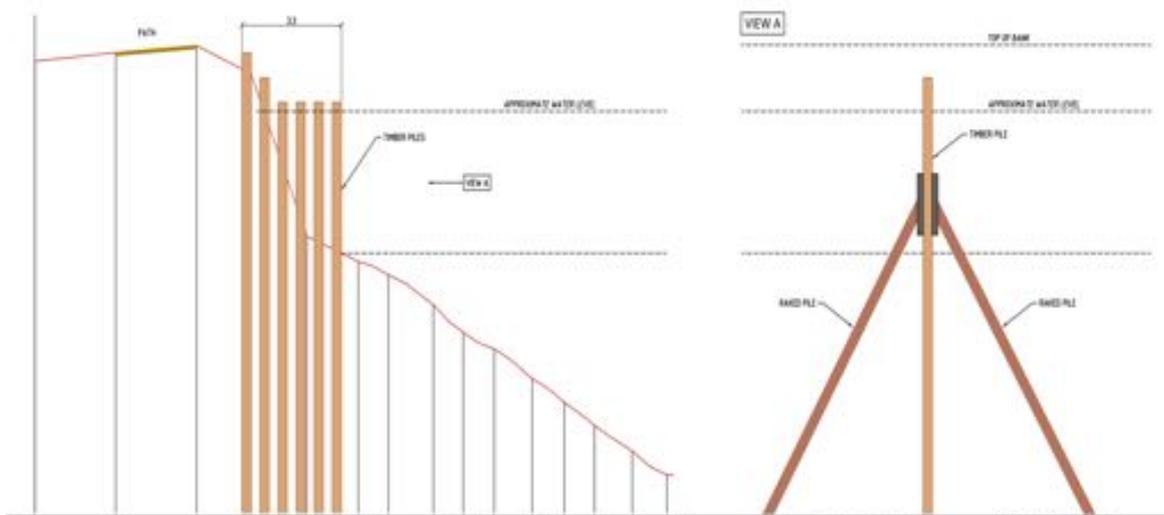
Timber pile fields are a common approach to achieve bank stabilisation in rivers that are experiencing bank erosion due to fluvial processes. The pile fields are installed perpendicular to the flow providing resistance to flow and deflecting the faster flow towards the middle of the waterway. The reduction in flow velocity at the pile field allows sediment to be deposited along the bank, thereby reversing the erosion trend, and facilitating vegetation establishment.

Figure 3. Example of a pile field design

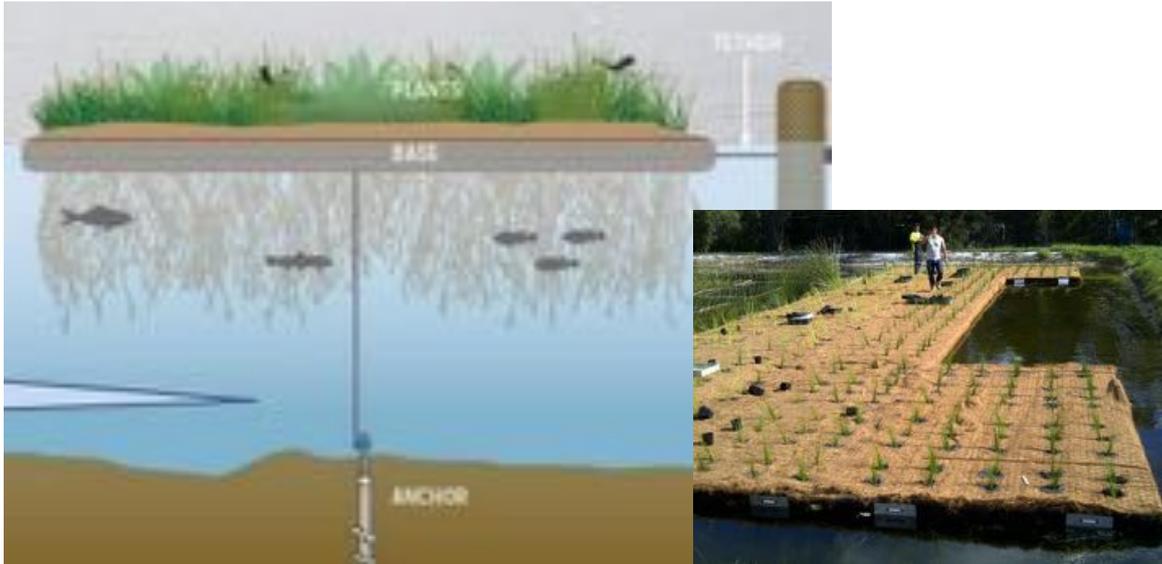
They are made up of a multi-layered low density base that floats on the water surface. Plants are introduced to the upper part of the base with their roots growing down through the base and into the water column.

Figure 4. Example of a floating wetland design

The floating wetlands would be tethered to the bed of the River, near the bank. At normal and low water levels, the wetland is able to have move towards, or away, from the bank to the extent of the tether cable. Similarly, it could move upstream or downstream in response to flows and tidal movements. The floating wetlands can be installed from a barge on the River, without any need for machinery on the weak soils of the bank or pedestrian path.

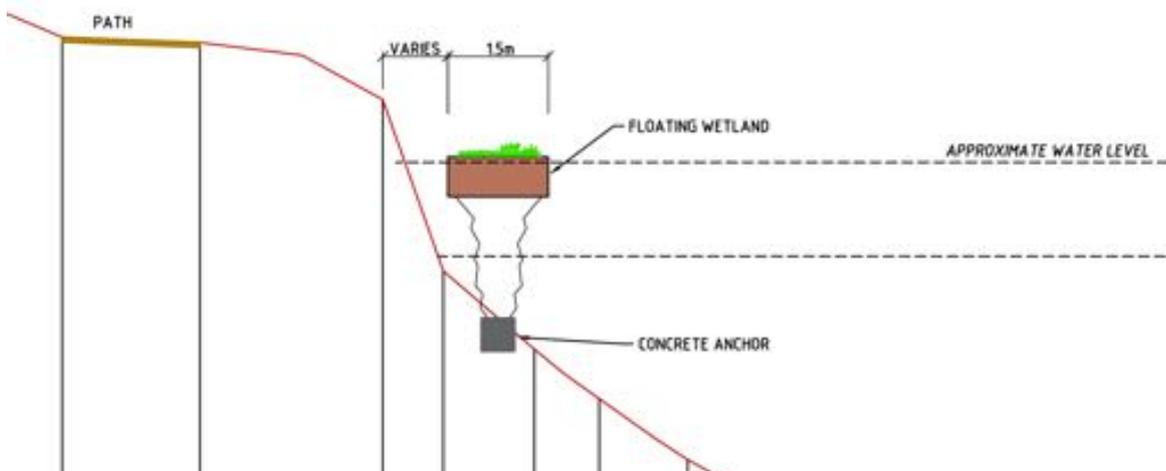
Figure 5. Example of floating wetland design

- To reduce the potential cross flow currents, eddies and waves from boat wash an open mesh skirt would need to be installed on the underside of the base. This can be complex to achieve and potentially destabilising for the floating wetland.
- Floating wetlands may also represent a hazard where a person or animal try to access the wetland from the bank.

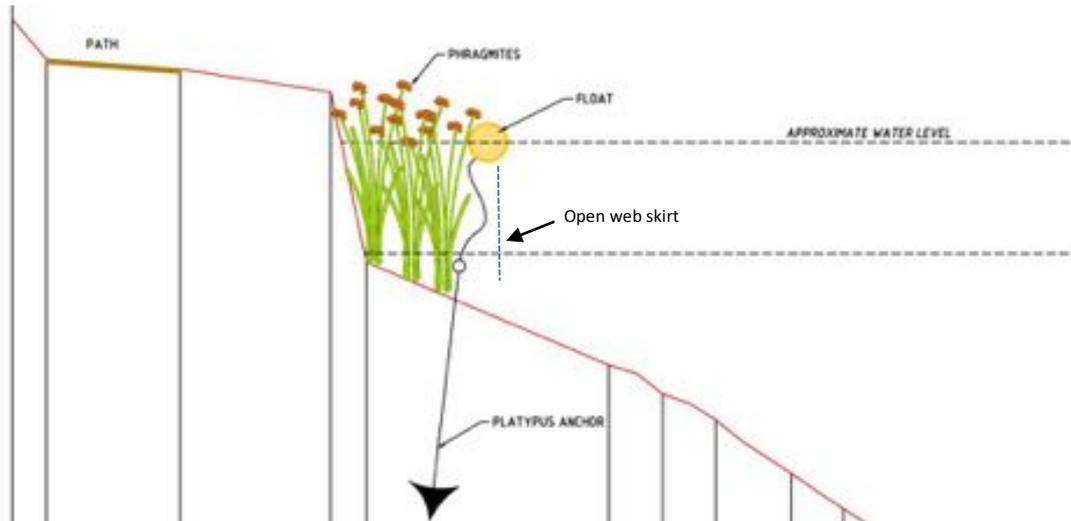
This option is similar to that of the floating wetlands, except that it uses a pipe boom instead of the wetland. The boom is laid out parallel to the bank and anchored to the bed with a slack tether cable. It has a geotextile skirt attached to it that is weighted to hang vertically in the water column.

The floating boom provides an isolated area of less turbulent water near the bank where vegetation can be established. Semi-aquatic vegetation is placed against the bank, behind the boom. The vegetation should quickly establish roots in the soft alluvial materials at the base of the embankment.

Figure 6. Floating boom cross-section

Each floating boom segment is fitted with a flexible skirt, 0.8m long. The skirt is a woven geofabric material that has a high tensile strength. It is weighted to hang vertically in the water column, but can lie on the river bed when water levels are low. The weight in the skirt also sets the float height in the water which is set to have about two-thirds of the float above the water level.

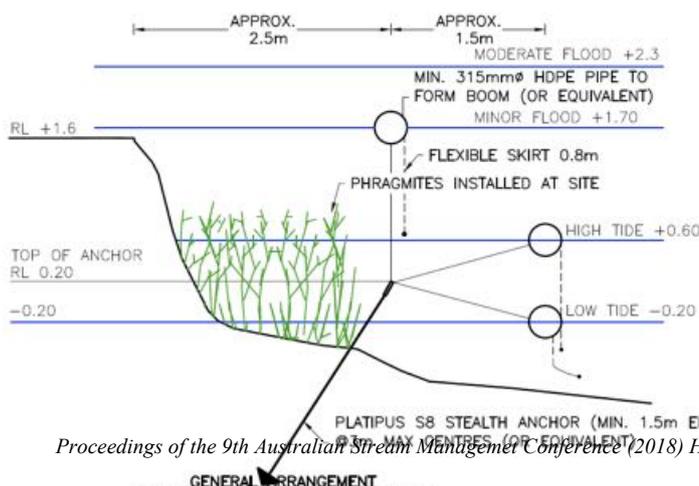
The floating boom is a sealed HDPE pipe, made up of 6 metre lengths with hinged joints, aligned adjacent to the left bank. It is anchored to the river bed via a tether allowing it to move up and down with the water level in the river.

This means that the lateral position of the boom is not fixed. It will be vertically above the anchor point when the water level is high enough to put the tether into tension, but can move laterally at lower water levels due to slackness in the tether. The risk of the boom moving into the vegetation and tangling or damaging it had to be considered.

Figure 7. Floating boom general arrangement

Also the anchor and boom system had to be designed for flood events when the boom was held below the surface of the water with high buoyancy forces, in addition to the fluvial loads.

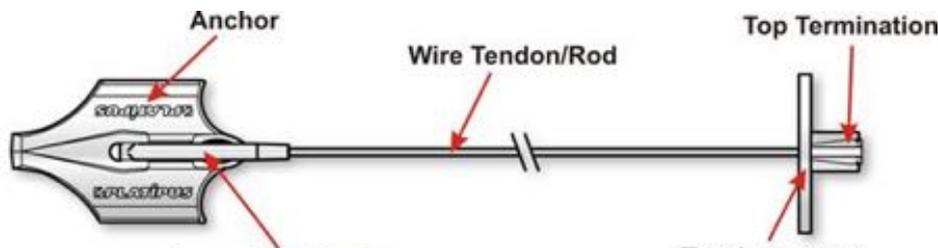
The anchors needed to be simple to install underwater, but be able to sustain the maximum uplift forces in the weak alluvial soils. We elected to use a platypus anchor system that has been developed for this type of application. The anchors needed to be installed at 3 metre intervals to ensure the load capacity was not exceeded while maintaining an adequate factor of safety.

Figure 8. Platypus anchor design

There is a risk with these types of systems that if one anchor fails the load is shed onto the next anchor which may then be overloaded and fail itself, leading to a cascade failure of the whole system. This is addressed by using a large safety factor of greater than 2, but also by installing large concrete mass anchor blocks in the bank at each end of the floating boom. These blocks are designed to resist the total drag from the whole length of the pipe. Thus, in the case where all the platypus anchors fail, the system cannot be carried away down river.

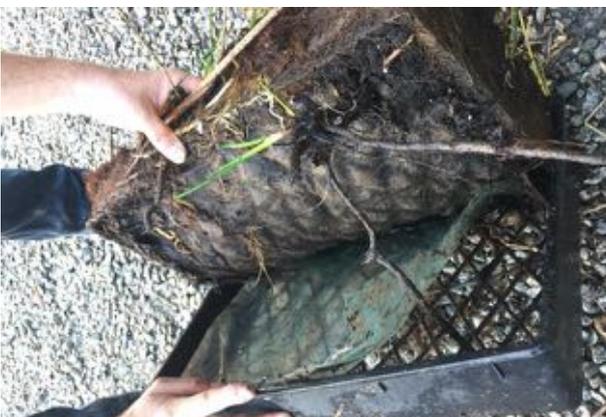
In order to prepare the plants for delivery directly to the riverbed the plants were grown as 'slabs' in plastic multipack trays (refer Figure 8 below). The aim was to have the trays filled with dense active roots that would hold together once the tray was removed at planting. Each plant slab was staked into the river bed with a single hardwood stake. A 1.5m gap was maintained between each slab to allow sufficient space for the vegetation to expand and colonise the site.

Figure 9: Multipack tray format proposed for seedlings
