Maintenance of WSUD Assets – “The good, the bad and the ugly”

Niloo Tara¹, Cath Thrupp²,

Abstract

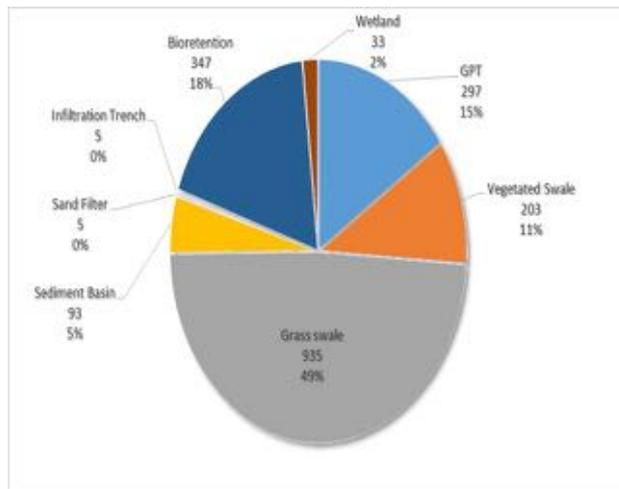
Figure 1: WaterSmart Asset type distribution in BCC

Overall, within Brisbane Local Government Area (LGA) over 4000 watersmart assets are registered, with a diverse range of systems and sizes. Of these assets, about 50% are belong to BCC. Currently the asset register include 1918 assets of approximately 90% of the assets have been surveyed. Below Figure 1 presents the asset type distribution for the assets that are management by BCC and the Figure 2 shows the condition of most common watersmart asset types in Brisbane.

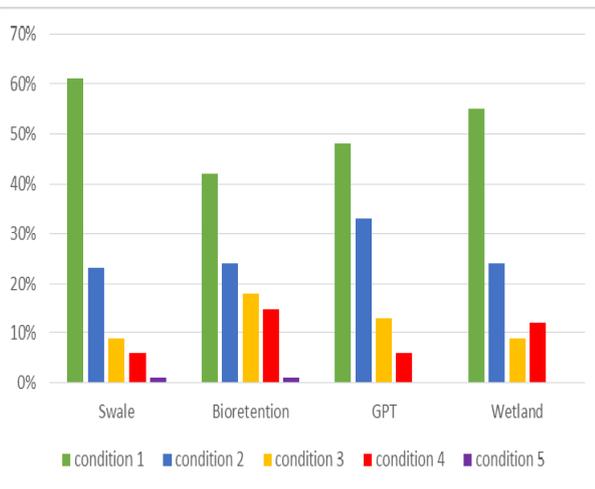
Figure 2: Asset condition assessment results

Approximately, 20% of the assets are not in functional condition (4 & 5) and majority of these assets are bioretention systems. The majority of swales (vegetated or turf) are in good condition. Wetland are generally operational but most of them are functioning as lakes, not a wetland. Currently the Council maintenance budget for Watersmart asset maintenance is around \$2.2 M which is predominately spent on GPTs and trash racks. The development of an asset database and condition assessment for each asset enables council to request for additional funding for maintenance of these assets. It also enables Council to also streamline and improve processes and working relationships between different parts of Council.

The high portion of assets in condition 4 and 5 initiated a new program of works in BCC which focused on rectification and rehabilitation activities for these assets. These assets, in their existing condition are not performing the role they were designed for and generally require a substantial redesign to become functional. This new program is called "Schedule 84: Rectification of WaterSmart assets". The following section explains the program objectives and policy linkages of this program.

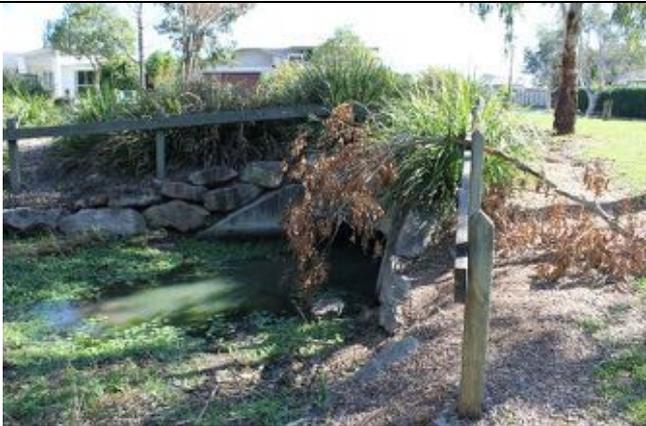
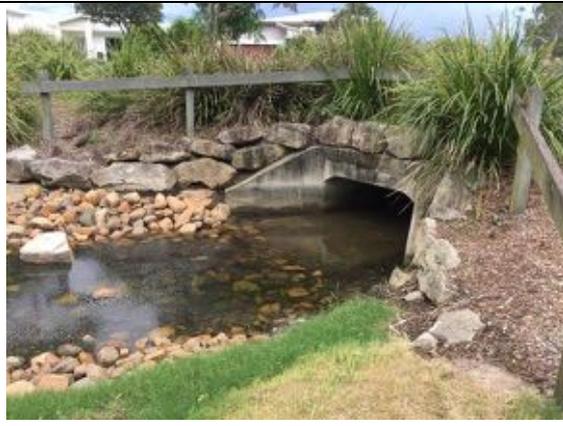
- Ponding water at the inlet;
- Algal biofilm in low flow channel;
- Low flow channel not adequately conveying low flows to the outlet;
- Build-up of sediment in low flow channel;
- Potential blocking of outlet pipes due to gross pollutants; and
- Weed infestation and encroachment of planting within the basin.

Before	After
Inlet arrangement with ponding water

- Desilt the swale and regrade the channel to improve the drainage;
- Planting within and on the banks of the swale;
- Clear the sediment build up and weed growth;
- Improve the drainage by providing subsoil drainage; and
- Change the outlet grate.

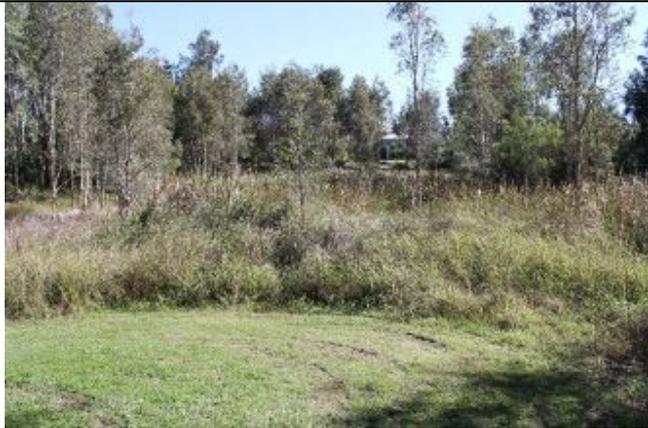
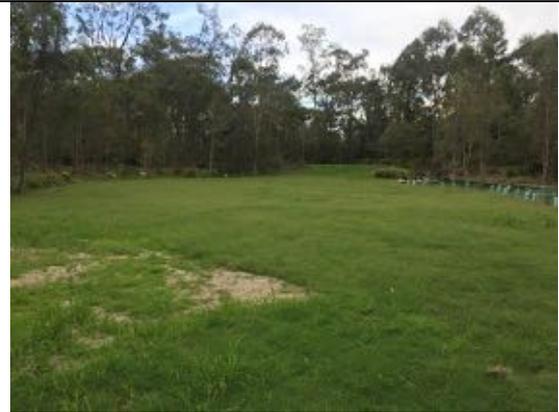
Weed and vegetation establishment within the detention basin.

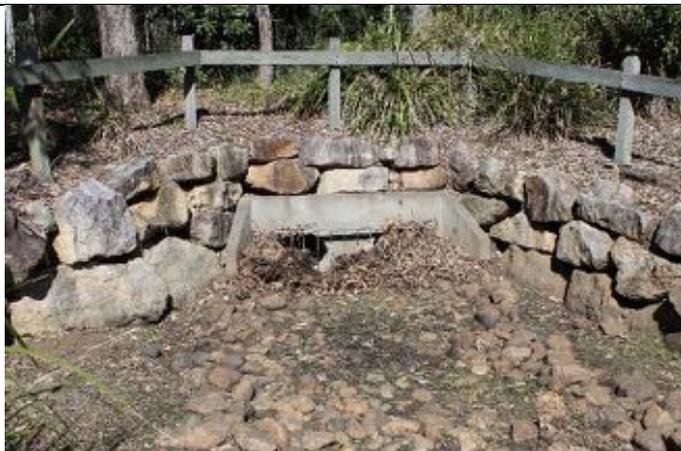
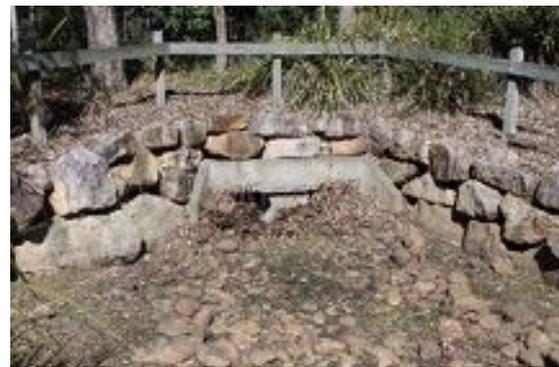
Outlet arrangement showing leaf litter build up

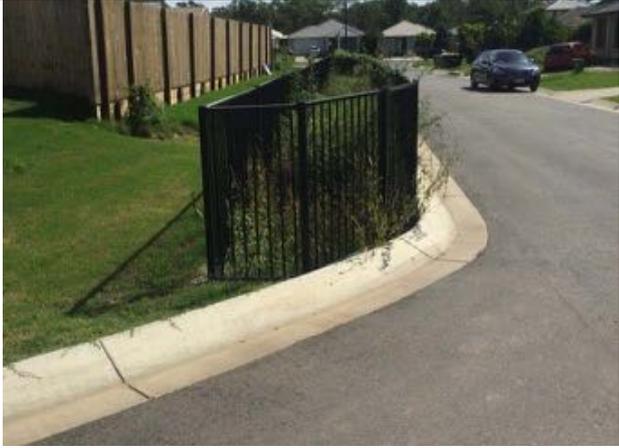
- Aesthetically displeasing and unsafe pool fencing around systems (visual impairment);
- Visibility and safety risk for motorists;
- Difficult to access and maintain; and
- Overgrown with weeds etc.

Before	After
<p data-bbox="134 607 778 674">Pool fencing around the system due to the drop from the kerb</p>

- Remove the pool fencing;
- Remove the mountable kerb and replace with flush kerbing;
- Provide a field inlet cover to each inlet ;
- Fill the system with topsoil and grade the system toward an outlet to function as a swale

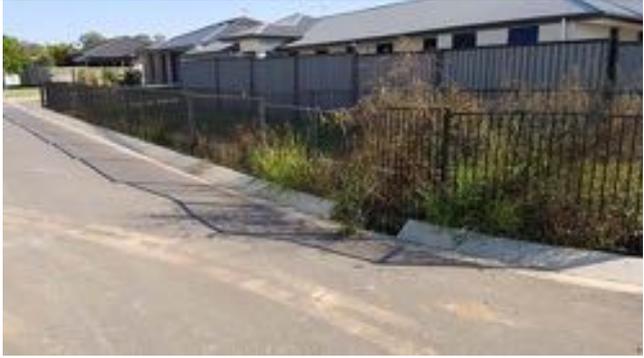
<p data-bbox="134 1189 778 1256">Weed and vegetation overgrown in bioretention basins</p>

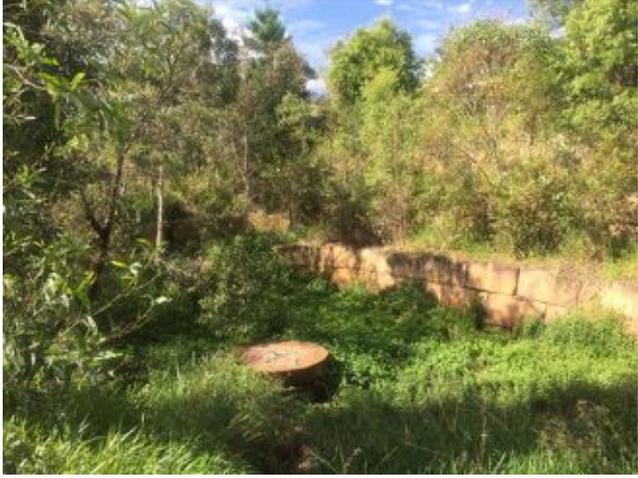
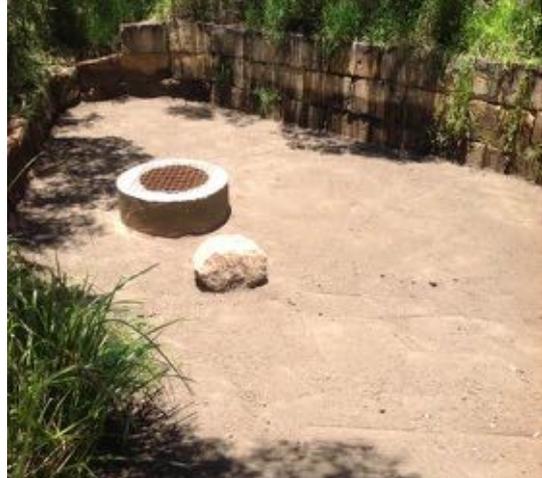
- Excessive extended detention;
- Clogged filter media;
- Devoid of plants;
- No inlet scour protection, energy dissipation measures or flow spreaders;
- Large set-down from inlet pipe to filter media finished surface; and
- Standard outlet pit grate that could be prone to blockage.

Before	After
Weed infested bioretention	Cleared system during construction

- Remove the weeds;
- Remove the Geofab covering the surface of the bioretention;
- Reduce the extended detention depth by lowering the outlet;
- Place outlet protection;
- Change the outlet to a dome type ; and
- Replant the system by adding nutrient to the soil.

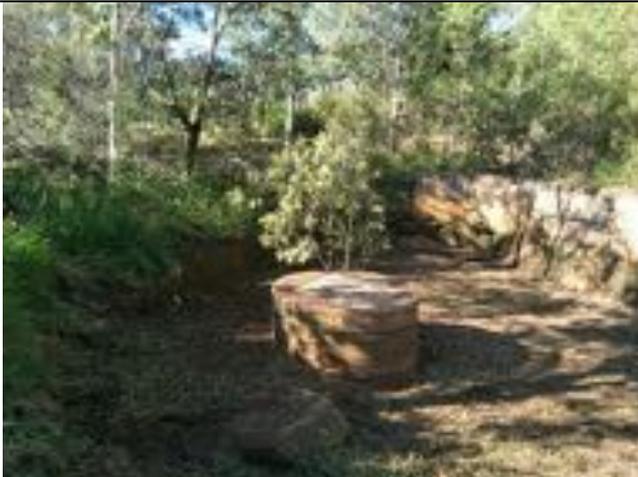
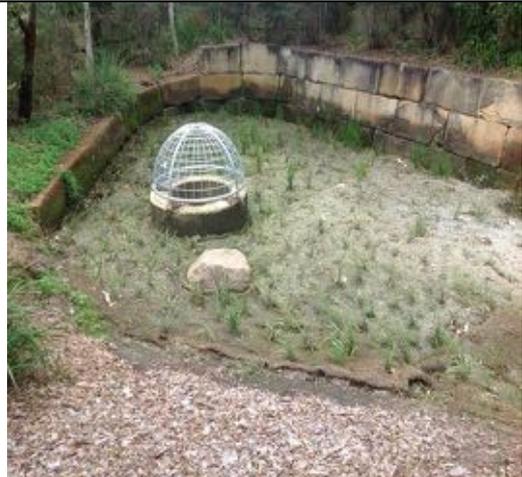
Outlet type changed from flat to Dome to improve overflow

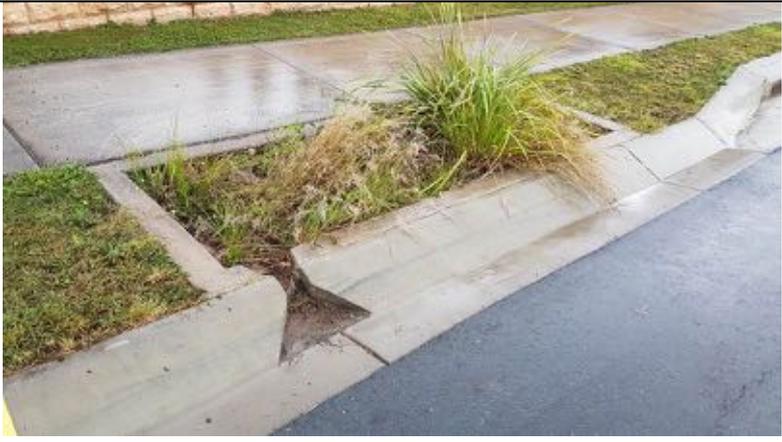
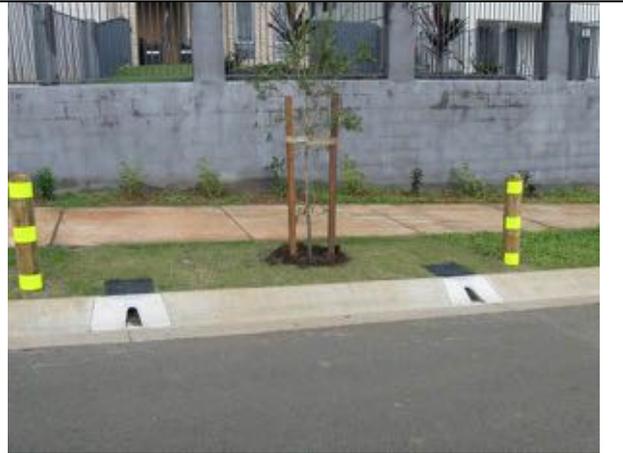
- Sediment build up at the inlet;
- Excessive weed growth;
- Stormwater gully located just upstream the system; and
- Steep street 4%>.

Before	After
<p>Weed infested bioretention</p>

- Decommission the systems that has a stormwater gully just upstream; and
- Refunction the system from a bioretention to a self-watering garden
