Challenges of improving the connectivity of an abandoned Yarra River water course

Roberts A¹, Robertson D²

1 GHD, 180 Lonsdale St Melbourne, 3000, ashley.roberts@ghd.com

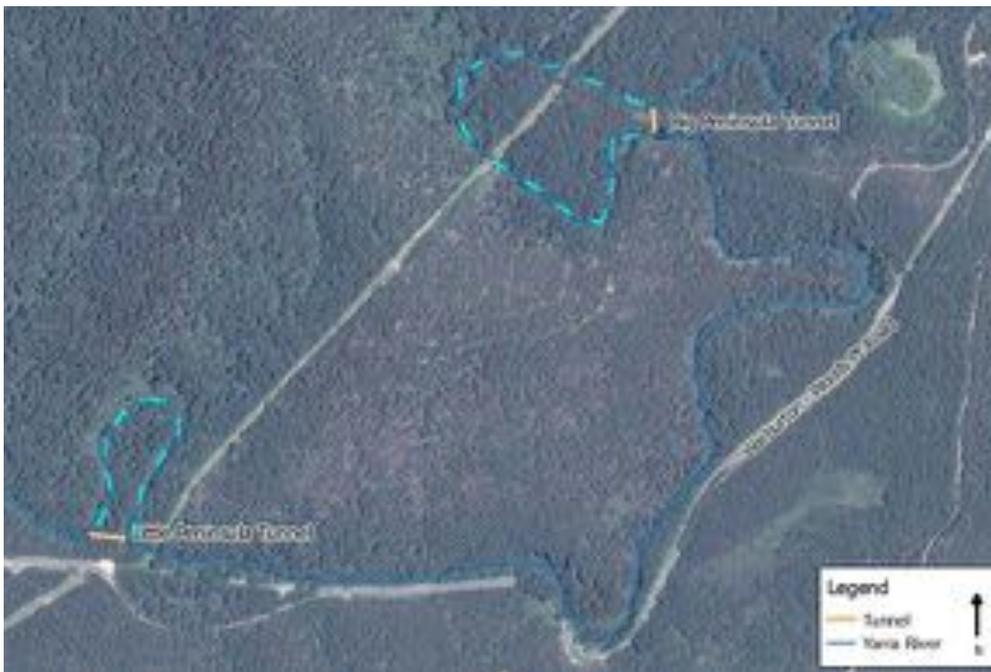
Figure 1. Locality plan – Big Peninsula & Little Peninsula sites

An investigation was undertaken to consider the benefits and assess the feasibility of reengaging sections of Yarra River, cut off by the creation of the Little Peninsula Tunnel and Big Peninsula Tunnels on the Yarra River. The sites are located on the Yarra River downstream of McMahons and Armstrong Creek. The locality plan in Figure 1 below indicates the locations of the tunnels and abandoned channels

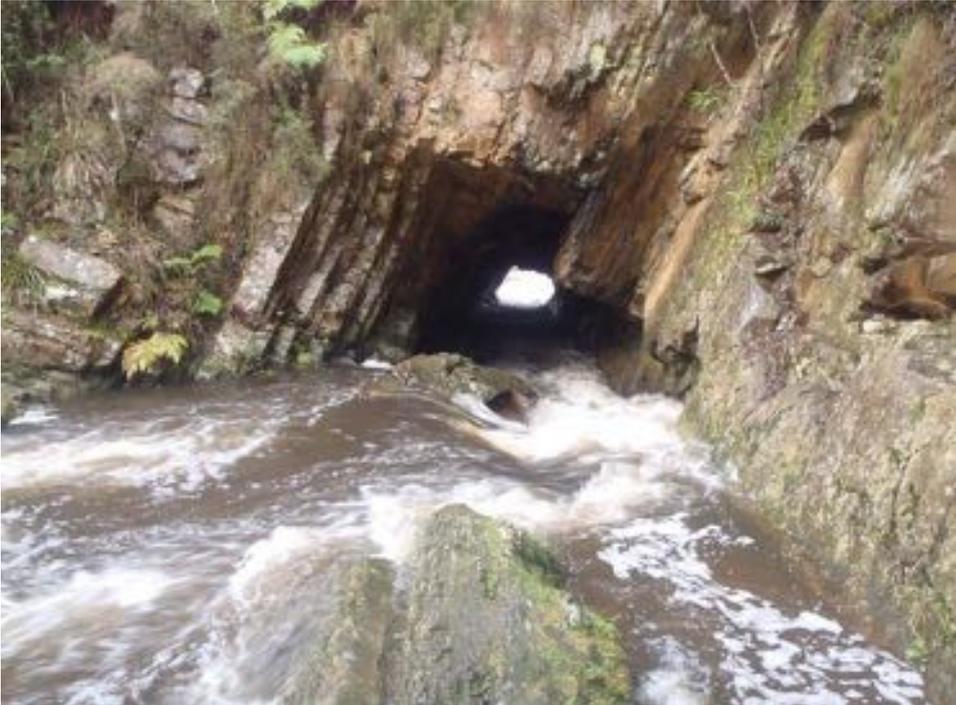
Figure 2. Yarra River, Big Peninsula Tunnel River, Big Peninsula Tunnel

A recent project of a similar nature became bogged down in controversy with a number of community groups opposing the project, leading to significant delays and reputational damage to the government authority. Given the similarity of the environmental objective of fish passage competing against the social value and heritage of the historical diversion, this has led to a cautious approach with the design in terms of not modifying the “normal” flow regime to the tunnel (refer to Figure 2). To avoid potential community backlash

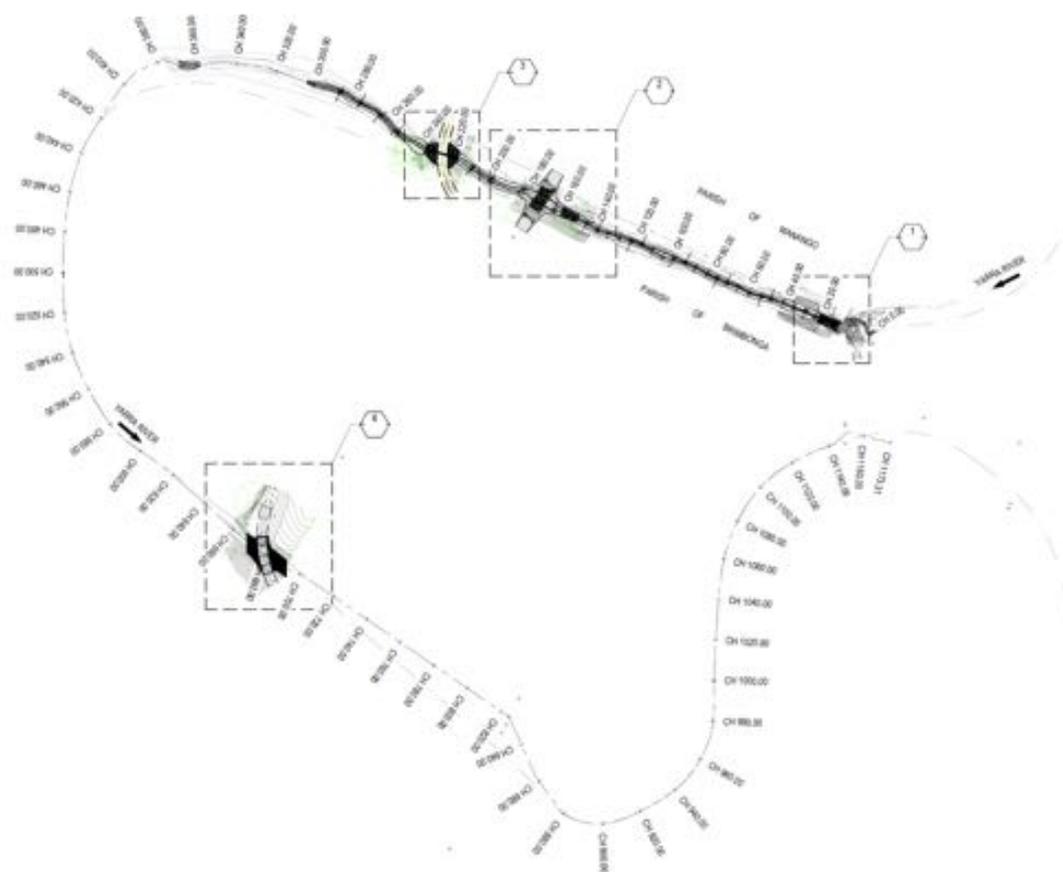
Figure 3. – Yarra River Re-engagement Works (Layout)

The design of the reengagement works included the weir connection configuration as well as the various discrete works required to achieve the hydraulic through flow. The works as presented in Figure 3 and 4 were required as part of the design, and further described following:

Site 1 - Side cast weir works– The effective side cast control was configured and formed as a graded rock structure with rock rip rap to protect from erosion and be fish passage friendly. To achieve this the weir control and channel width was limited to 1.0 metre base width to create more favourable depth conditions whilst still achieving the targeted effective inflow.

Site 2 -Pipe track crossing works #1 (including MWC Yarra Valley Water Main Water protection) – The bed of the channel over the MWC Water supply pipeline needed to be lowered by over 1000 mm, which then required protection of the MWC pipe and maintain a minimum cover of 800 mm. To achieve this the design included 300 mm concrete encasement for length of water supply main pipeline, 200 mm bedding on top of concrete pipe encasement with rock beaching of 300 mm thick to surface of the bed

Site 3 - Lowering of pipe at access crossing - The existing culvert pipe invert level at the access road crossing was 600 mm above the proposed lowered level at the pipe track crossing. The pipe was replaced with a culvert (600 mm x 400 mm) matching the re-profiled bed levels and preferred from a fish passage perspective.

Site 4 - Pipe track crossing works #2 – The works included formalising the ford crossing arrangement as well as providing rock protection of the access road crossing and pipe crossing from erosion due to increased flows and more frequent periods of inundation to be expected.

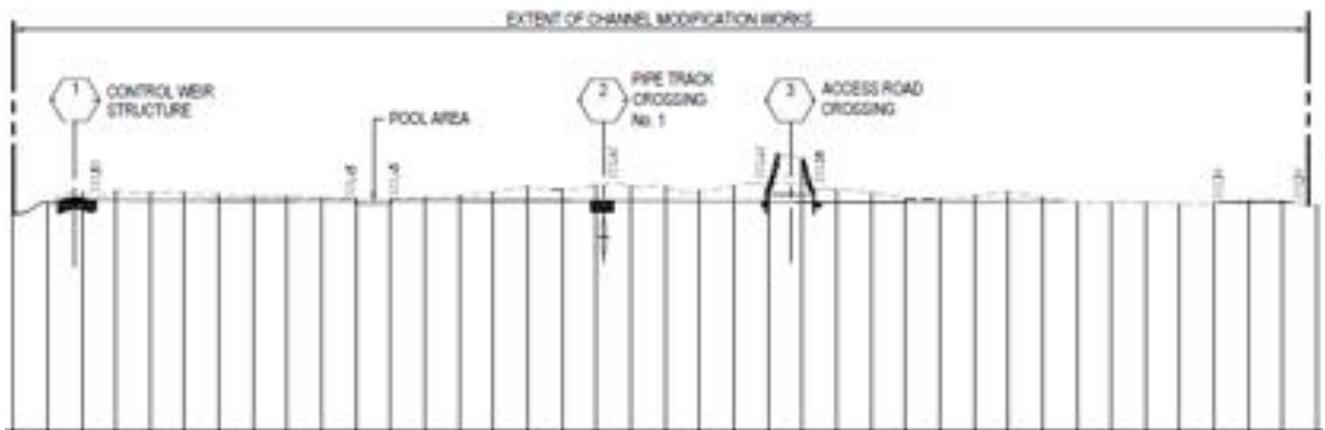
Figure 4. – Yarra River Re-engagement Works (Reprofiling)

Meander loop channel profiling (including pipe track crossing) – Channel profiling works were required over 300 m as to complete the connectivity of the flow path beyond the extent of works at each of the above discrete works sites (refer to Figure 4). The design intent was to achieve this whilst minimising the disturbance and footprint of the works. The works were design as a small low flow channel cut into the

existing bed of the channel. The works included locally variable batters, designated pool areas providing further habitat benefits, and planting with a combination of prescribed aquatic and semi aquatic plants.

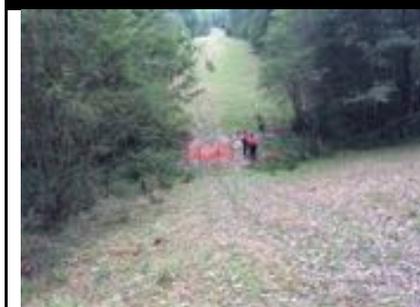
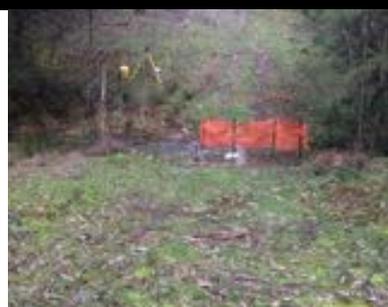
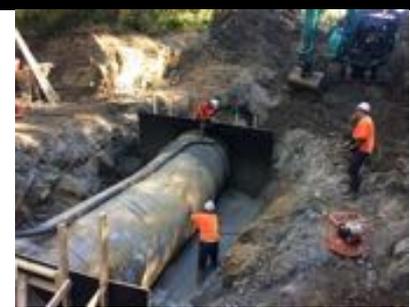
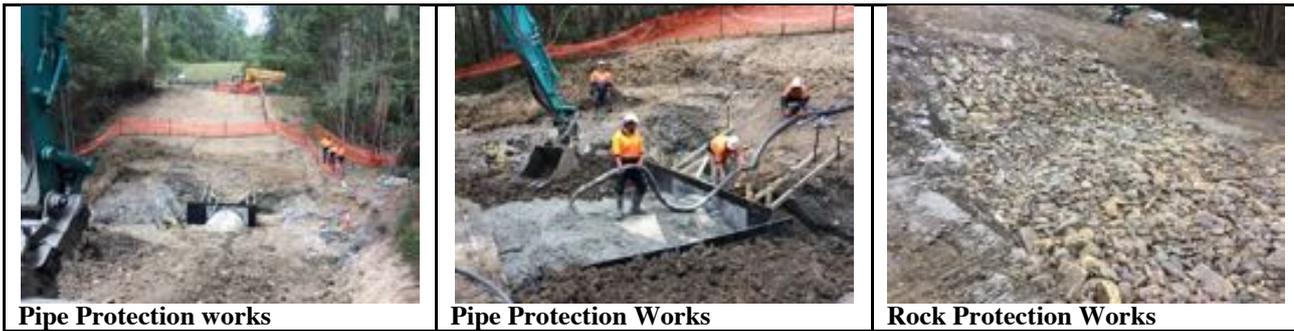
Table 1.- Construction Photos (Site 2).

MWC Pipe Track Crossing and pipe Protection Works

Pre-existing

Pre-existing (flowing reverse)

Pipe protection works

For the works that occur within the vicinity of the MWC water supply asset, the alignment and depth from existing surface was proved at 3 locations as part of the set of works. To address issues with potential lateral movement the exposure of the water supply pipe main was limited to 8 m lengths. The sequence was then pour concrete, wait at least 2 days for concrete to cure, then expose and pour the remaining 8 m sections, before backfilling and reinstating.

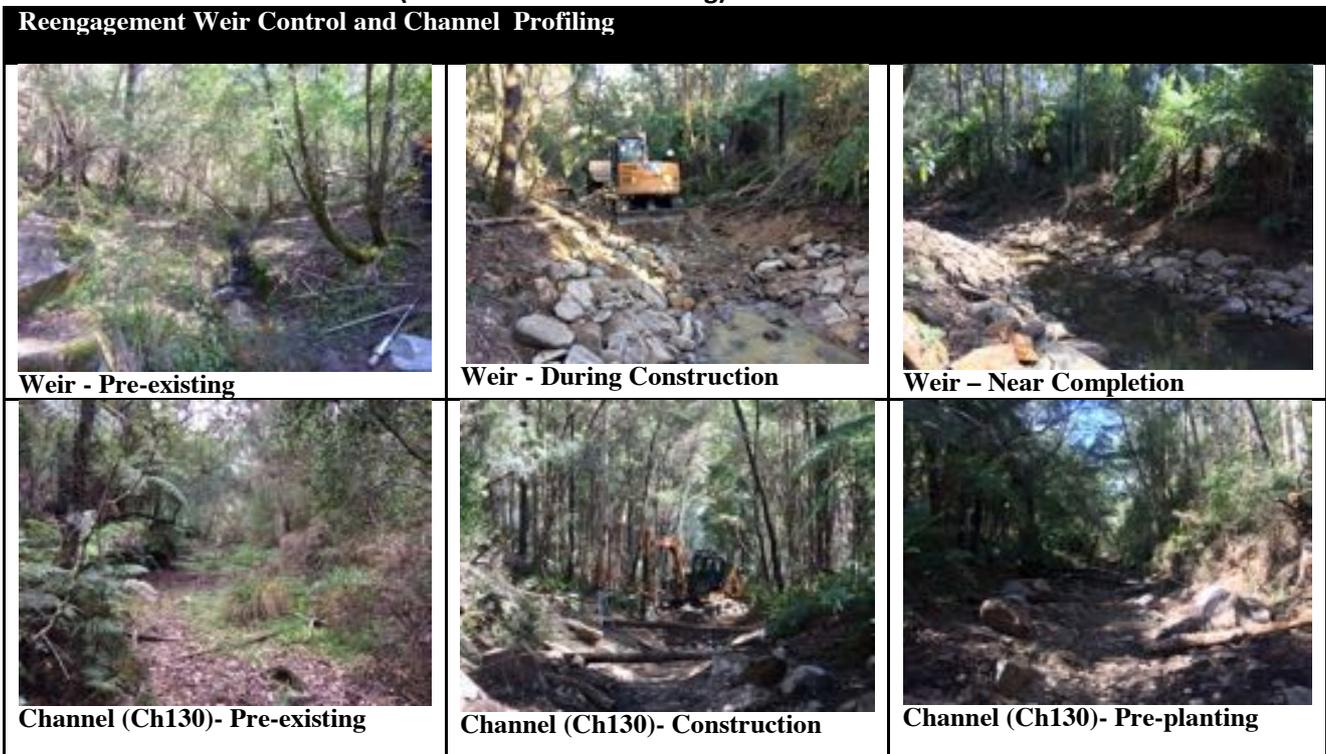
Table 2.- Construction Photos (Site 1 & Channel Profiling).

The channel reprofiling works was undertaken using the low impact compact machinery and low impact construction methods. Many of the trees that were expected to be removed in plan, were able to be retained via adjusting the alignment and footprint of the channel works where possible. The construction methodology for the rock weir was expected to use hydraulic breakers to cut into the rock shelf. The constructor was able rip the underlying rock shelf and reuse the rock as part of the graded rock formation.
