## **Striking gold - Thomson River fishway & walking track (Horseshoe Bend)**

Stork D<sup>1</sup>, Cleven S<sup>2</sup>, Berrill G<sup>3</sup>

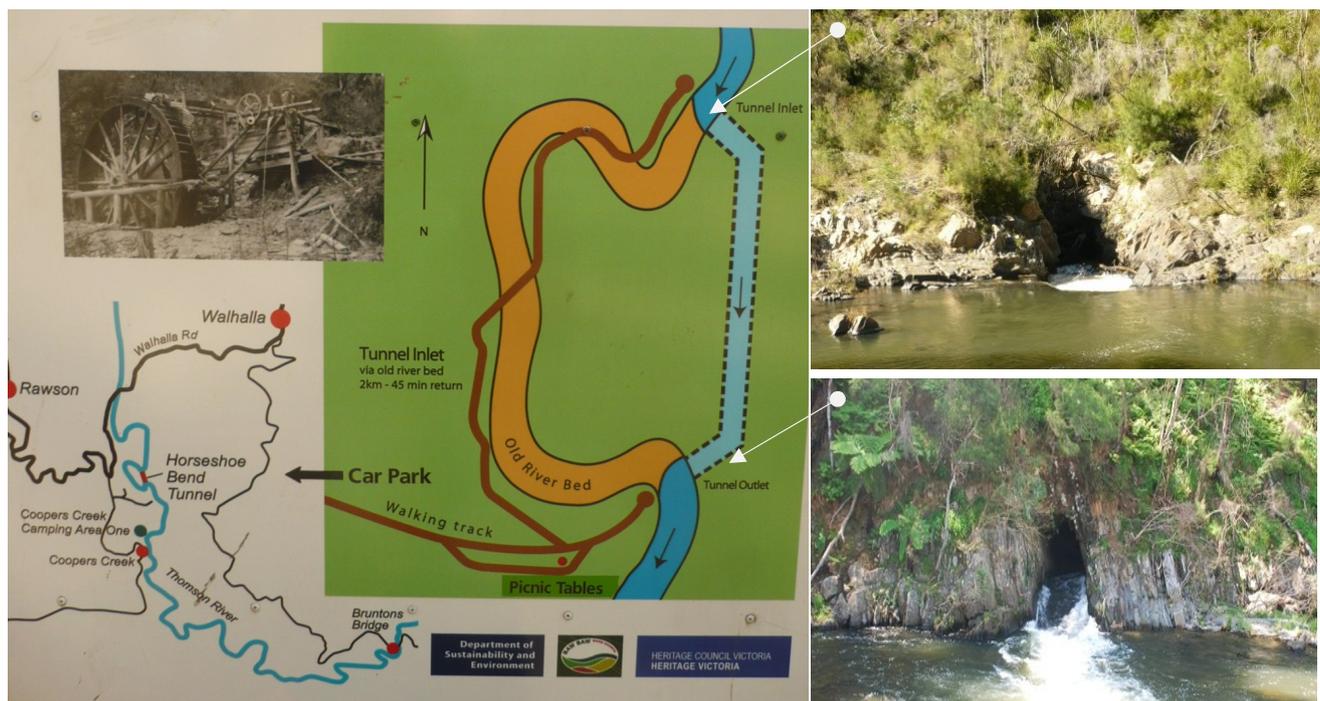
**Figure 1. Horseshoe Bend on the Thomson River - Site information board (left), inlet and outlet (right)**

In 1912 the ambitious task to create a 210-metre-long river diversion tunnel through thick bedrock in the upper Thomson River was completed. The tunnel was to provide dry access to one kilometre of riverbed that had provided significant alluvial gold winnings fifty years prior. The tunnel was driven through a ridge of land called Stockriders Spur by the Thomson River Alluvial Gold and Tailings Recovery Company. Stockriders Spur provided the barrier around which the river formed a horseshoe bend. The site was one of many actively mined areas in and around the gold mining town of Walhalla in Victoria.

Because the inlet portal was dug into the bottom of a deep natural pool in the river, it lowered the river significantly leaving the downstream riverbed more than a metre above the new water level. River flows only engaged the abandoned riverbed section during very high flow events that occurred about 30% of the time in an

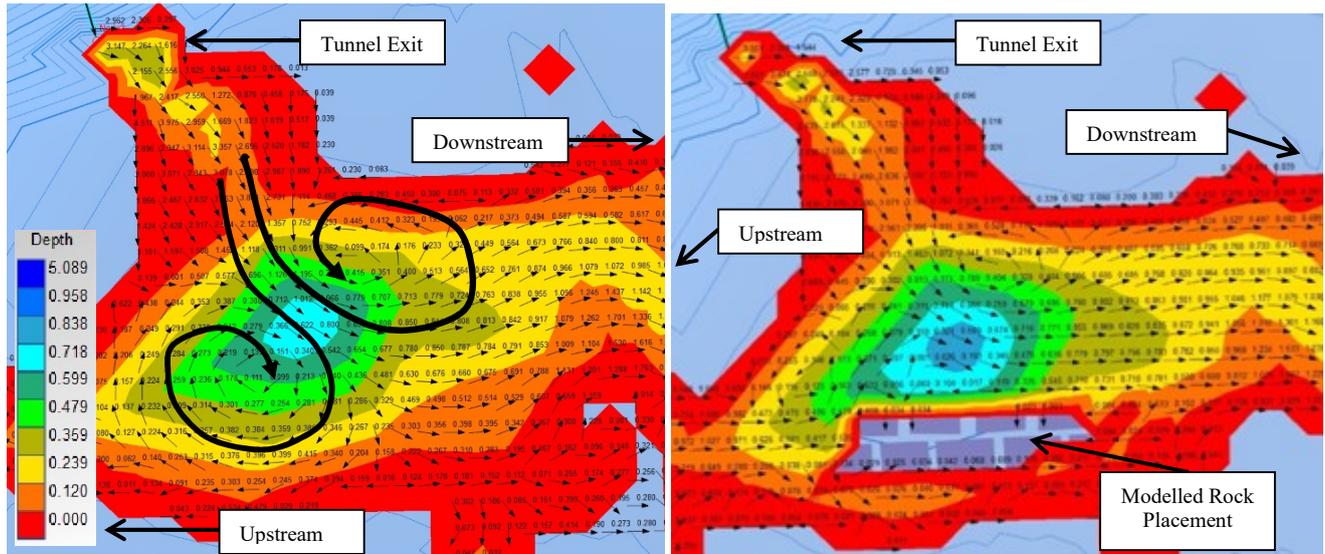
Figure 2. Horseshoe Bend tunnel outlet - modelled recirculating flow before works (left), after works (right)

The first barrier to upstream fish migration at the site was a recirculating current created by the flow exiting the tunnel. The 40% flow split through the fishway and old channel didn't have enough energy to break up this current. Thus, a novel design approach was required that would limit/restrict recirculating current at tunnel outlet and create a path of low velocity and adequate depth at the fishway entrance.

An innovative design approach was undertaken through the use of a high resolution XPSWMM model to test the placement of rock at the top of the potential flow path down the right side of the valley floor. To assist with fish movement past the tunnel outlet, one metre diameter rocks, sourced from the excavated fishway, were to be installed in two parallel rows in the bed of the river opposite the tunnel outlet (Figure 2). The rock concentrated the flow from the fishway and created a sheltered low flow pathway past the tunnel outlet (Figure 2).

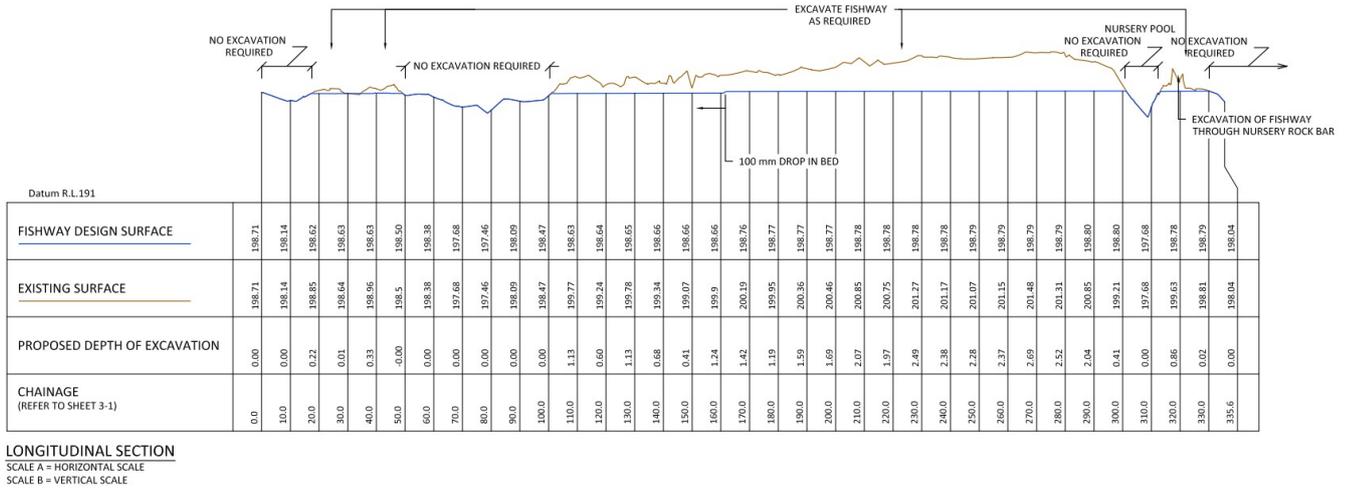
Figure 3. Horseshoe Bend fishway longitudinal section showing cut through rock bars

The constraints around the fishway design, particularly constructability, no imported materials, and only 40% of flows required an innovative and new design solution. In a first for Australian fishway design, an arrangement was derived consisting of 230 m long excavated fishway through the upstream river bedrock (Figure 3 and 4).

The design intent was to lower a limited section of the existing bedrock-controlled riverbed to a level that will enable a split of flows between the tunnel and the river. Thereby maintaining the engineered function of the tunnel, while also providing sufficient flows around the old channel for fish passage.

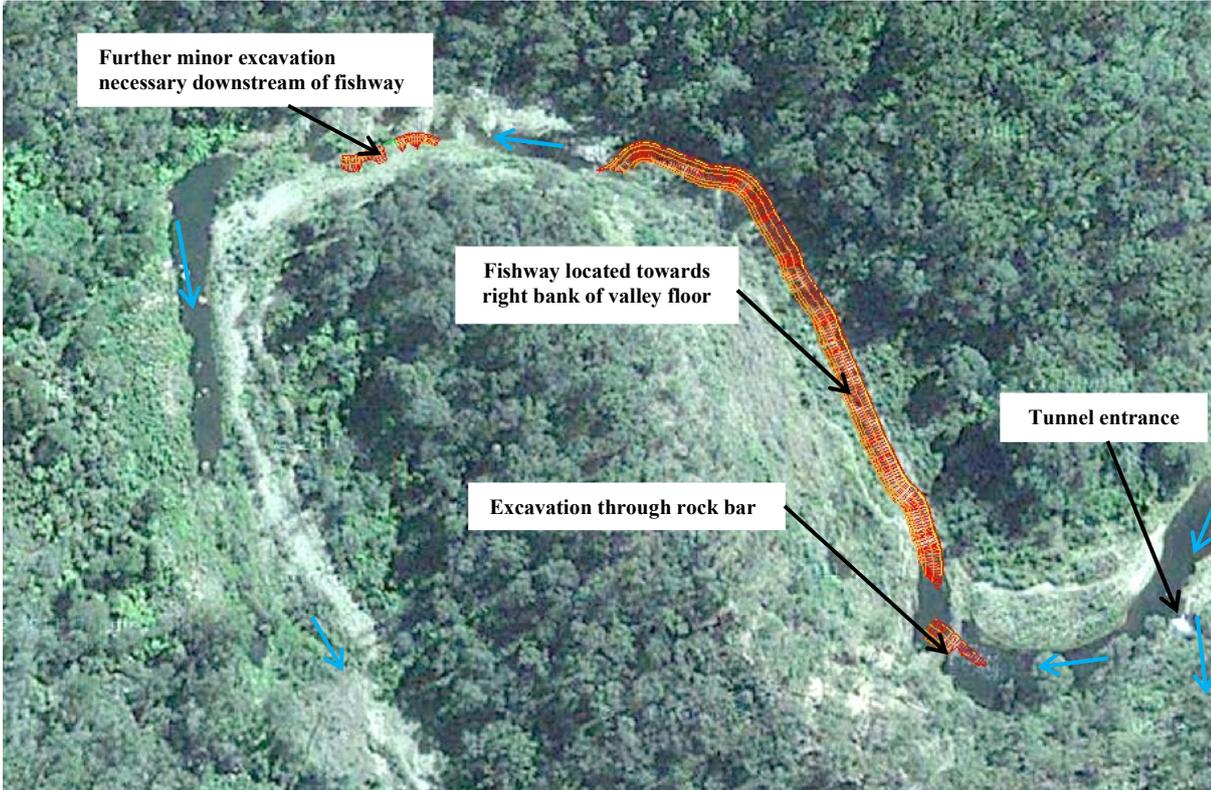
Figure 4. Horseshoe Bend fishway design overview

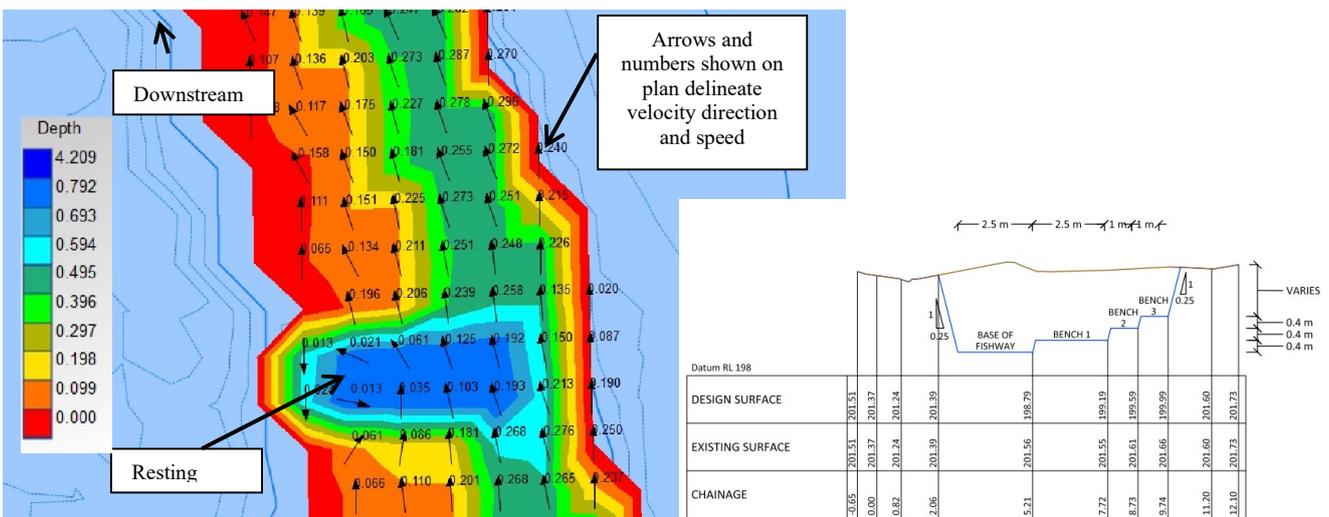
Figure 5. Fishway modelling output showing resting pool (left), fishway cross-section (right)

A stepped cross section arrangement through the bedrock fishway was adopted to provide a more diverse velocity and depth profile than trapezoidal cross sections, minimise excavation volumes, overall footprint and limit the impact on site aesthetics. Use of a stepped bank increases the hydraulic roughness over the left bank resulting in reduced velocity and depth distributions for range of different design flows. A series of deeper resting pools provided further diversity in flow conditions and larger areas for fish to rest during migration up the fishway (Figure 5).

Testing of the final design arrangement was undertaken using the XPSWMM 2D hydraulic model to assess if water depth, velocity, flow spilt, and a range of other criteria for fish passage were met throughout the constructed fishway.

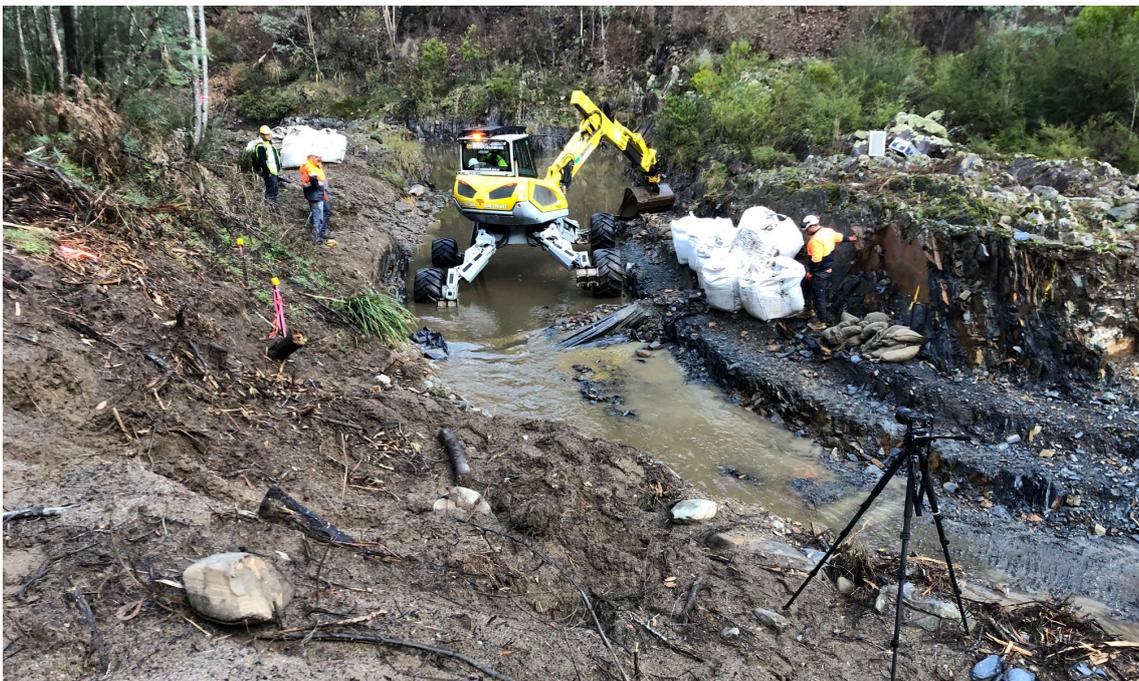
**Figure 6. Horseshoe Bend Fishway Construction – Use of Spider Excavator to minimise impact**

The unique site constraints meant that traditional construction approaches had to be rethought and new and innovative methods developed to protect both heritage and environmental values at the site. A construction environmental management plan was developed that responded to these constraints and included use of low impact rubber tracked machinery and rock breaking methods. This included the use of fully articulated rubber wheeled Swedish excavator (Menzi Muck or "Spider" excavator) to step through and around the site, and the reuse of all excavated materials on site. The end result being a low impact construction method that retained natural features and facilitated a speedy site recovery.
