### **Title: Building Stable and Resilient Foreshores using a Naturalised Approach**

**Authors:** Oram M<sup>1</sup>,

*1 City of Gold Coast, PO Box 5042, GCMC Qld 9729. Email: m.oram@goldcoast.qld.gov.au*

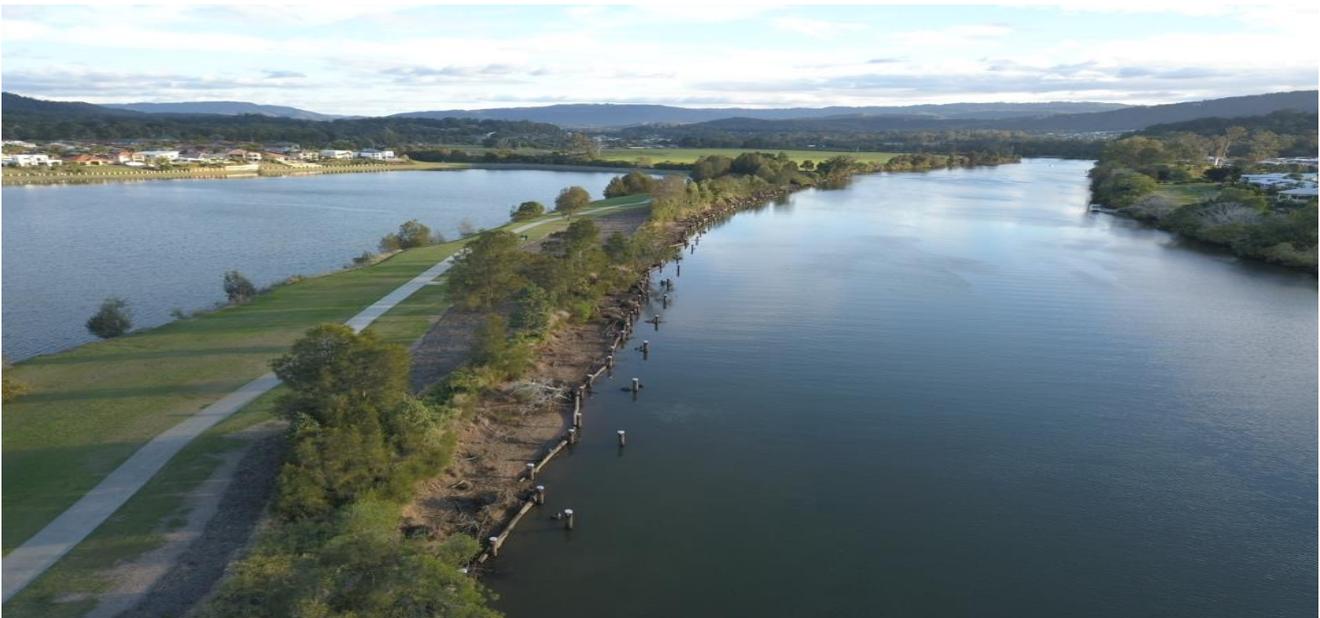
**Figure 1 Drone photo of Damian Leeding site showing piles and logs.**

The instream construction works consists of 96 hardwood tree logs with root balls that were placed on the riverbed together with systematic revegetation of the riparian bank. The works provide hydrological protection to the foreshore, restore bed erosion by sediment accretion, and encourage mangrove seedlings to establish each season behind the logs by natural river processes (figure 1).

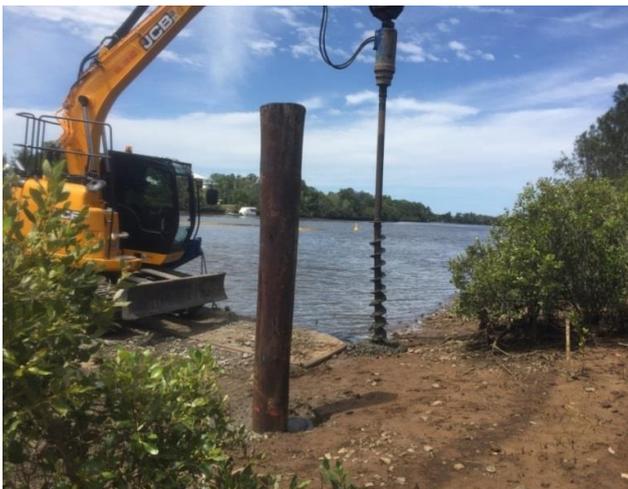
**Figure 2. Auger preps the hole for pile.**

Piling of 106 hardwood piles commenced early January 2018 and took four weeks to complete. First an auger drilled a pilot hole, then the pile was placed in the hole by sling (figure 2). The pile was vibrated to a depth of 5 meters for inside piles and 6 meters for outside piles and checked by the engineer. Material removed from the pile holes was removed from site as Potential Acid Sulphate Soils (PASS) were present.

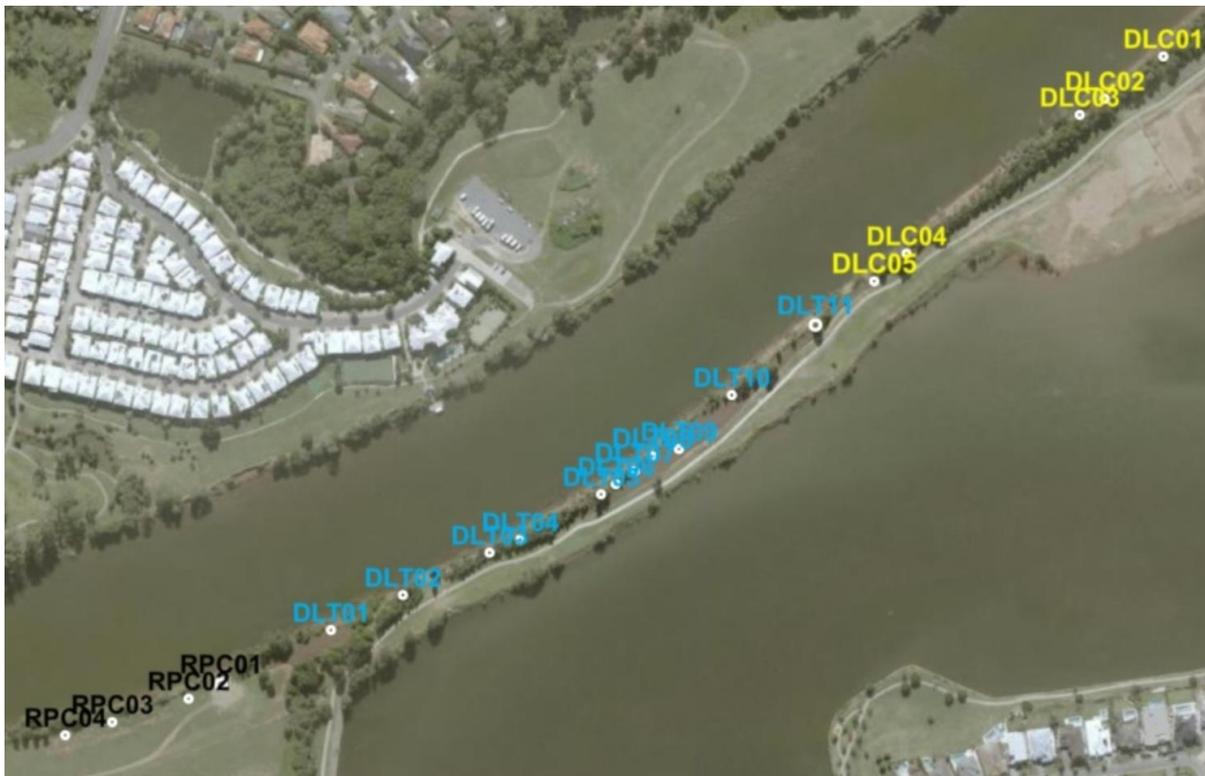
Figure 4. Monitoring sites: blue text-Treatment sites, yellow and black text-Control sites

The monitoring program consist of 11 treatment sites within the restored area and 9 control sites, 4 upstream and 5 downstream (figure 4).

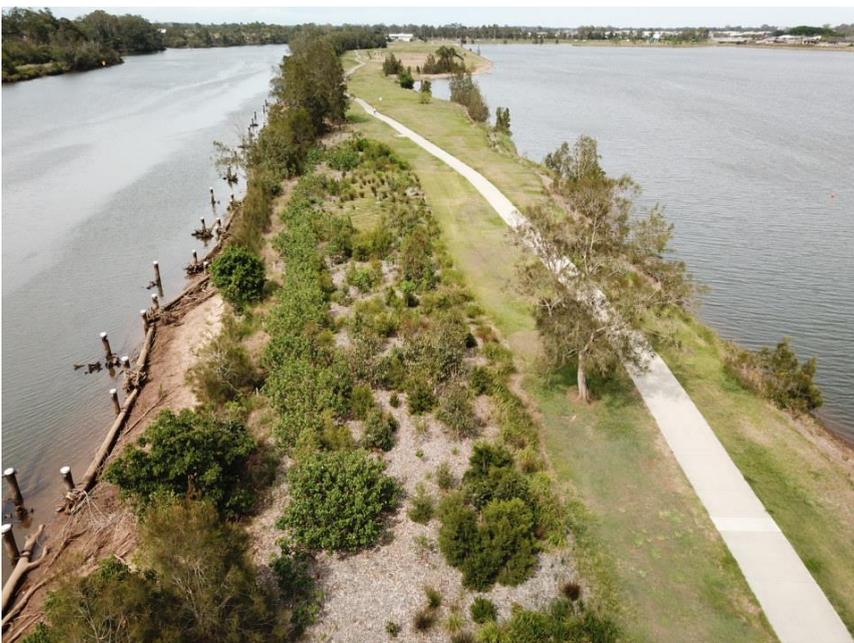
**Figure 9. Drone shot of riparian zone September 2020**

The planted and existing vegetation in the riparian zone took some time to establish and recover due to dry weather but started thriving after approximately one year. Sections of the riparian buffer have been planted with lower type vegetation to maintain views of the river while walking in the park (figure 9).
