Bushfire recovery in the Nariel Valley – a long way to go.

The 19/20 Bushfires impacted much of the Upper Murray, including the Nariel Valley. This paper will explore the challenges of fire recovery focusing on riparian areas and the many complexities of landholder engagement.

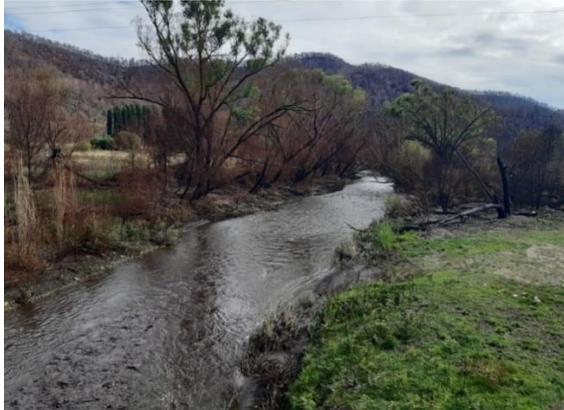
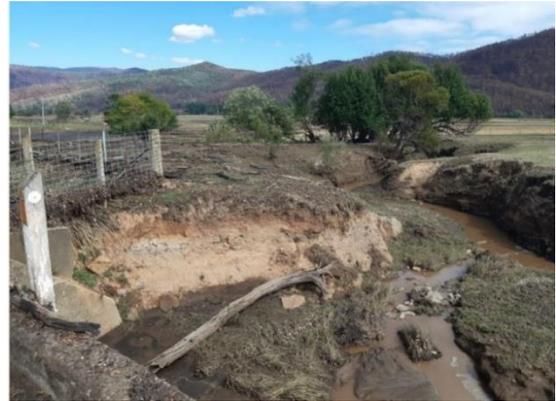
Figure 4: Two sites on the Corryong Creek February 2020

Figures 4 and 5 below show the impacts of a relatively small rain event in February 2020, following the bushfires:

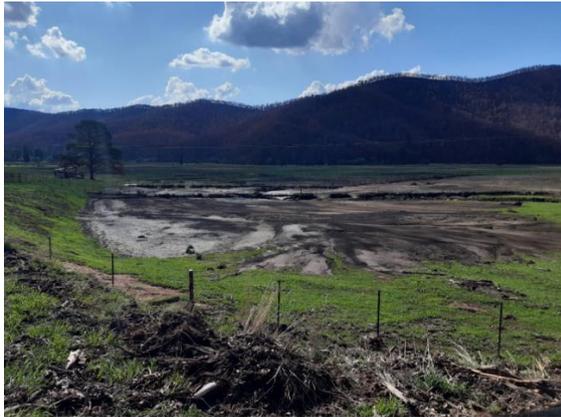
Figure 7: Property in the Nariel Valley post fires

The impacts of these interventions were evident during site visits following the bushfires. CMA staff were faced with sites that were impacted at such a severe intensity that it was clear a change in thinking from traditional intervention methods would be required'. The images below (figures 7 and 8) are examples of sites CMA staff were faced with while undertaking landholder inspections after a relatively small rain event. Figures 7 and 8 below demonstrate the severity of the fires on sites that had been impacted over time by traditional intervention methods.

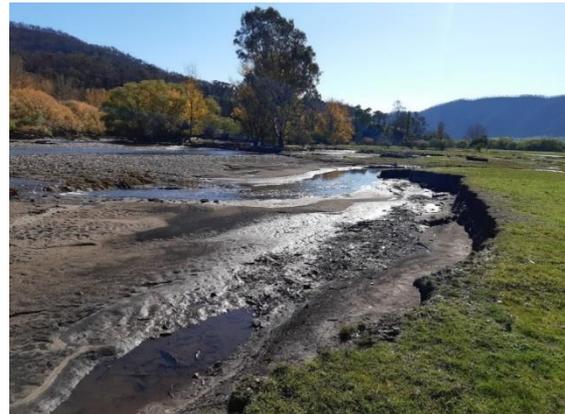
Figure 8: Channel Abandonment, erosion, smothering of habitats and loss of riparian vegetation on the Nariel Creek Post Fire & Flooding, 2020.
