# Sell the sand to save the river: how in-stream extraction accelerates recovery from a sand slug

A.J. Sims<sup>1,2</sup>, I. D. Rutherford<sup>1</sup>

<sup>1</sup> The University of Melbourne, Parkville, VIC 3010

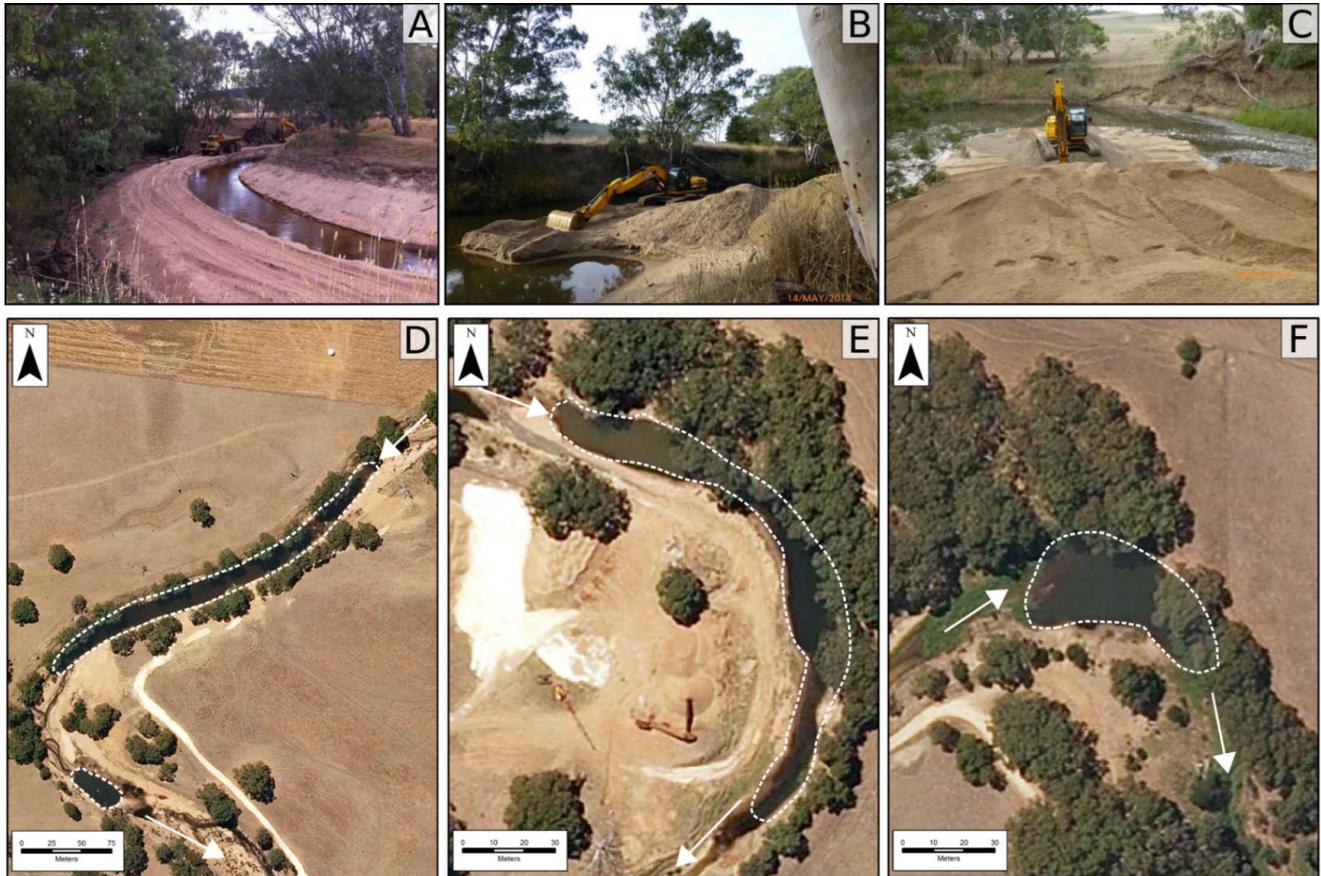
**Figure 2.** The extraction technique used in the Glenelg River (A) looking upstream at an extraction access ramp on the bend of the river, (B) an excavator in the final stages of 'backing-out' from an extraction pit in the bed of the river, (C) an excavator on the remainder of a platform during point bar removal on a sharp meander bend, (D) plan view of two pits immediately after excavation at the Corndale extraction site, (E and F) plan view of freshly excavated extraction pit at the toe of a point bar at the downstream end of the Corndale extraction site and the Claybanks extraction site, respectively. Photos A-C supplied by Vickery Bros, aerial photos D-F were captured in 2010, as part of the Victorian Index of Stream Condition program, white arrows show flow direction.

Historically a combination of bucket excavators, drag-line excavators and front-end loaders have been used to remove sand from the bed of the Glenelg River. The resulting extraction ‘pits’ varied in depth and width, and often disturbed large areas of the stream bed. Since the mid-2000s the Glenelg Hopkins Catchment Management Authority (GHCMA) has worked with extractors to minimise disturbance to the river bed and protect the channel banks from being undermined during extraction. These more ‘environmentally sensitive’ techniques are driven by a shift in how the GHCMA manage in stream extraction in the Glenelg River: from a passive role that focused on coordinating removal of a commercial resource, to the use of extraction as a management tool that is funded through the sale of extracted sand.

1. The deep, discrete extraction pits excavated in the Glenelg River do not disturb the channel banks, they have been excavated in straight sections and at the toe of point bars. Not every pit at every extraction site is excavated each year.
2. Extraction pits are excavated in an upstream direction, as excavators ‘back-out’ of the channel. On meander bends, excavation starts from a temporary sand platform on the point bar and bed on the outside of the meander is removed first (Figure 2). The temporary platform is removed last, leaving a discrete pit. The extraction technique leaves a pit that resembles extraction pits modelled in flume studies.

3. When two pits are excavated at the same extraction site, both pits begin to re-fill at the same time (the upstream pit did not 'protect' the downstream pit from filling). Each pit fills at a different rate.
4. The rate pits re-fill depends on the magnitude and frequency of winter flows, which are stochastic. Pits completely re-fill during floods and sheets of sand are deposited on the streambed between pits.

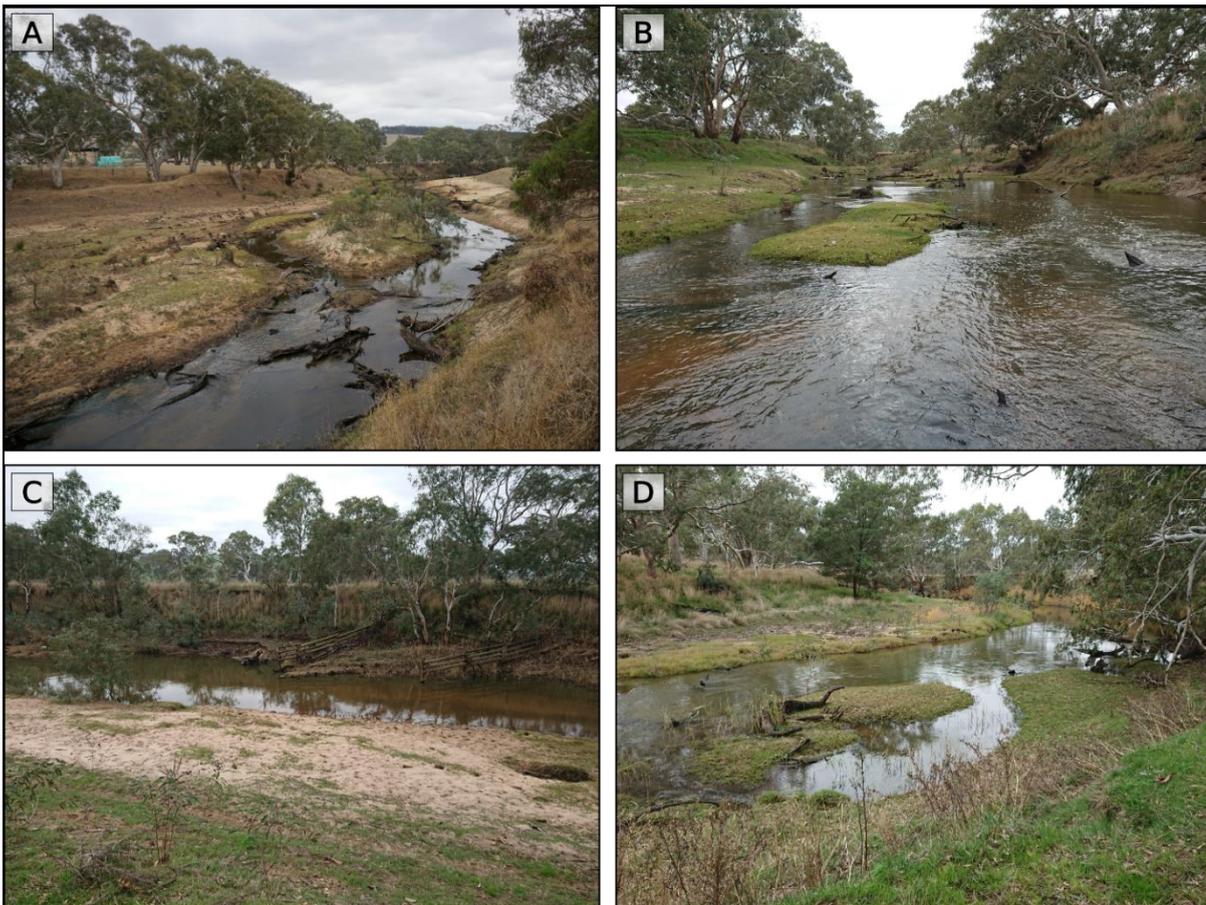
**Figure 3.** The morphology of the upstream part of the study reach showing (A) the low-flow channel immediately downstream of Corndale pit 2, looking upstream, erosion has exhumed abundant in stream wood that was previously buried, (B) the low-flow channel with remnant island in the channel, (C) bank protection structures on the outside of a meander bend (flow is from right to left), (D) the low-flow channel inset within benches, showing exposed tree stumps on the channel bed.

The *upstream* morphology is generally a flat, featureless sheet of sand that meanders through irregular, low-elevation benches on the channel margins (although at some cross-sections these benches are absent entirely) (Figure 3). The channel banks support sparse, discontinuous stands of mature vegetation (mainly *Eucalyptus camaldulensis* and *Eucalyptus globulus*), but few trees shade the low-flow channel (Figure 3A). Steep, eroding banks are common in straight sections and on the outside of meander bends. Bank erosion is

most pronounced in a highly sinuous sub-reach that includes bank protection structures, some of which have collapsed (Figure 3C) and exposed clay on the channel bed. Abundant in-situ tree stumps are exposed in the bed (having been previously buried by sand, or sawn off in-situ during 'de-snagging' in the 1960s) (Figure 3A and B). The inner margins of some of the benches have been colonised by red gum seedlings (*Eucalyptus camaldulensis*) and small patches of spiny rush (*Juncus acutus*) have established on the benches. Some isolated stands of *Phragmites australis* have established in meander bends with high banks and limited stock access.

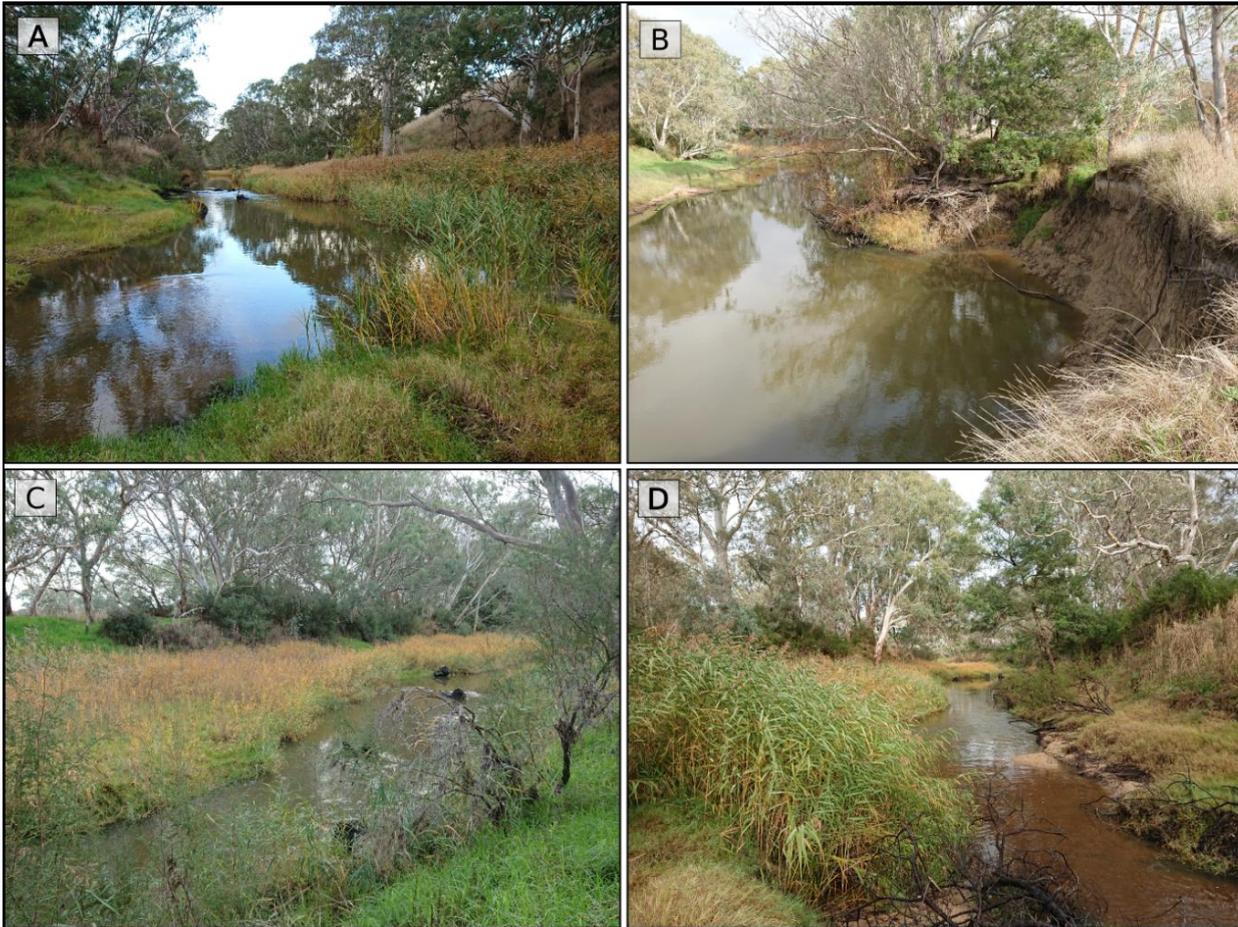
Figure 4. The morphology of the lower section of the study reach, where stock have been excluded from the riverbed and *Phragmites* have colonised many surfaces, showing (A) *Phragmites*-lined benches on the channel margins, which support some mature vegetation near the base of the adjoining bank, and a deep low-flow channel, (B) bank erosion and collapse of vegetation (flow is from away from viewer), (C) a deep low-flow channel cutting through *Phragmites*-covered benches that have been partially eroded and, (D) The uneven colonisation of the channel margins by *Phragmites* which have established on the true left (left of the image) but not on the true right in this part of the channel. Here the low-flow channel is relatively shallow.

The *downstream* morphology is very different from the *upstream* morphology. A deep low flow channel cuts through benches and bars, most of which have been colonised with dense stands of *Phragmites australis*. The banks support mature vegetation (also a mixture of *Eucalyptus camaldulensis* and *Eucalyptus globulus*) that shade the low-flow channel (Figure 4). Several portions of the banks exhibit signs of erosion, especially on the outside of meander bends. Several small, *Phragmites*-covered islands occur within the active portion of the channel, and sand is accumulating at their downstream margin (Figure 5). There are deep pools on the outside of several meander bends (Figure 4B). Aerial imagery shows these pools were in place by 2010 and have not changed in size. Isolated scour holes have developed on the surface of several of the benches and bars, despite the cover of *Phragmites* (Figure 6).
