Reducing sediment delivery to the Great Barrier Reef using spatial data

Reid, J.¹, Ivezich, M.², Teague, J.,³ and Byran, R.⁴

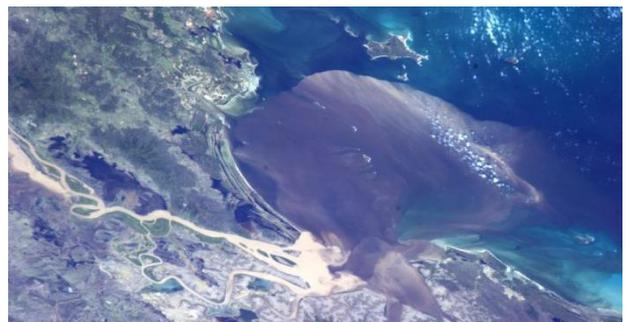
Figure 1. Sediment plume from the Fitzroy River following flooding resulting from Cyclone Oswald in 2013

The Fitzroy Region (the Region) is located in central Queensland and drains into the Great Barrier Reef (GBR) near Rockhampton. The Region is approximately 156,000 km² in size, more than twice the area of Tasmania. Channel erosion within the waterways of the Region has been identified as a significant source of sediment and nutrient loads to the GBR. For example, Major flooding in 2013 and 2017 resulting from Cyclone Oswald and Cyclone Debbie respectively

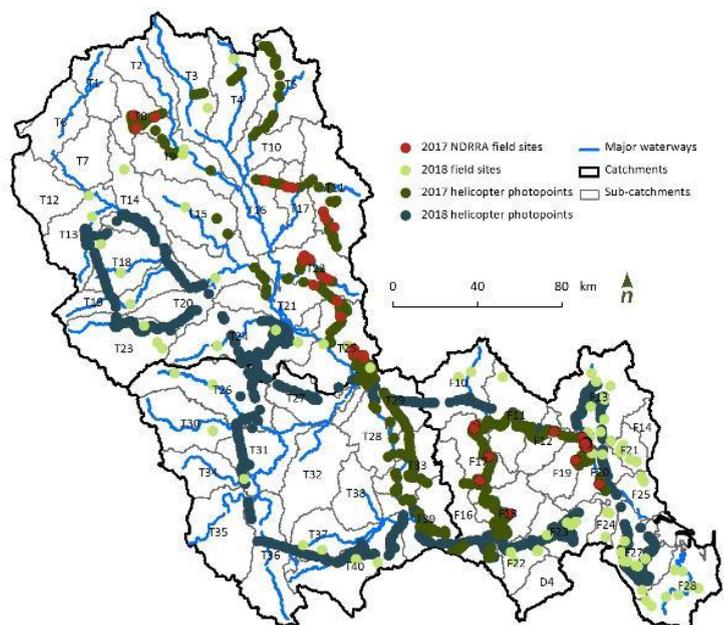
Figure 3. Field locations and helicopter photo locations visited by Alluvium and FBA staff within the study area

On-ground rapid geomorphic assessments were also undertaken by Alluvium personnel. The location of the field sites were determined through a combination of accessibility from adjacent public land, which were predominantly road crossings, and ensuring maximum coverage of the study area. A total of 84 sites within 29 sub-catchments were visited across the three catchments. During the field assessment, observations relating to bed and bank material/morphology/condition, riparian vegetation condition and instream habitat were recorded. The locations of field sites and helicopter assessments undertaken as part of this study, as well as the Fitzroy Basin Flood Recovery Assessment are shown in **Figure 3**.

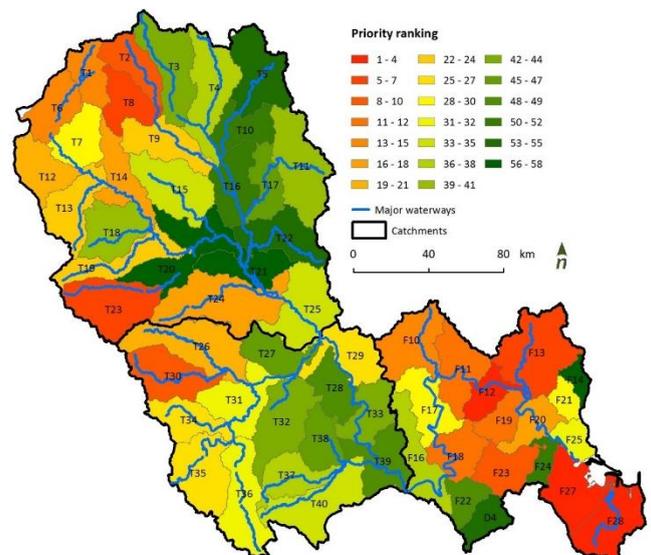
Figure 4. Priority ranking for management intervention across the study area

The prioritisation ranking for management intervention within the study area is shown in **Figure 4**. The majority of high-ranking sub-catchments are located within the Fitzroy catchment. Higher ranking sub-catchments are also located in the north-west of the Isaac catchment and the along the western boundary of the Mackenzie and Isaac catchments. The priority for management intervention may change as objectives for management interventions change or if the sediment connectivity ratios are updated during future water quality modelling.

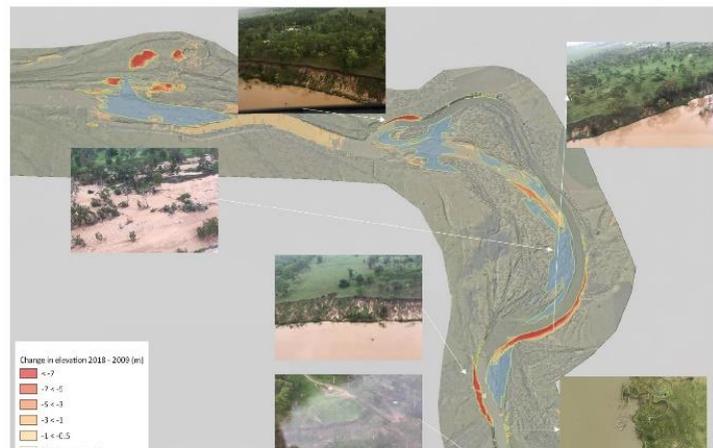
Figure 5. Example of a DEMoD in the Fitzroy River – Red showing erosion and blue showing deposition

The analysis of high-resolution data included the development of Digital Elevation Models of Difference (DEMoD), which identify changes in ground surface elevation from two LiDAR datasets captured at various temporal scales to determine the volume of sediment eroded from the banks and the dominant erosional process (Figure 5).

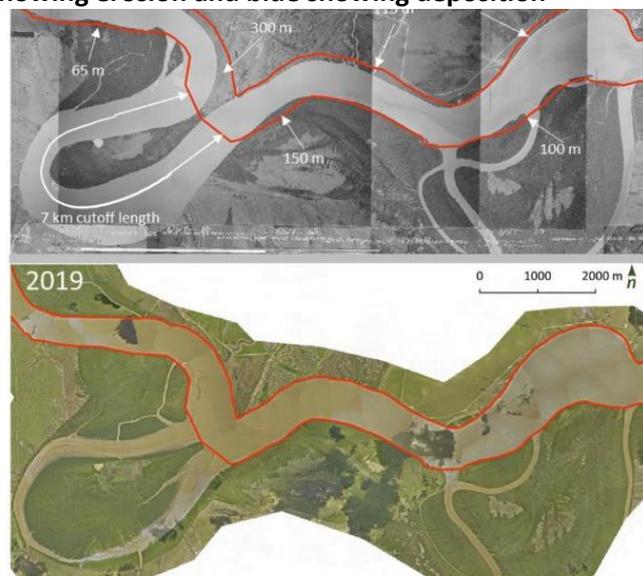
Figure 6 - Comparison of historical aerial imagery – red line indicates 2019 streambank alignment

Aerial imagery from various years between 1952 and 2019 were available to assess the historical channel change (Figure 6). The analysis of historical aerial photos enabled changes in vegetation condition, channel width and planform to be assessed. Understanding historical rates of channel change can assist in predicting the future trajectory of the system. Additionally, in areas beyond the extent of the DEMoDs, estimations of sediment mobilisation volume due to bank erosion were made using historical aerial imagery and LiDAR data.

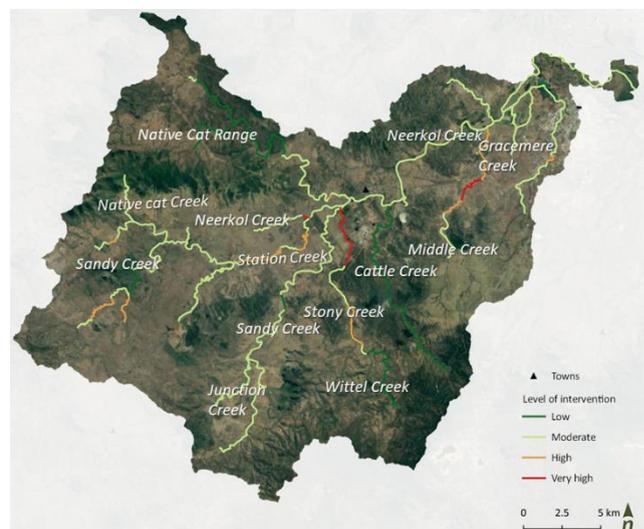
Figure 7. Example of recommended level of intervention in a priority sub-catchment

To assist in determining the most appropriate erosion treatments throughout the study area, the erosion potential for each section of bank throughout each reach was identified (Figure 7). Additionally, stakeholder assets/values and desired outcomes were identified through a stakeholder consultation as part of the Lower Fitzroy River Assessment (Alluvium, 2019b). Subsequently, a level of management intervention was recommended for each section of bank through each of the reaches. The findings could be used to develop a prioritised program of works. The program of works would include structural intervention at major streambank erosion sites with a high erosion potential, and protecting and enhancing riparian vegetation in areas of moderate and high erosion potential throughout the remainder of the reach.

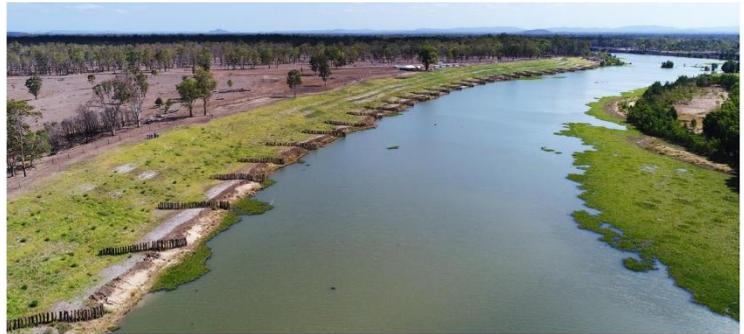
Figure 8. Streambank stabilisation works implemented along the Fitzroy River

Stream restoration works have been designed and implemented at several of the major erosion sites identified on the Lower Fitzroy River (**Figure 8** and **Figure 9**). The works include both soft and hard engineering solutions, including bank battering, installation of pile fields and revegetation. These works included one of the largest stream bank stabilisation project in Australia and represented over \$2M worth of investment. Detailed bank erosion modelling at two of the sites estimates that the stabilisation result in sediment mobilisation reductions of over 90 %, which equates to over 50,000 m³ of sediment per annum.

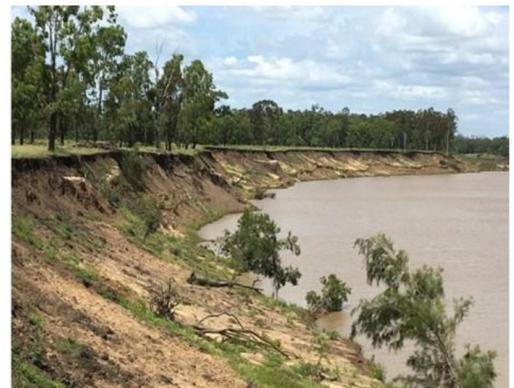
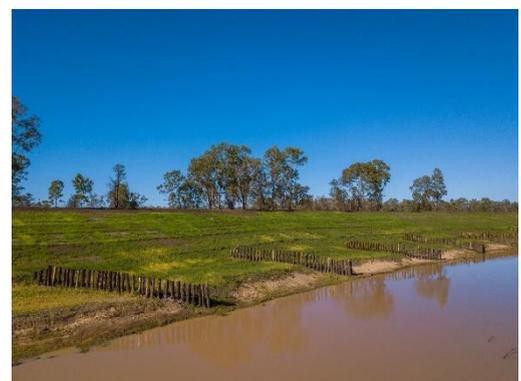
Figure 9. example of a major erosion site on the Fitzroy River before (top) and after (below) stream stabilisation works
