***Where has all the sand gone? Understanding the implications of sand movement following renourishment works to protect Threatened tern habitat in the Gippsland Lakes***

# **Where has all the sand gone? Understanding the implications of sand movement following renourishment works to protect Threatened Tern habitat in the Gippsland Lakes**

A collaborative project was completed in 2016 to use dredge spoil (sand) to renourish nesting habitat for Threatened terns on sand islands within the Gippsland Lakes. Following this, the distribution of sand has changed, along with patterns of use by terns.

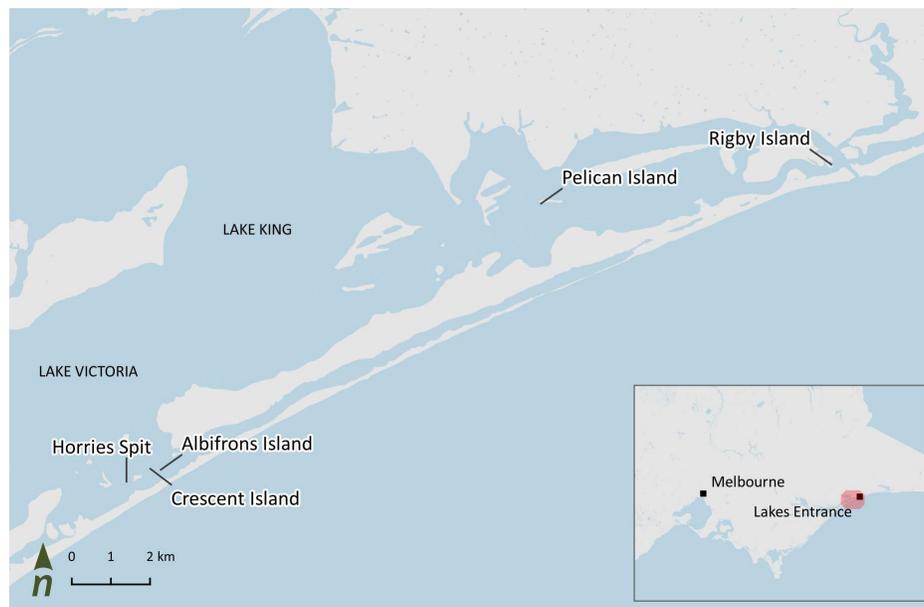
**Figure 2. Sand renourishment sites for small tern habitat in the Gippsland Lakes (Alluvium, 2020)**

Habitat restoration using sand renourishment and other techniques was undertaken between 2015 and 2017 on Crescent, Pelican, Rigby, and Albifrons Islands, and Horries Spit, in the Gippsland Lakes (Figure 2). The objective of the works was to maintain or establish areas of critical habitat for the breeding of threatened small terns.

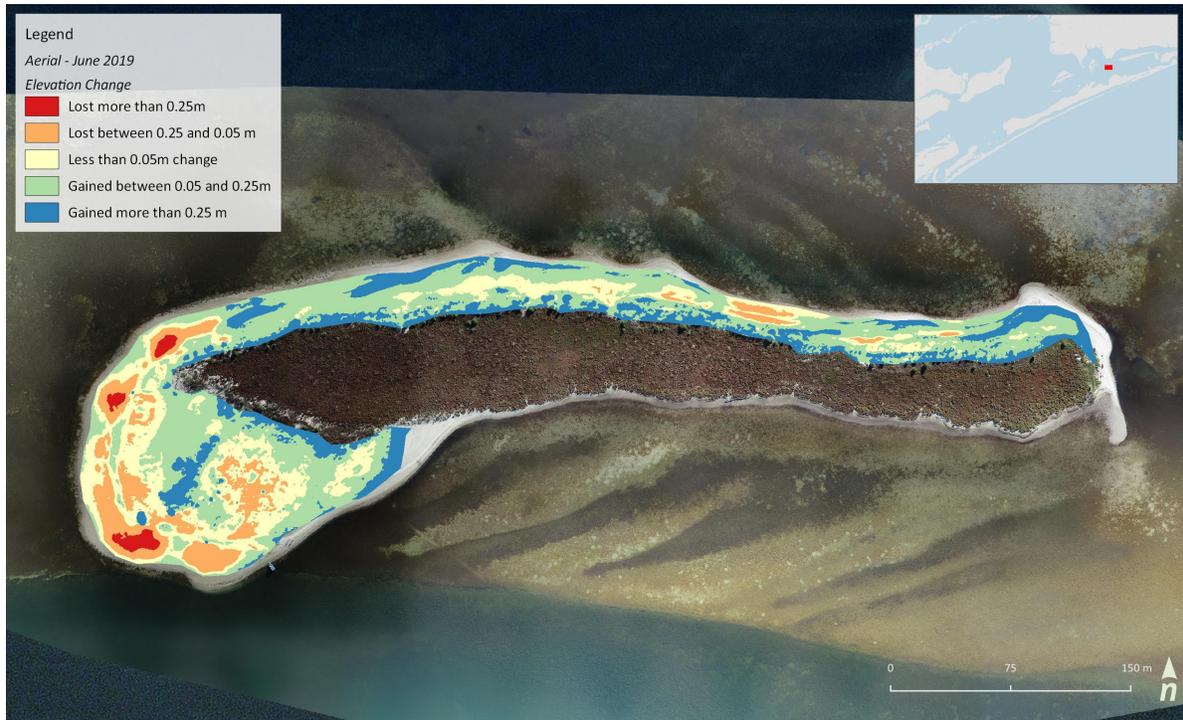
Over the period of analysis (2016 to 2019) Pelican island showed a net accumulation of sand (total volume) as well as an increase in area of sand above both median and spring tide levels (Figure 3, Table 4).

**Figure 3. Pelican Island elevation change, post renourishment to 2019 (Alluvium, 2020)**

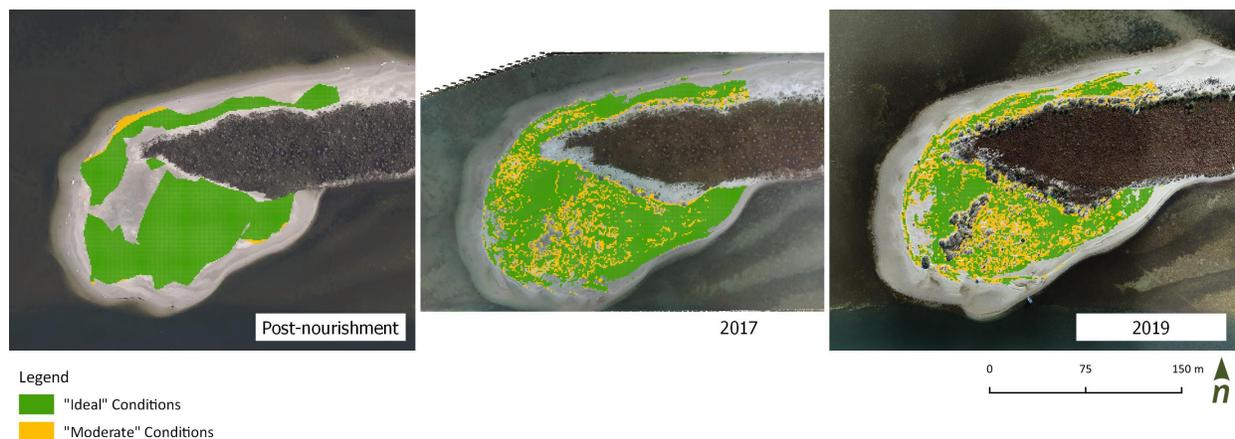
However over the same time period, mean slopes increased across the site, with the site developing a less consistent microtopographic landform. The more stable shoreline environment provided by the renourishment works, supplemented by revegetation, appears to have contributed to the expansion of vegetation extent and density. As a result, the ‘ideal’ conditions for tern habitat became more fragmented (Figure 4).

**Figure 4. Pelican Island habitat distribution changes (Alluvium, 2020)**
