Cockatoo Swamp Hydrology Improvement Project

Sarah Gregor¹, Joe Greet², Sarah Gaskill³

1.Melbourne Water, 990 Latrobe St, Docklands, VIC; sarah.gregor@melbournewater.com.au

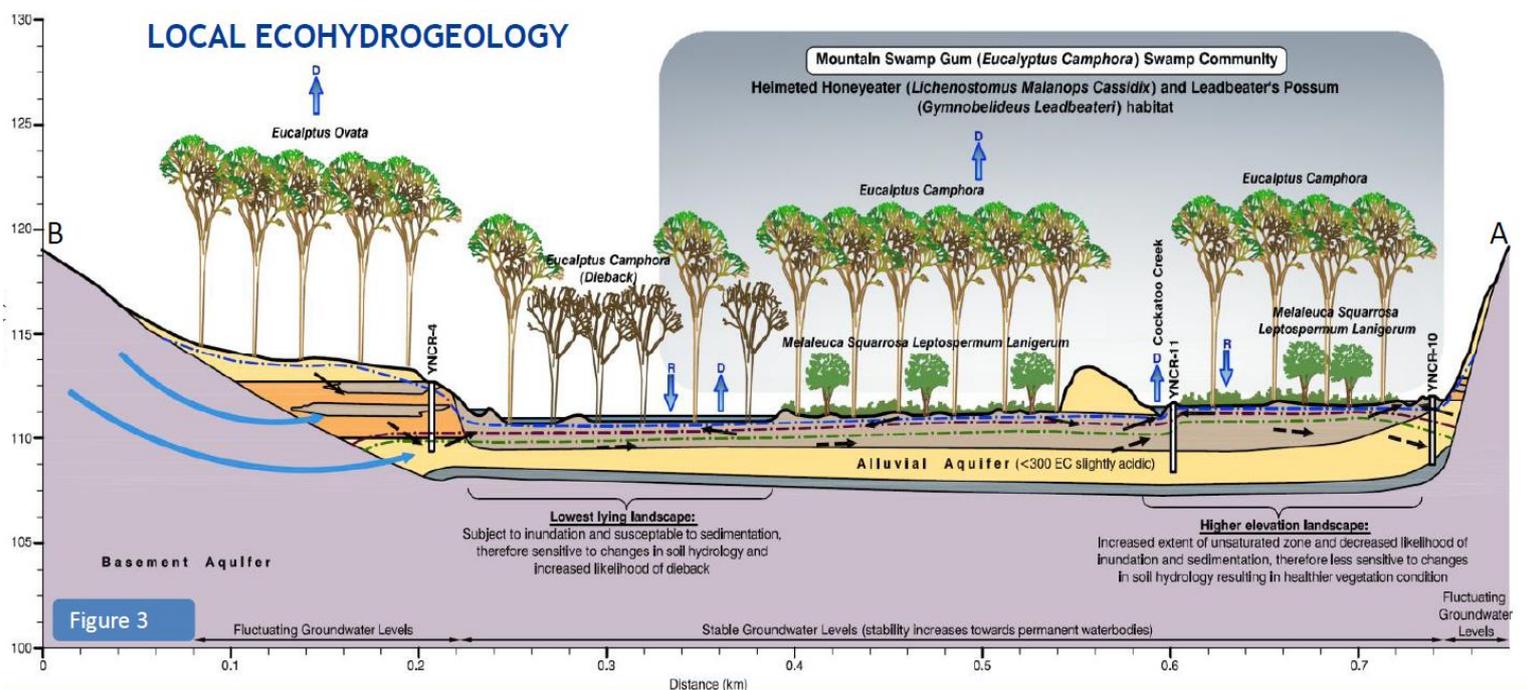
Figure 1. Hydro-eco-geological conceptual model for Yellingbo (SKM 2014).

Research was undertaken over many years to ascertain the cause of the vegetation dieback in the swamp. Investigation of the causes suggested that an inappropriate watering regime is one of the main threats to the persistence of wetland forests within the Cockatoo Swamp (Greet 2012; Boon 2016). Prolonged inundation was driving the dieback of mature *E. camphora* wetland forest in parts, and a lack of appropriate wetting and drying was preventing its regeneration (Greet 2012) (Figure 1).

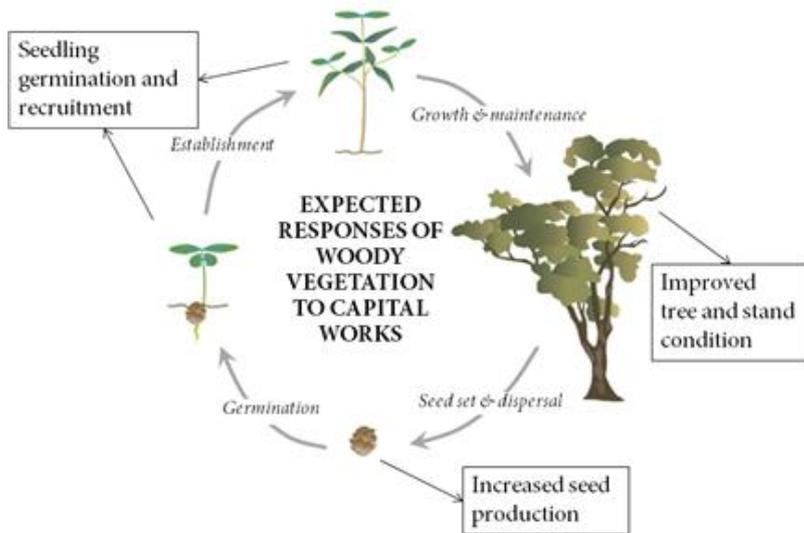
Figure 2. Expected responses of critical woody vegetation at different life-history stages to water regime changes resulting from the Melbourne Water capital works program at the Cockatoo Swamp (Greet 2015).

Specific vegetation response variables are being monitored for each of the important life-history stages of the vegetation. They include mature tree and stand condition (using The Living Murray Method and hemispherical photography, respectively); seed production (using seedfall traps); and seedling germination and recruitment (using three permanent 5m x 5m quadrats at each site) (Figure 2). Additionally, changes in vegetation structure at the whole-of-swamp scale are being assessed using high-definition multi-level LiDAR data captured using a drone (Greet 2015).

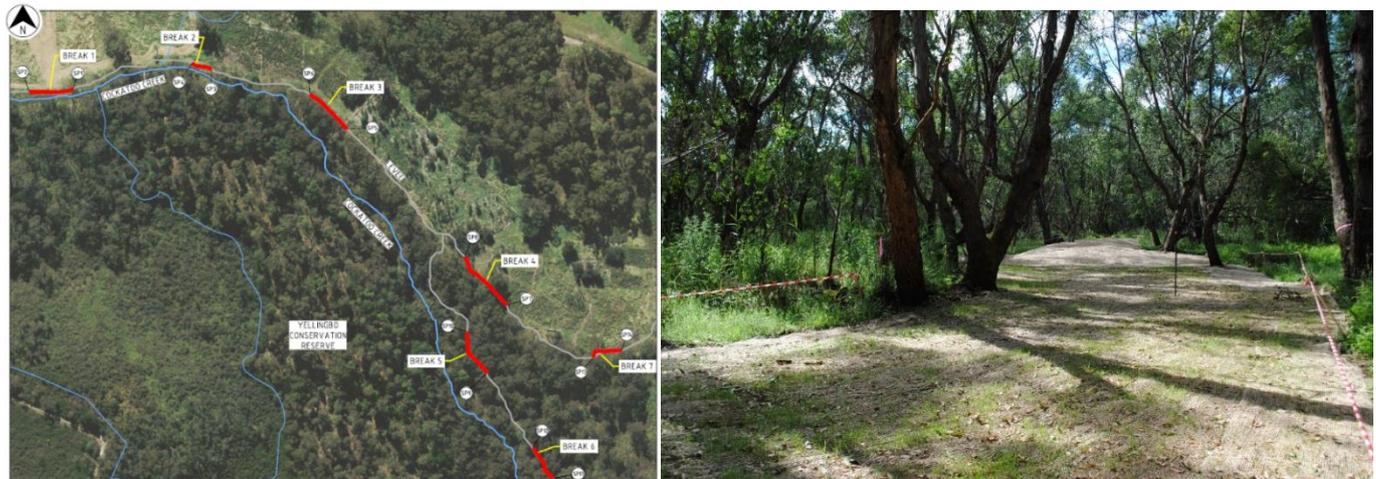
Figure 3. Sections of the levee bank removed in 2017/2018 and photo of levee Break 6 taken 6/12/2017 (Jacobs 2017)

From Nov 2017–Jan 2018, several sections were removed from a levee alongside the Cockatoo Creek. These were covered with mulch, jute matting and planted with Sterile Rye for stabilisation (Figure 3). This was undertaken to improve the distribution of overbank flows over the floodplain into disconnected dry areas of the swamp.

Since construction, there has been minimal engagement through the more upstream breaks. Break 1 regularly inundates where the Cockatoo Creek is less incised. Apart from the absence of large floods, the incised nature of the channel in the vicinity of the levee breaks limits overbank flows and thus the engagement of disconnected floodplain areas via the levee breaks (Greet 2020). Further work will need to be undertaken to address channel incision through this reach.

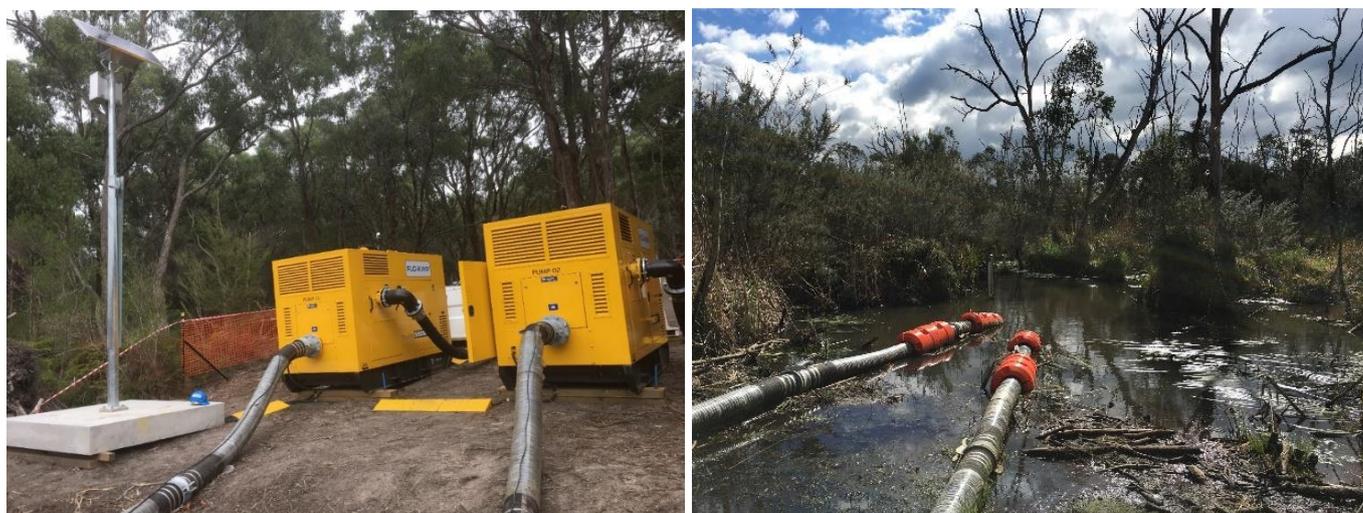
Figure 4. Pumps on site (left photo) and inlet site with gauge board visible (right photo).

Installation of two temporary pumps and pipes were undertaken between December 2017 and March 2018 (Figure 4). Two initial pumping events were conducted in 2018. Both events were of short duration (days) and were conducted to refine operational rules.

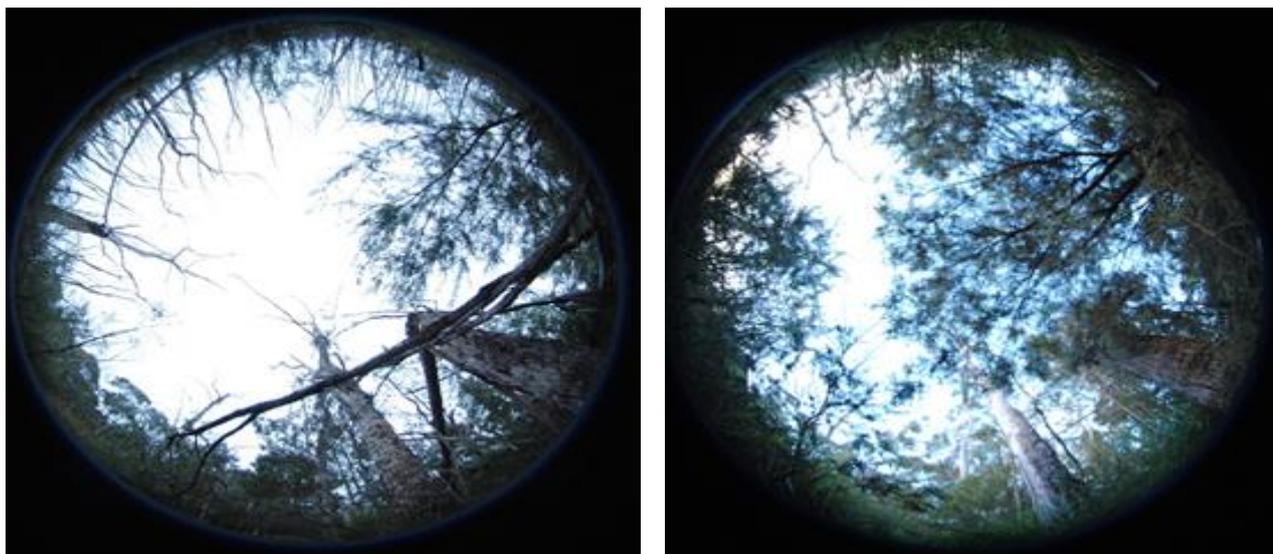
Figure 5. Hemispherical photographs taken at one of the dieback-affected monitoring sites in 2015 (left photo) and 2019 (right photo). There is a clear increase in woody plant cover over that period (Greet 2019).

Vegetation monitoring initially indicated a positive response. Against the backdrop of a drying trend, field assessments between 2015–2019 revealed there have been increases in tree crown extent and stand condition within dieback-affected sites (Greet 2019) (Figure 5). It was noted at the time that the positive responses observed were likely attributable to climatic trends, and the contribution of the pumping trial to these changes was likely to have been minimal. This has been further indicated with recent vegetation monitoring data collected following two wet years showing a decline in *E. camphora* tree condition within dieback-affected areas (Greet 2020).
