## Living with change: Working with geomorphic-groundwater processes to inform river rehabilitation in Seqwater's Source Protection Program, North Pine River, QLD

This paper presents the outcomes of the Erosion Control at Dayboro Project, delivered as part of Seqwater's Source Protection Program. The project explored how geomorphic and groundwater process understanding can inform rehabilitation strategies that work with river adjustment processes rather than attempting to prevent change entirely.

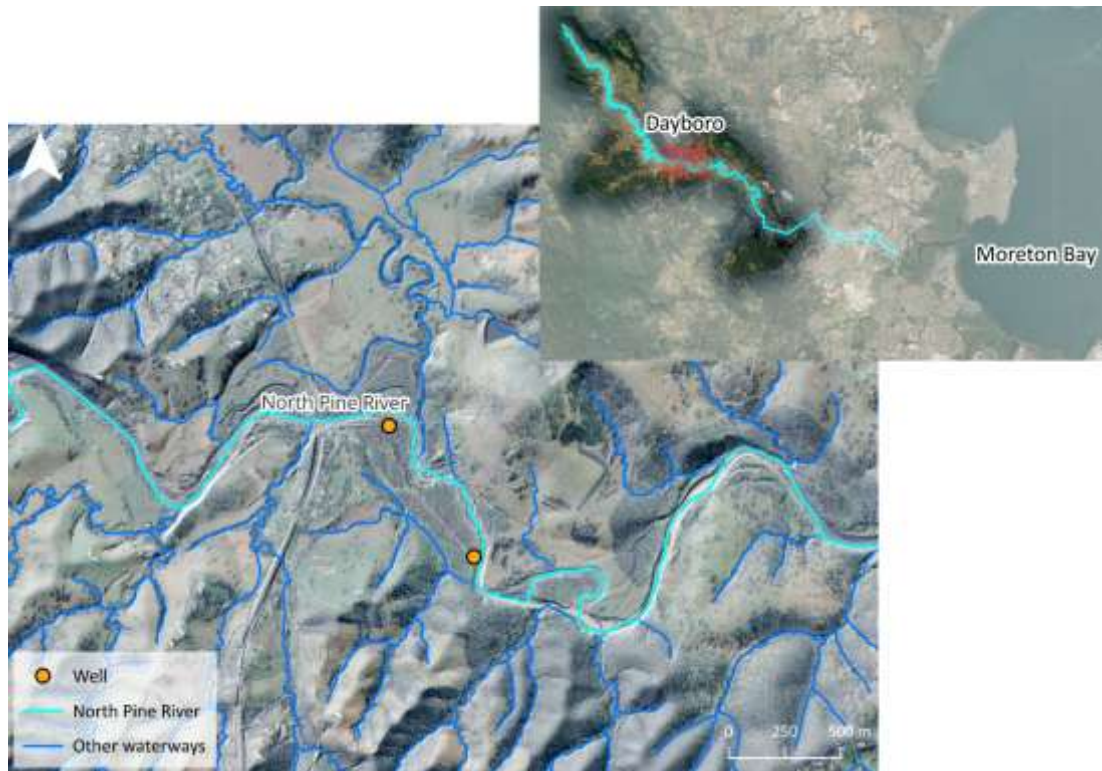
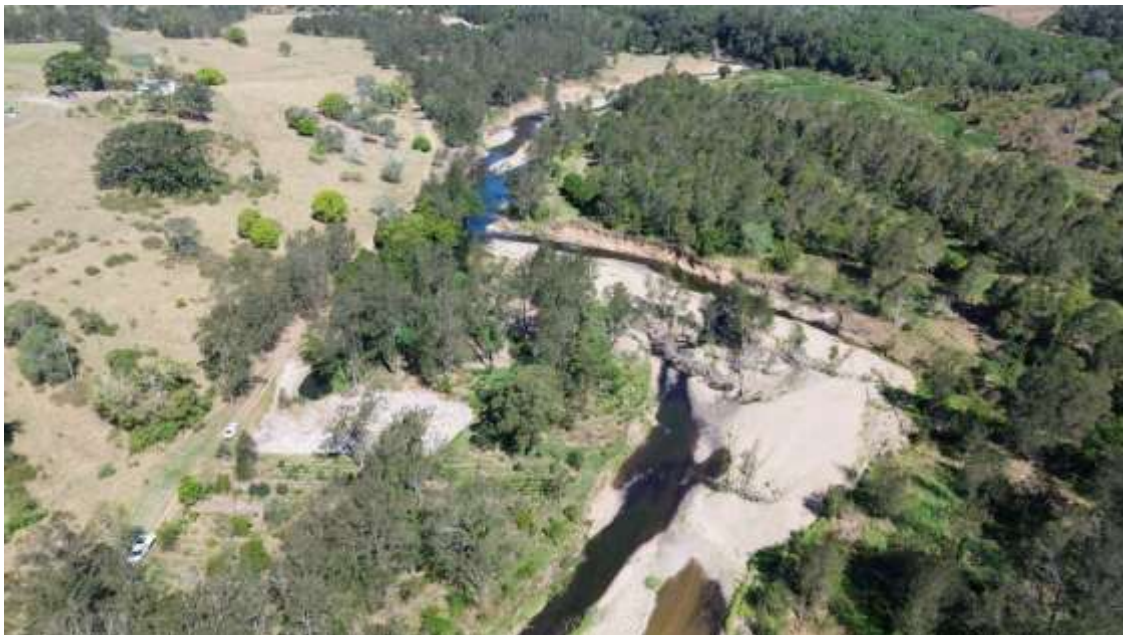
**Figure 1 (a) Study site extent, Dayboro Reach of the North Pine River, Queensland. (b) Dayboro study reach drone image**
