# **Environmental Response of Reconnecting Billabongs along the Yarra River**

Sarah Heard<sup>1</sup>, Simon Treadwell<sup>2</sup>, Sarah Gaskill<sup>3</sup>

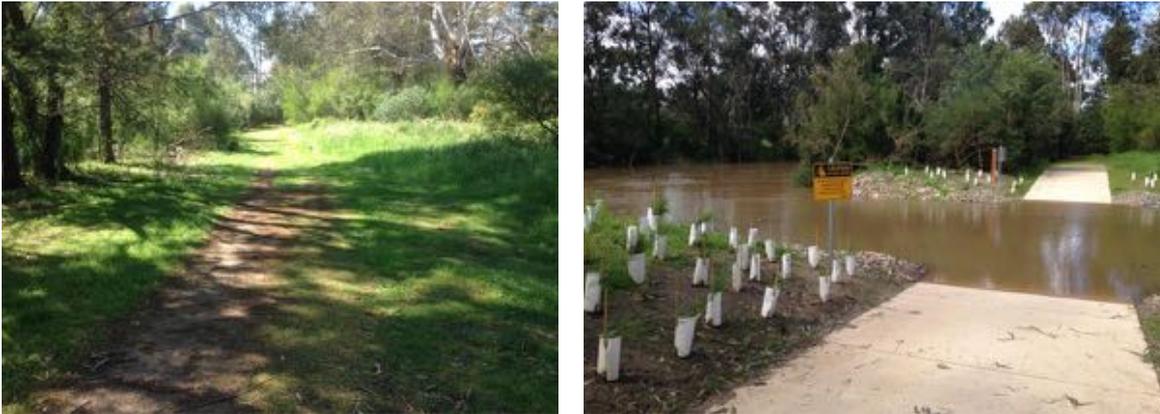
Figure 1. Spadoni's Reserve Billabong – Left: inlet prior to works. Right: works undertaken to lower the inlet level and the lowered inlet in operation.

In April 2016, Melbourne Water undertook the works to lower the inlet channel at Spadoni's Billabong. The lowered inlet channel is a grassed channel (up to 20 m wide), with rock embankments at the inlet and a low bank slope to facilitate foot traffic and vehicle access (Figure 1). Revegetation works were also undertaken at the inlet to help promote restoration of aquatic vegetation at the site.

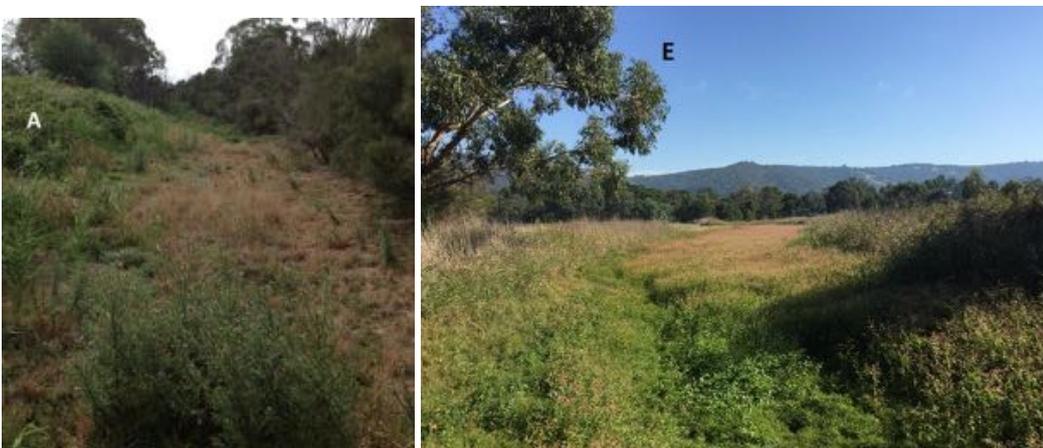
Figure 2. Spadoni's Reserve Billabong – vegetation response over time. A - January 2015 pre works,

**dominated by exotic species. E - April 2017 post works, increase in native vegetation**

Monitoring of the vegetation within Spadoni's Billabong has been undertaken yearly since the completion of works and has shown that the vegetation cover has greatly improved as a result of the inundation, changing from a predominantly non-native vegetation community to a predominantly native Aquatic Herbland community dominated by Slender Knotweed (*Persicaria decipiens*) and Lesser Joyweed (*Alternanthera denticulate*), and the exclusion of weeds such as Drain Sedge and Toowoomba Canary Grass, that were noted prior to the works being undertaken (Figure 2). The extent and condition of this community is likely to increase overtime with more inundation events. Common Reed on the boundaries of the billabong may creep into the Aquatic Herbland community in drier periods, but is expected to recede with frequent or prolonged inundation to maintain the boundary between the herbland and fringing swamp and floodplain communities.

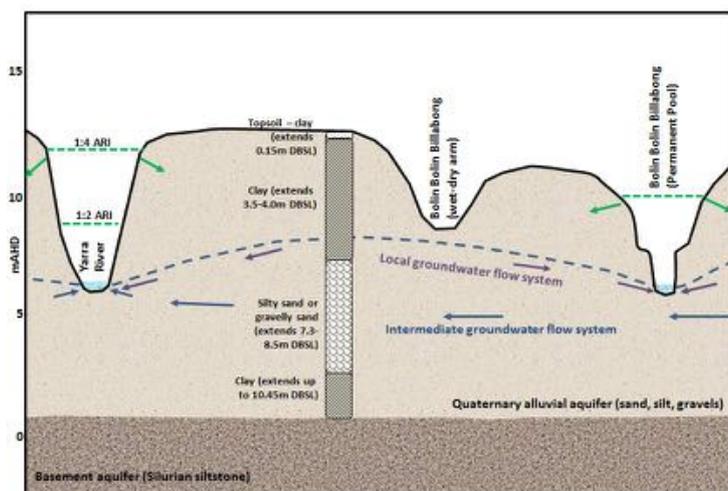
**Figure 3. Conceptual diagram of Bolin Bolin Billabong including stratigraphy.**

Stage 1 and Stage 2 of the framework were undertaken for Bolin Bolin Billabong and a number of uncertainties were identified including the stratigraphy of floodplain (i.e. varying gravel, sand, clay layers), seepage rates and billabong volume and how these may influence the delivery of an environmental watering solution at the billabong. If the source of the water that maintains the permanent pool is sub-surface flow from the Yarra River through the sand/ gravel lens beneath the billabong (Figure 3), there is potential that any environmental water delivered to the permanent pool may drain to the Yarra River through the lens (when the river height is below the water level in the pool). This sub-surface connection to the Yarra River would not have been an issue prior to the regulation of the river as the river water level was higher and therefore the river height would have always been above water level in the pool.

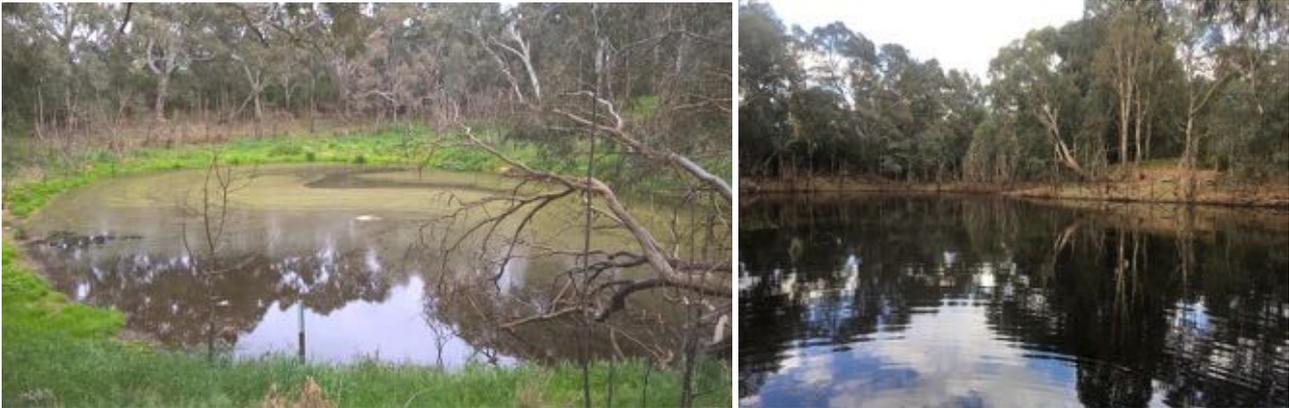
**Figure 4 Bolin Bolin Billabong pre and post environmental watering event (November, 2017). Left – permanent pool prior to watering. Right – permanent pool post watering.**

In October 2017, Melbourne Water undertook a trial watering event to investigate the uncertainty around the billabong substrate and seepage rates and to inform the development of a water regime delivery design (Stage 3 of framework). Water was pumped directly from the Yarra River at the natural inlet on the southern arm using around 70 ML of water from the Yarra's Environmental Entitlement. Monitoring was undertaken pre, during and post the watering event to monitor water levels and vegetation response in the billabong. Monitoring included vegetation assessment before and after, photopoints before, during and after, surface water and groundwater level monitoring and time lapse photography (Jacobs, 2018).

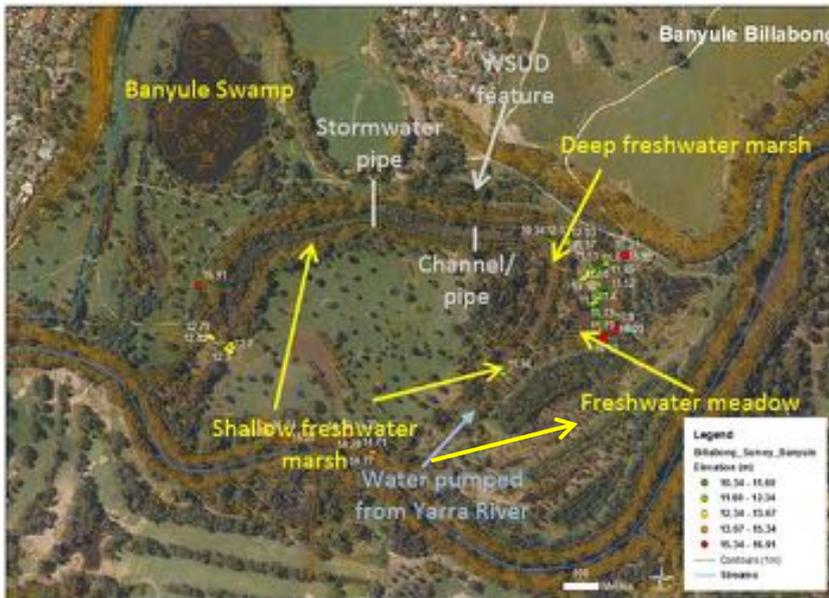
Figure 5. Banyule billabong zones – freshwater meadow and deep and shallow freshwater marsh

Banyule Billabong sits within the Yarra Valley Parklands at Banyule Flats, Heidelberg and is recognised as a priority area for fish, vegetation, frog and social values in Melbourne Water's Health Waterways Strategy. The billabong has a number of distinct zones (Figure 5). The main billabong (9.2 Ha) is comprised of two

different habitats, a deep freshwater marsh and a shallow freshwater marsh. It is typically inundated seasonally, but may dry out for extended periods every 4-5 years. A smaller associated billabong is located to the east of the main billabong (1.9 Ha) and comprises a freshwater meadow which is typically <0.3 m deep and inundated for <4 months/yr. Both billabongs are remnants of river channel migration across the Yarra River Floodplain. A lack of inundation from the Yarra River compared what would have occurred naturally is affecting a range of wetland values, such as the health and distribution of wetland vegetation (e.g. increased terrestrialisation of the billabong) (Jacobs, 2017).

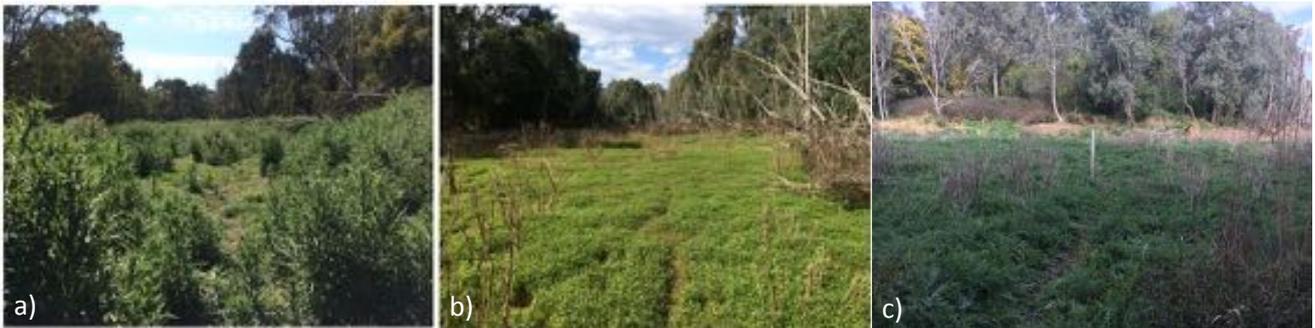
**Figure 6. Banyule Billabong Permanent photo monitoring points. a) November 2016 looking east, b) April 2017 looking east (Melbourne Water, 2017), c) September 2017 looking north.**

Prior to watering (December 2016), vegetation across the bed of the billabong was dominated by weeds, including Fat Hen (*Chenopodium album*) and Spear thistle (*Circaim vulgare*): 70-75% of the bed was covered by Spear Thistle (Melbourne Water, 2017, Figure 6a). Native species present prior to watering included Shrub Nettle (*Urtica incisa*), Lesser Joyweed (*Alternanthera denticulate*), Tall Sedge (*Carex appressa*) and Pale Rush (*Juncus pallidus*). Post watering (April 2017), the native Knot Weed, (*Persicaria* sp.) became dominant with overall weed coverage reduced to <1% cover (Figure 6b). However, more recent observations December 2017 (Figure 6c) show that the weed coverage has returned to a level comparable to that observed prior to the watering. A key learning for the delivery of environmental water for these sites is that a follow up inundation event or targeted weed control after watering may be required to prevent recolonisation by weeds. Similar to Spadoni’s Billabong, other ecological responses observed by Melbourne Water and community members as a result of the trial watering included an increase in frogs and birdlife at the billabong.

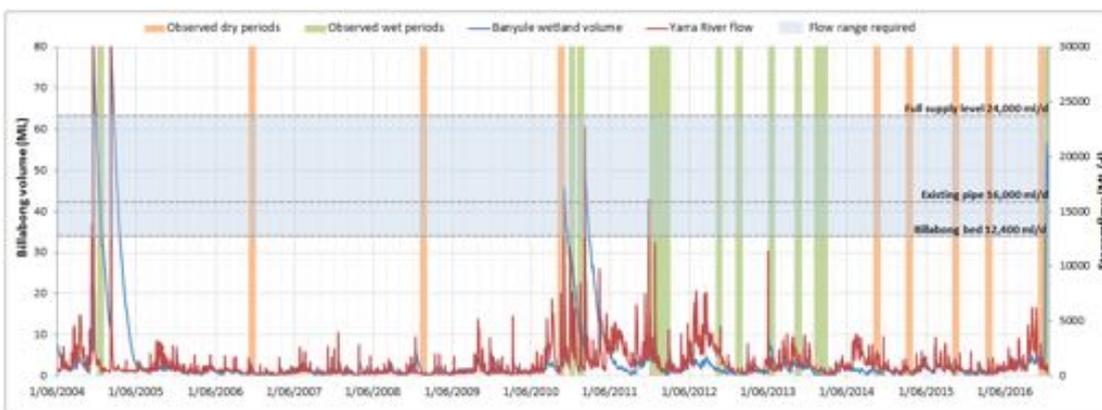
**Figure 7. Banyule billabong – modelled volume of water in the billabong (blue line), Yarra River streamflow (red line), and aerial imagery and historical observations showing wet or dry conditions (orange and green shading).**

Under current conditions, water commences to enter the billabong through a pipe buried in the river bank when flow in the Yarra River reaches 16,000 ML/d (11.4 m AHD). Overbank flow then enters the billabong when flow reaches approximately 24,000 ML/d (12.2 m AHD). The deepest part of the billabong is at 11.0 m AHD (~12,400 ML/d). Hence, if the inlet to the billabong was lowered in an attempt to increase the frequency of duration of inundation the lowest that level could be is 11.0 m AHD. An analysis of the flow regime in the Yarra River suggests that flow in this range (12,400 ML/d to 24,000 ML/d) is significantly higher than is currently experienced in the Yarra River and therefore there is limited opportunity to lower the inlet to the billabong to increase the frequency of inundation (Figure 7).
